**SUBJECT:** FASTENER ADJUSTMENT FOR THROTTLE WIRE**VEHICLE(S) AFFECTED:** MY2023 CFMOTO Ibex 800 Motorcycles (850 Total Affected VINs)**ISSUED:** August 21, 2024

CFMOTO-USA is issuing **MANDATORY Safety Bulletin SAF-2024-03**, requiring dealers to adjust the problematic configuration of throttle wire fasteners on their sold and unsold inventory of all affected MY23 Ibex 800 motorcycles.

NHTSA Recall 24V-609

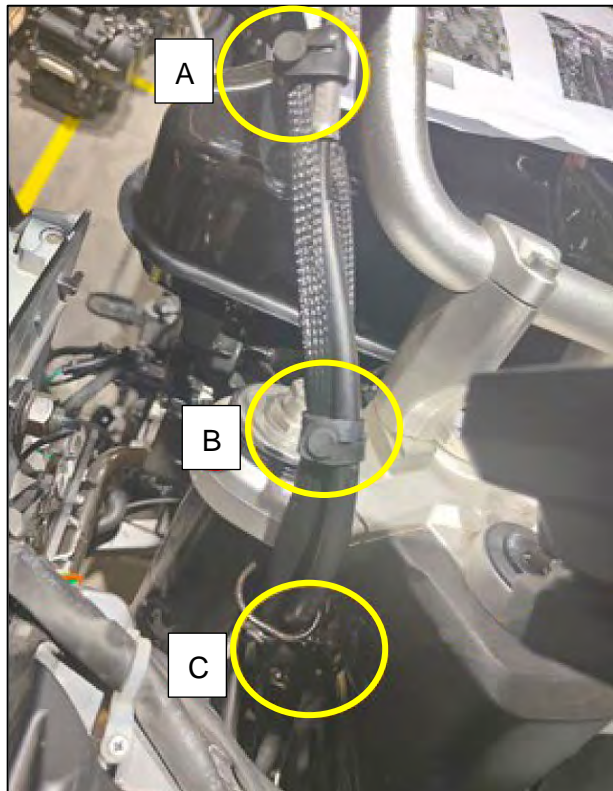
The electronic throttle assembly wire on some model year 2023 Ibex 800 motorcycles may break, resulting in a loss of throttle response, limited engine RPM, or engine stalling. CFMOTO has determined the wire breaks are due to a configuration of 3 clasps that make the throttle wire bend excessively during steering maneuvers.

1. Locate the throttle wire and the 3 rubber clasps shown. Turn the handlebars to the left and right, and note for reference how the throttle wire bends with this configuration of clasps.
2. Remove and discard rubber clasp 'B'.

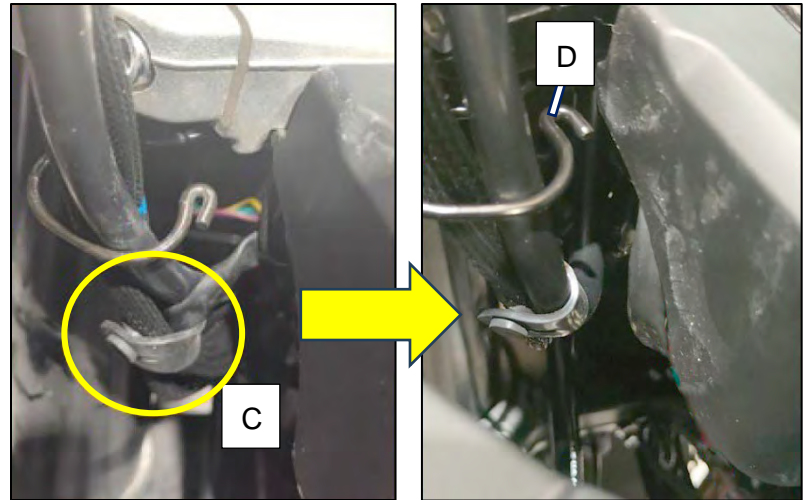
3. Undo rubber clasp 'C' and remove the throttle wire from it. Then redo the clasp.

**NOTE:** The throttle wire and other cables clasped together should remain within retaining bracket (D).

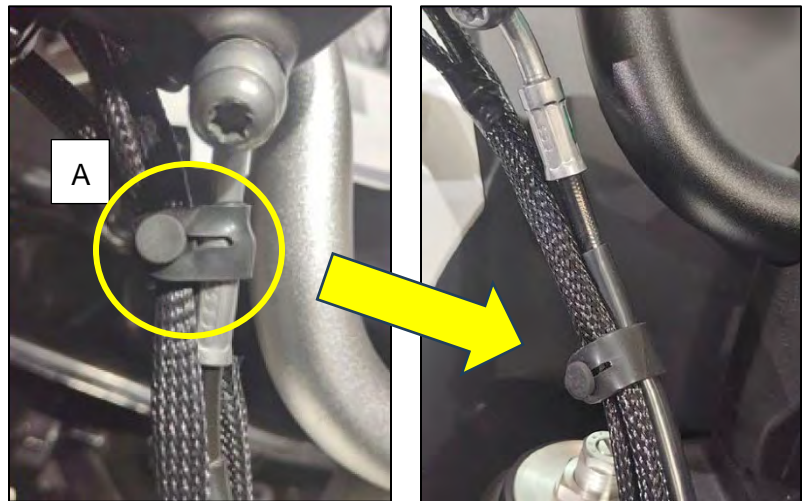
4. Move rubber clasp 'A' down approximately 1.5 to 2.5 inches to the position shown.

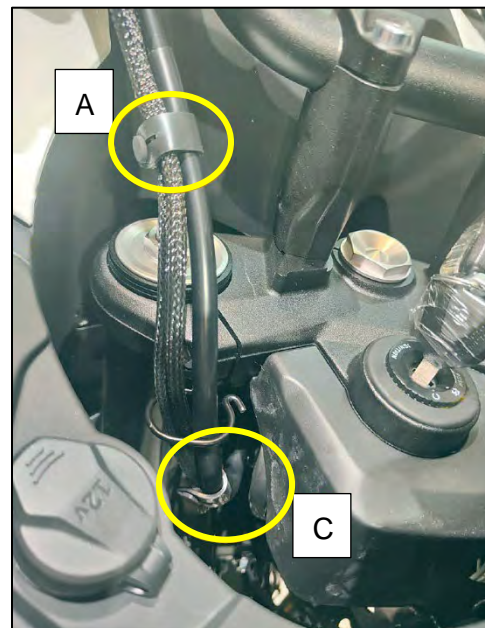
5. Turn the handlebars to the left and right, and check for excessive bending of the throttle wire. If necessary, adjust rubber clasp 'A' to lessen bending.
