Recall Campaign Bulletin

Campaign No. 2024090009, September 2024

SUBJECT: **Model G-Class (463 platform)**
Model Year 2019 – 2023

Function of the Rear Door Lock

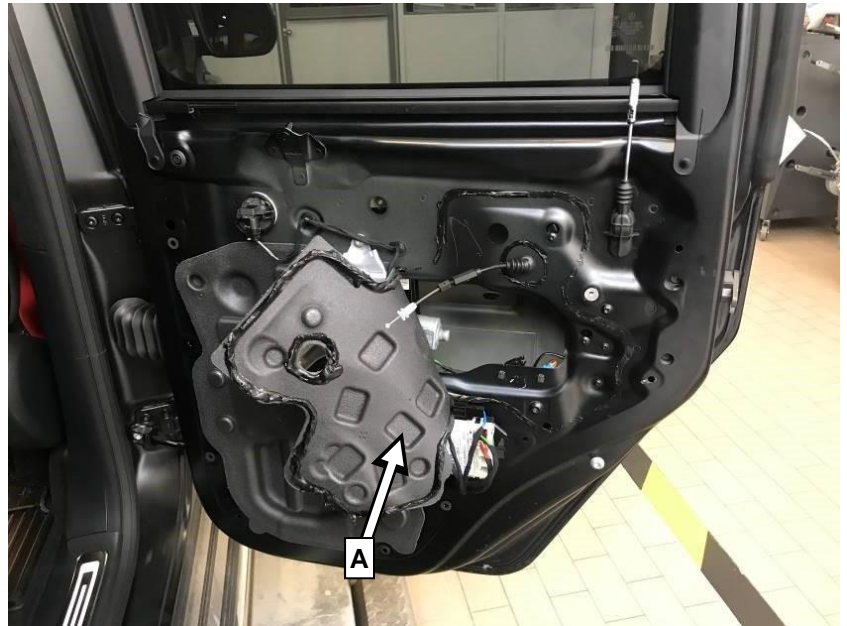
Figure 1

2. **Carefully** pull off the door foam membrane (Figure 1, A) from the rear door as shown.

i The door foam membrane does not need to be fully removed and will be reused!

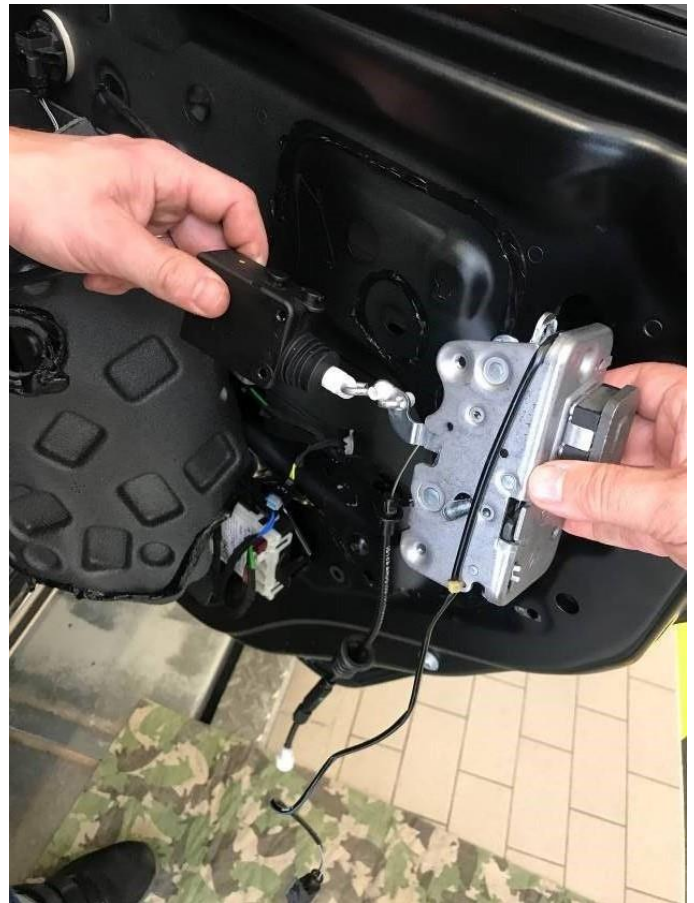
Figure 2

4. Assemble complete unit consisting of door lock, central locking actuator motor with release cable, and door handle (Figure 2) and insert into door for assembly.

5. Assemble in reverse order.
