IMPORTANT SAFETY RECALL

NHTSA Recall # 24V-036 Transport Canada Recall # 2024-024 Tiffin Recall # TIF-135

Villa Driver's Seat Pedestal Weld

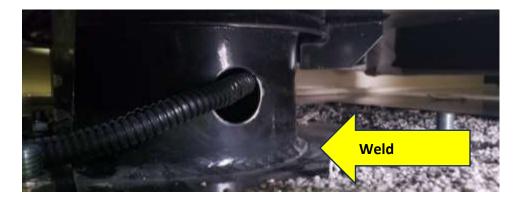
Owners may visually check the weld of the driver's seat to see if it is present or missing. A picture of a completely welded seat pedestal is below. If the pedestal of your driver's seat is welded, a picture can be emailed to Tiffin Motorhomes so that the recall can be cleared from the motorhome. Please email the picture to recalls@tiffinmotorhomes.com along with the last 8 digits of your motorhome.

Tiffin Motorhomes will have the driver's seat pedestal weld checked and if a missing weld is found, the pedestal on the driver's seat will be replaced.
