81B/NHTSA 24V-512

IMPORTANT SAFETY RECALL

Tire Certification Label

SAFETY RECALL 81B - TIRE CERTIFICATION LABEL OWNER INSTRUCTIONS

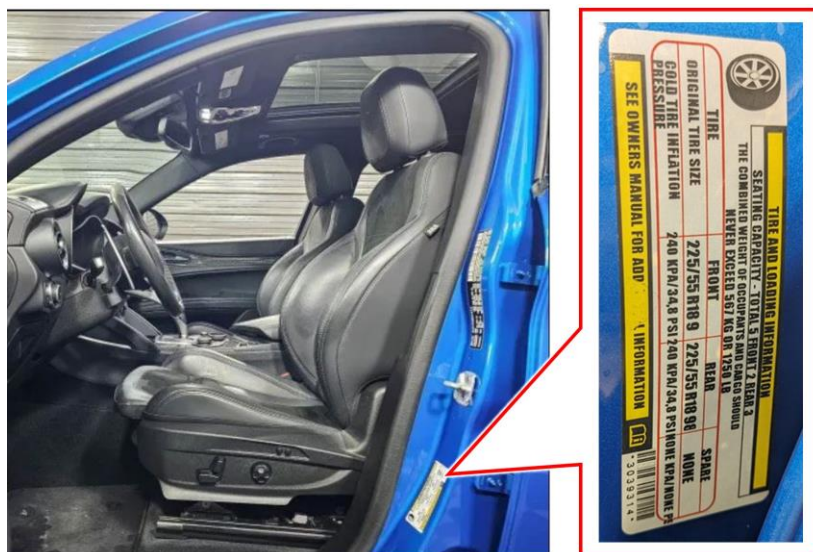
Figure 1 – Tire Placard Label Location

1. A **NEW** tire placard overlay label is enclosed with this letter for your vehicle.
 - If you believe you received an incorrect label, please contact your dealer.
2. Open the driver door then locate the tire placard label on the vehicle driver side B-pillar (Figure 1).

3. Use a heat gun or hair dryer to soften the label adhesive.

5. Peel the label slowly at a 45-degree angle to remove the label.
6. Using isopropyl alcohol and a clean cloth, remove all adhesive residue from the surface where the label was applied. Allow the alcohol to evaporate before applying the new label.
7. Remove the **NEW** label from the paper backing.
8. Apply the **NEW** label to the driver side B-pillar surface, in the original position, with the same text orientation.
9. Apply pressure to the entire surface of the label with firm overlapping strokes removing all wrinkles and air bubbles. Using a tool such as a squeegee is allowed.
