IMPORTANT SAFETY RECALL

NHTSA Recall Number: 24V821

Altec Identifier: CSN-3194

Outrigger Shoe Inspection

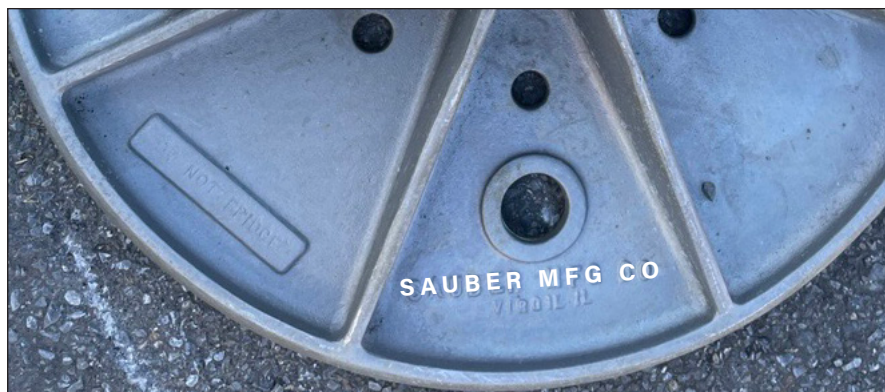
Figure 1 — Outrigger Shoe Manufacturer (Sauber Shown, Text Enhanced)

- Inspect each outrigger shoe to determine if it was manufactured by Sauber (refer to Figure 1). Record the results in the Inspection Table — Parts Only. Only complete the rows that match the number of shoes you ordered. For example, if your order was for 5 outrigger shoes, only complete the rows for Shoe 1 through Shoe 5.
 - If all outrigger shoes were manufactured by Sauber, no action is required. Proceed to step 3.
 - If any outrigger shoe was not manufactured by Sauber, further inspection is required. Proceed to step 2.

3. Inspect each outrigger shoe to determine if it was manufactured by Sauber. Record the results in the Inspection Table — Outrigger Shoe Installed.
 - If all outrigger shoes were manufactured by Sauber, no repair is required. Proceed to step 7.
 - If any outrigger shoe was not manufactured by Sauber, further inspection is required. Proceed to step 4.

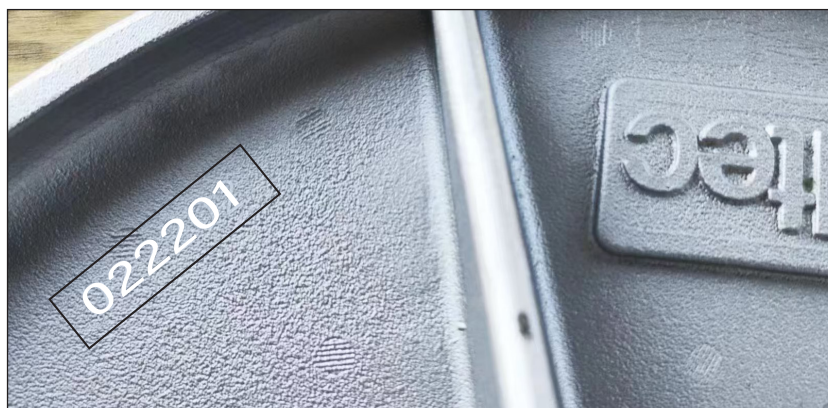
Figure 2 — Outrigger Shoe Serial Number (Text Enhanced)

- Confirm the outrigger shoe serial number (refer to Figure 2).
 - If any outrigger shoe serial number is 022201, the shoe must be replaced.
 - If all outrigger shoes are not serial number 022201, no action is required.
- Use the QR Code to submit your inspection results.
 - Altec will provide additional guidance.
 - Do not complete the remaining steps in this procedure.

4. At the street side rear outrigger, confirm if the outrigger shoe serial number is a match to 022201 (refer to Figure 2). Use soap and water to clean the outrigger shoe, if necessary. Record the results in the Inspection Results table.
