Safety Recall: 2022 Civic Seat Weight Sensor (DTC U3000-49)

BACKGROUND

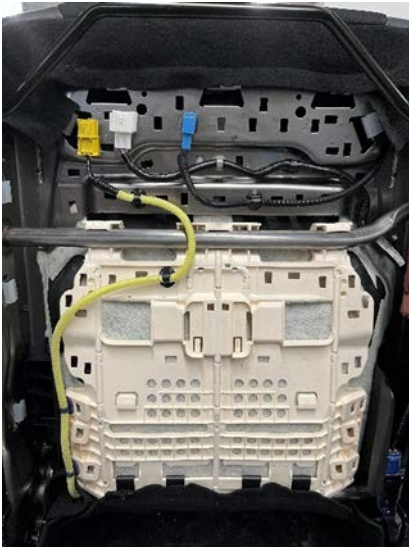
3. Disconnect all connectors,

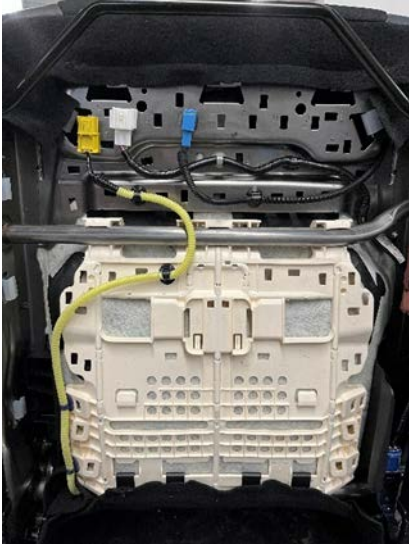
4. Carefully remove the seat from the vehicle and place it on a clean and suitable work area.
5. Carefully lay the seat on the seatback and take a photo of the wire harness layout for future reference.

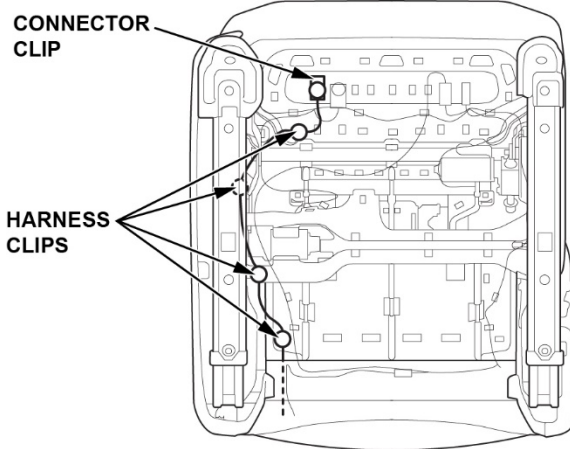
11. Remove the side airbag harness from the seat cushion frame.

- Remove the harness clips and the connector clip.

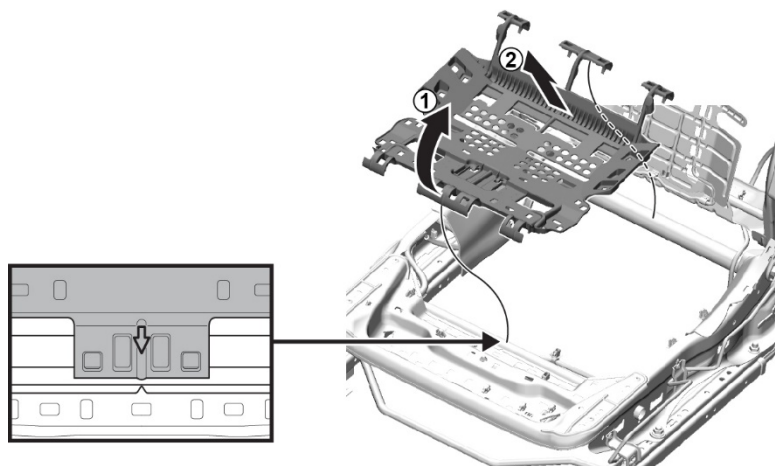
14. Remove the seat cushion spring.

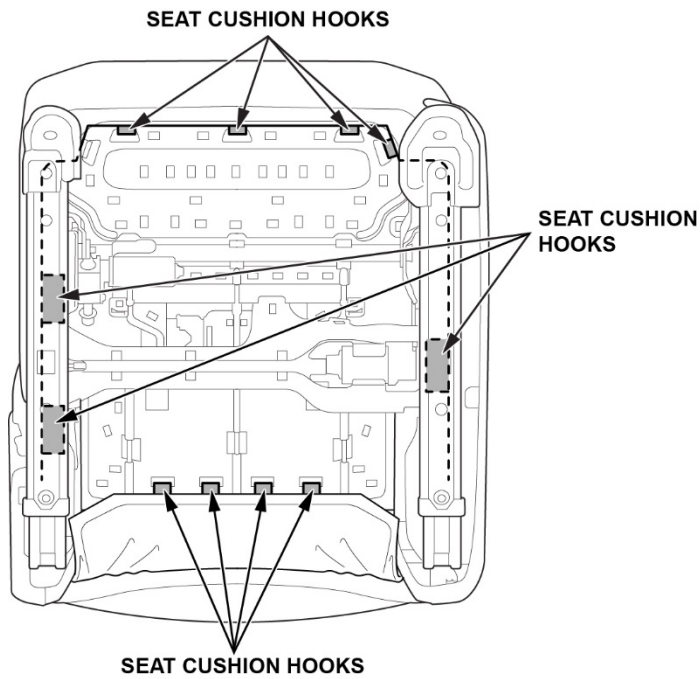
14. Remove the remaining seat cushion hooks.
