Safety Recall: 2020 TLX Seat Weight Sensor (DTC U3000-49)

Supersedes 24-017, dated October 8, 2024, to revise the information.

Affected vehicles may be equipped with seat weight sensors that are not built to proper specifications. Improperly built sensors could lead to cracking and/or a short circuit of the sensor, resulting in the illumination of the SRS warning light and the passenger airbag indicator remaining OFF. In certain collisions, these seat weight sensors may cause improper deployment of the front passenger airbags, increasing the risk of injury.

Replace the seat weight sensors.

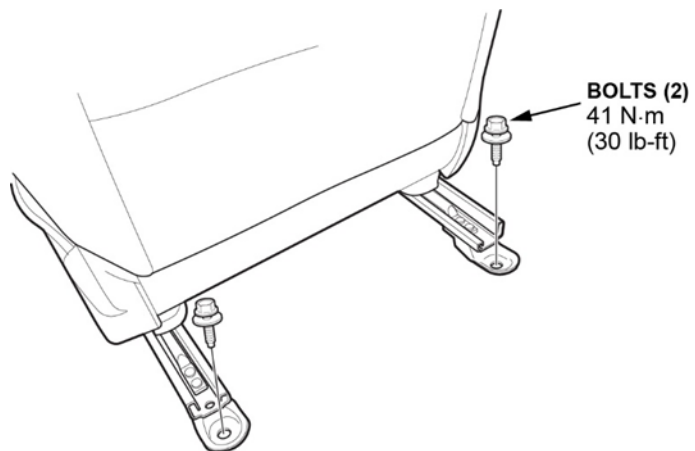
4. Remove the rear bolts of the front passenger's seat.

- **Thigh Support Only:** Slide the thigh support all the way forward.
- **8-way Power Seat Only:** Raise the front seat all the way up.

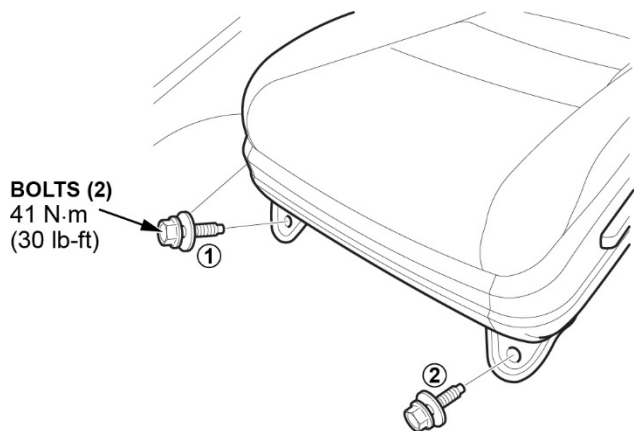
5. Slide the seat all the way back and remove the front passenger's seat mounting bolts.

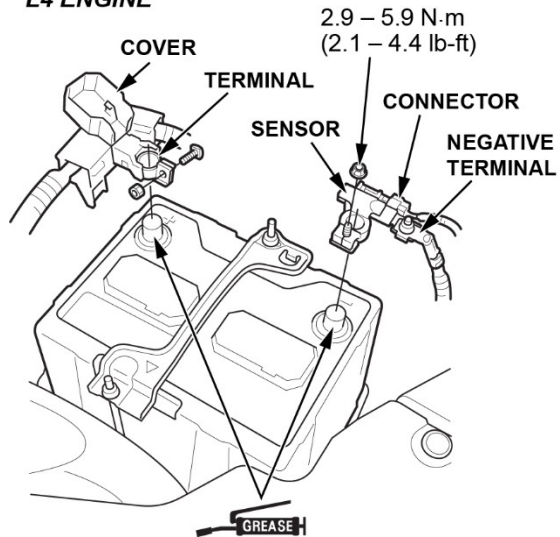
L4 ENGINE

6. Disconnect and isolate the negative cable with the 12-volt battery sensor from the 12-volt battery **2.9—5.9 N·m (2.1—4.4 lb-ft)**.

- Always disconnect the negative side first.
- To protect the 12-volt battery sensor connector from damage, do not hold it when removing the negative terminal.
- Do not disconnect the 12-volt battery sensor from the negative terminal.
- Wait at least **3 minutes** before starting work.

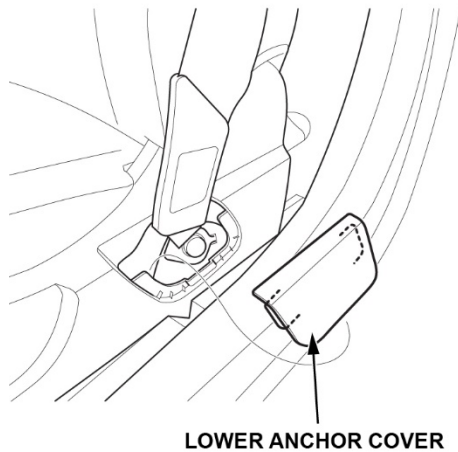
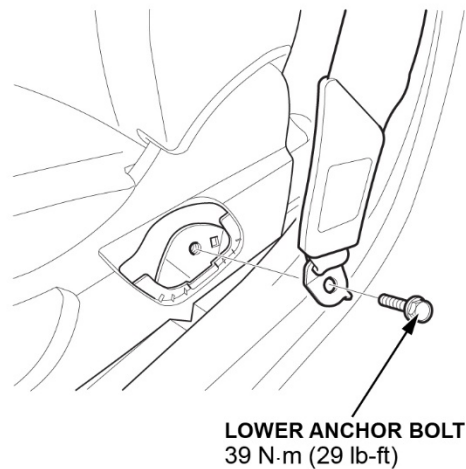
LEFT SIDE SHOWN

7. Remove the front seat belt lower anchor cover and the lower anchor bolt.

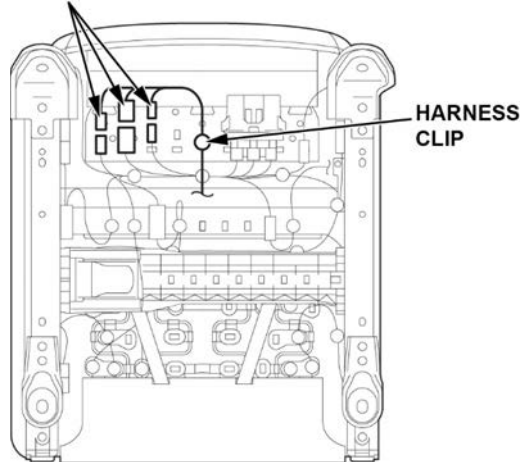
CONNECTORS

9. Lift up the front seat, then remove these items:

1. Remove the harness clip.

2. Disconnect the connector.
3. Remove the head restraint.
4. With the help of an assistant, carefully remove the front seat through the front door.

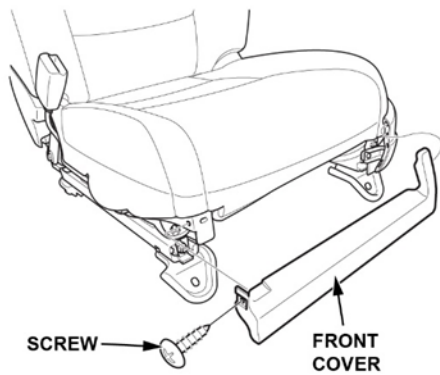
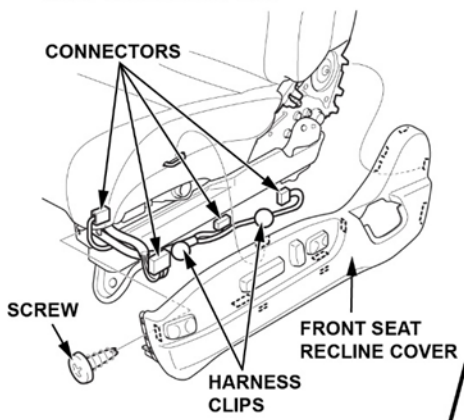
WITH THIGH SUPPORT

10. Remove the passenger's front seat front cover and front seat recline cover.

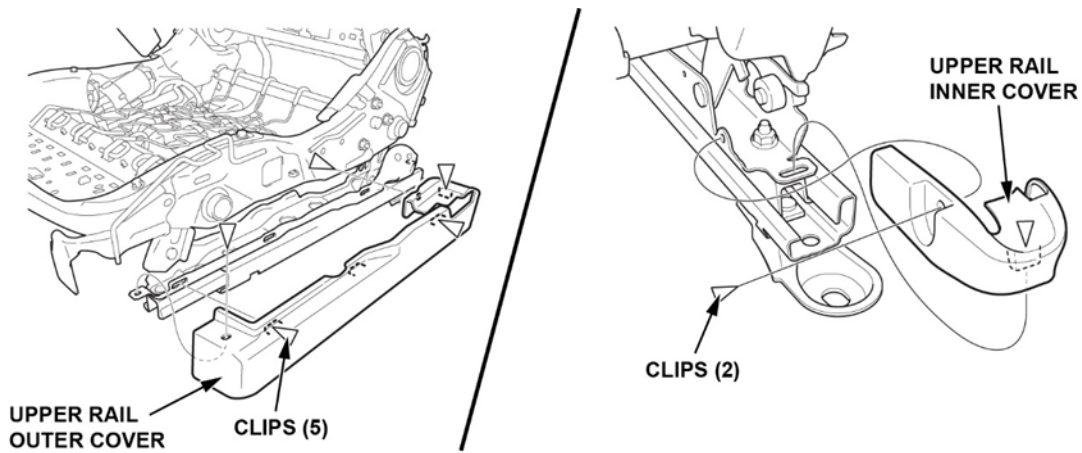
11. Remove the front seat frame upper inner and outer rail covers.

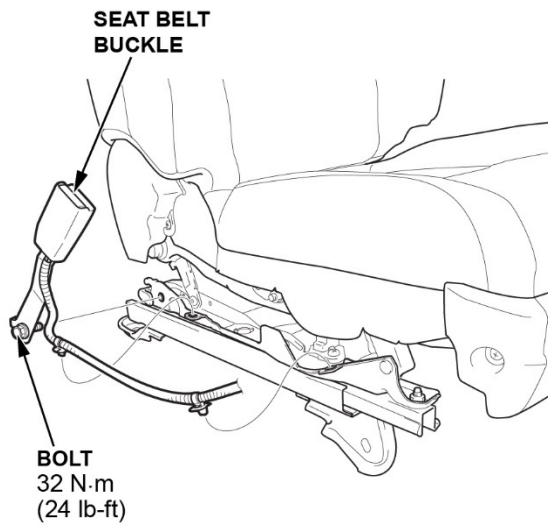
12. Remove the seat belt buckle.

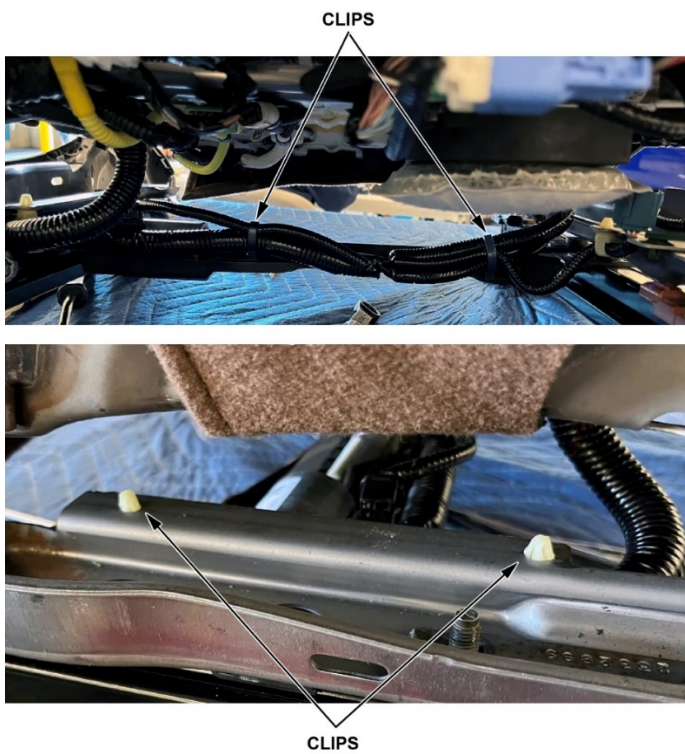
13. Disconnect the seat harness and then remove the 4 clips.

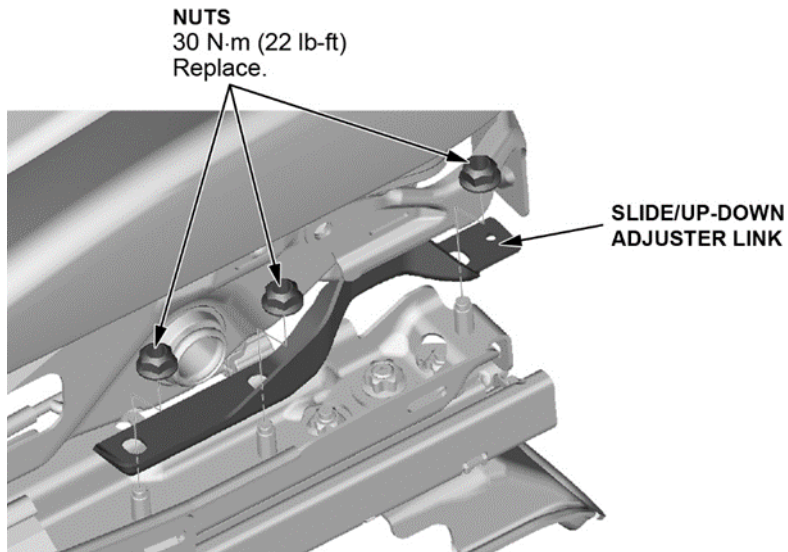
14. Remove the nuts, then remove the front passenger's seat side/up-down adjuster link.

NOTE: Discard the nuts after removal.

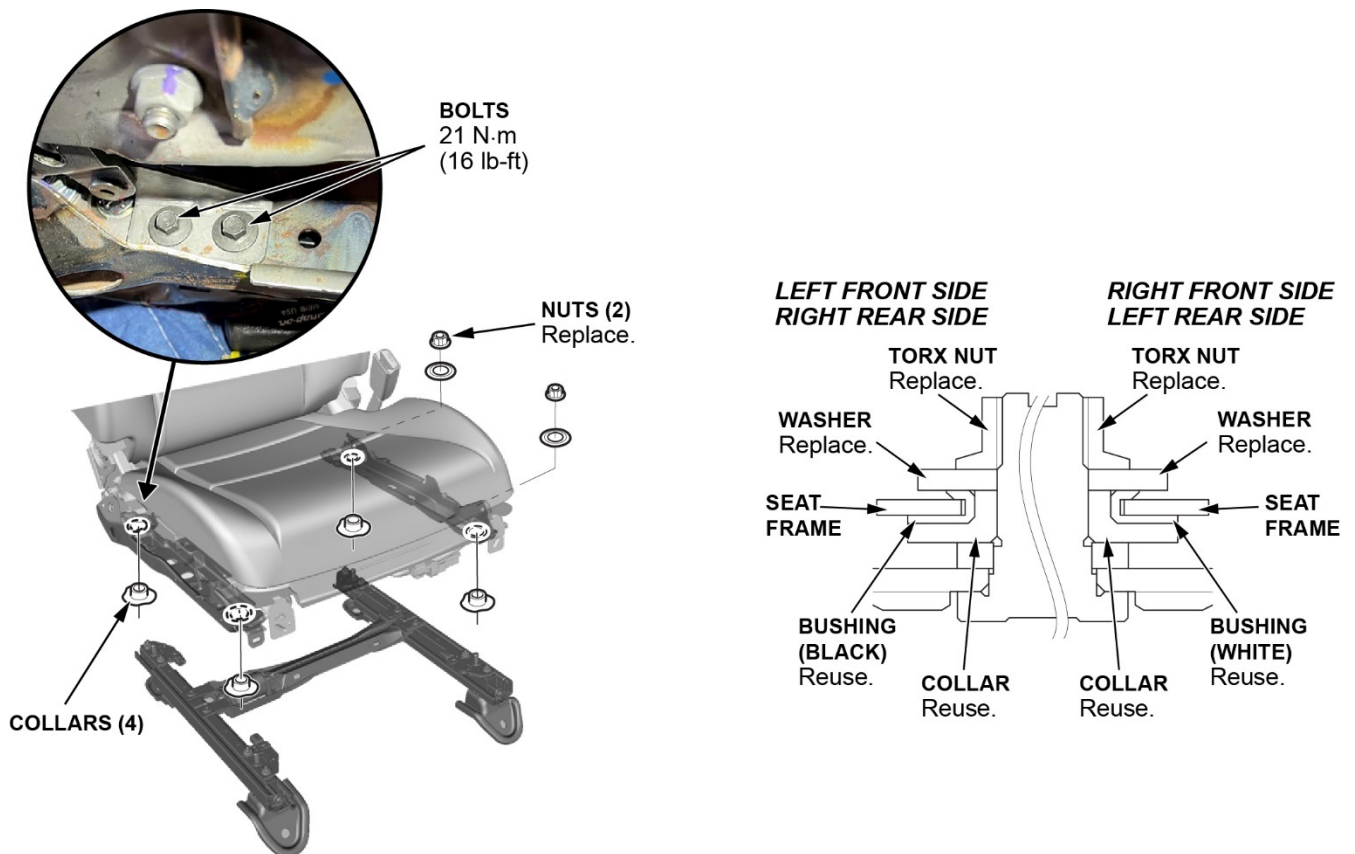
15. Remove the two bolts from the seat bracket and the two nuts, then remove the front passenger's seat rail as an assembly.

NOTE: Note the color and location of the collars and the bushings during disassembly.

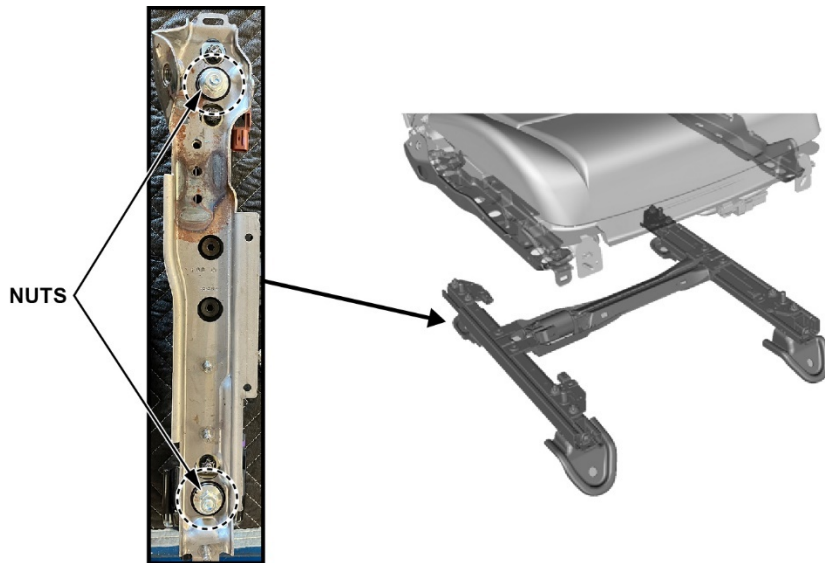
16. Remove the right top bracket from the seat rail.

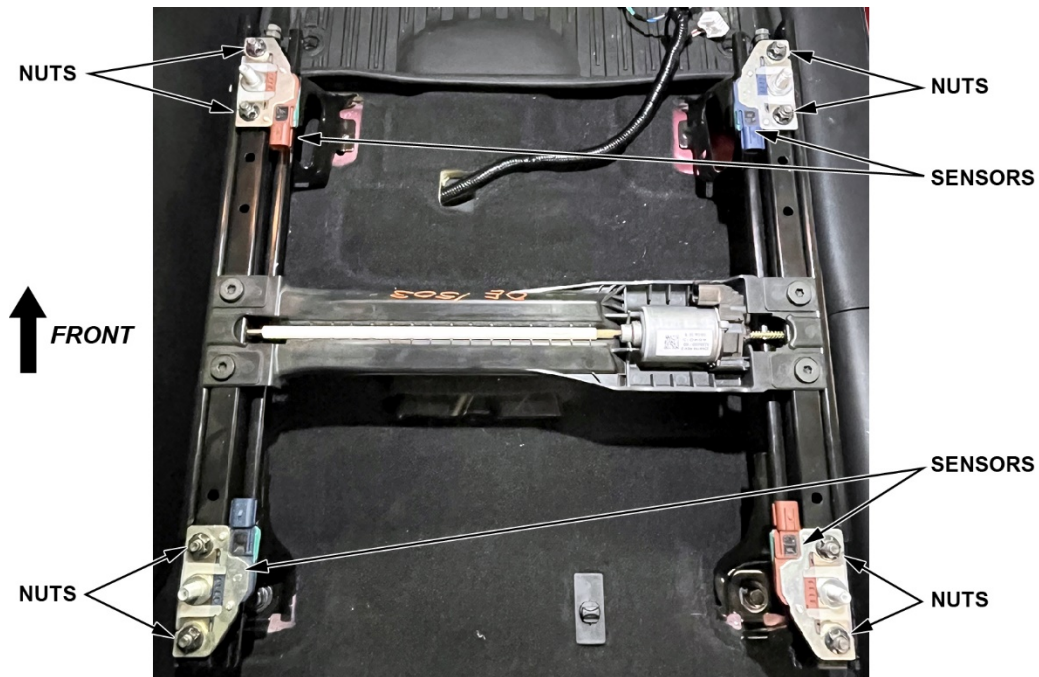
17. Mount the seat rail in the vehicle with the bolts and remove the 4 seat weight sensors, then discard the nuts and sensors.

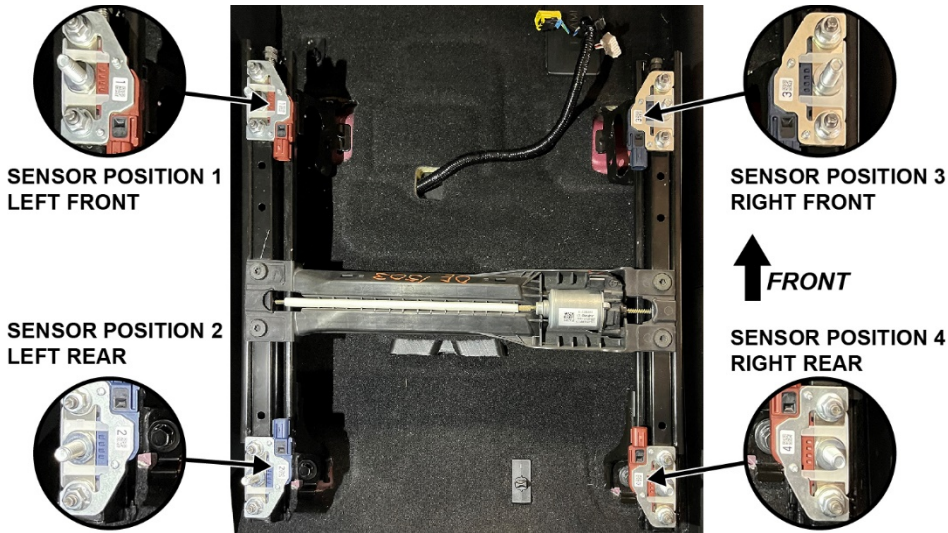
18. Install the new sensors and nuts in the orientation shown.

NOTE: The new sensors have a number for installation in the correct location.

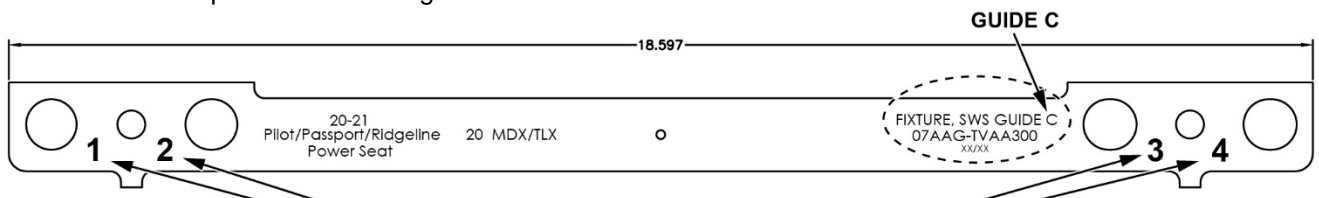
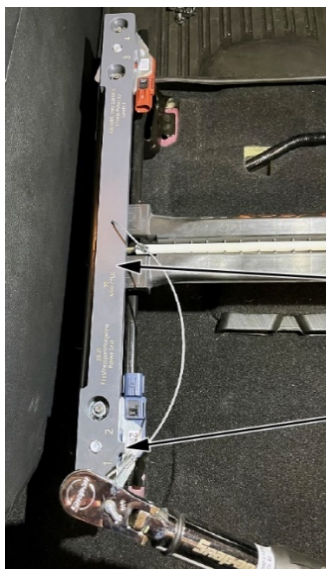
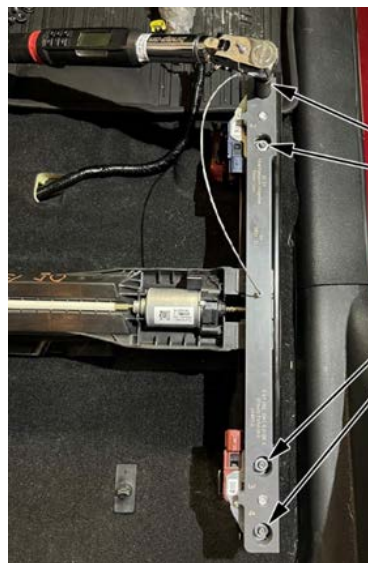
TORQUE SEQUENCE

19. Place the **SWS Fixture Guide C** onto the new seat weight sensors with the tabs located on the inside of the seat track. Using the guide properly seated on the new sensors and torque the nuts to **35 N·m (26 lb-ft)** in the order shown on the SWS Fixture Guide.

NOTE: Use the socket provided with the guide.

SWS FIXTURE GUIDE

TABS
Tabs located
to the inside.

8mm NUTS
35 N·m (26 lb-ft)

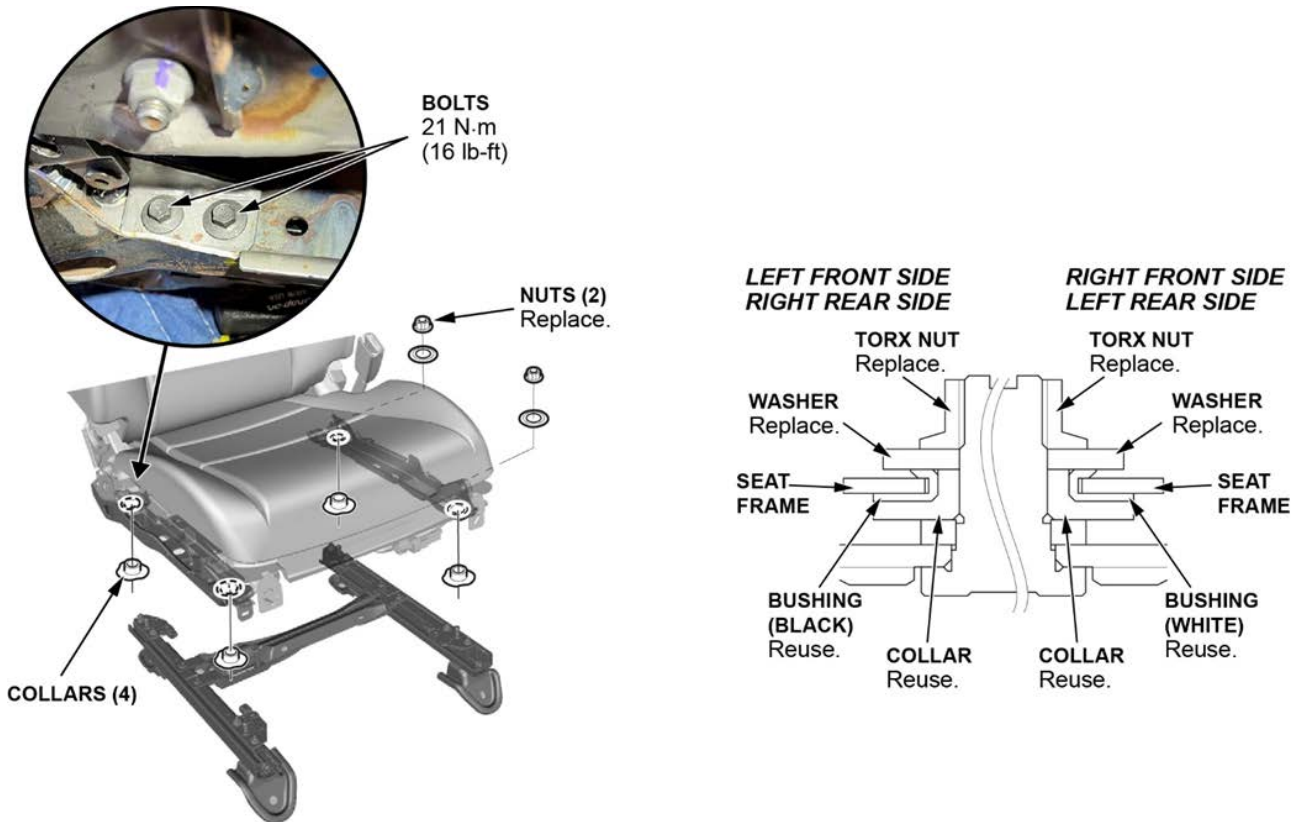
20. Remove the rail from the vehicle. Install the front passenger's seat rail back onto the seat frame, loosely install the new nuts and bolts, and reinstall all parts.

NOTE: The bushings and collars can be identified by their color. Make sure to install the bushings and collars as shown.

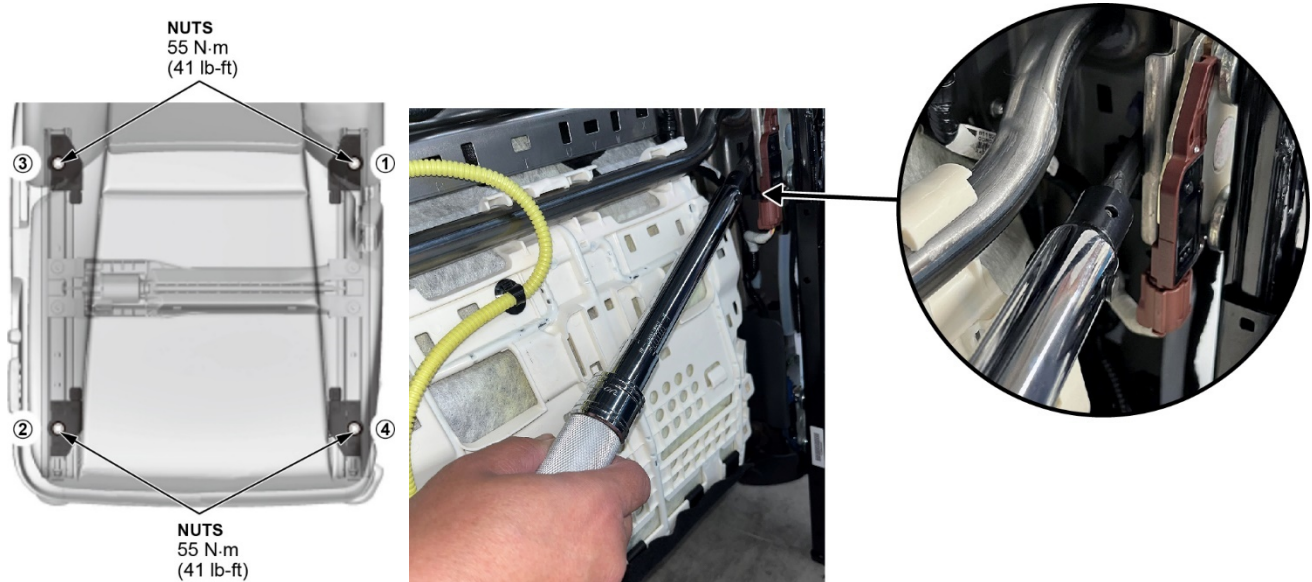
21. Torque the nuts to **55 N-m (41 lb-ft)**.

NOTE: Use the Snap-On Torque Wrench (07AAA-TVAA400) and the 16mm box-end head to tighten the seat rail nuts.

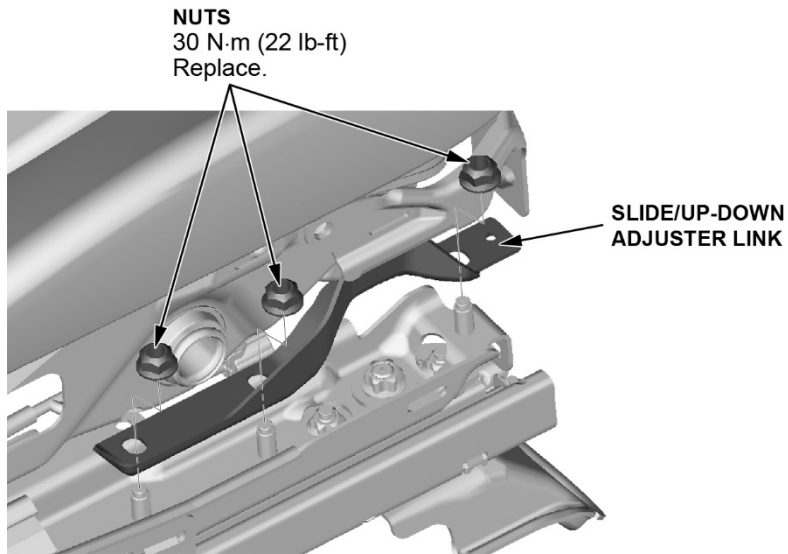
22. Install the nuts to the slide/up-down adjuster link and torque to **30 N·m (22 lb-ft)**.

NOTE: The replacement nuts are silver.

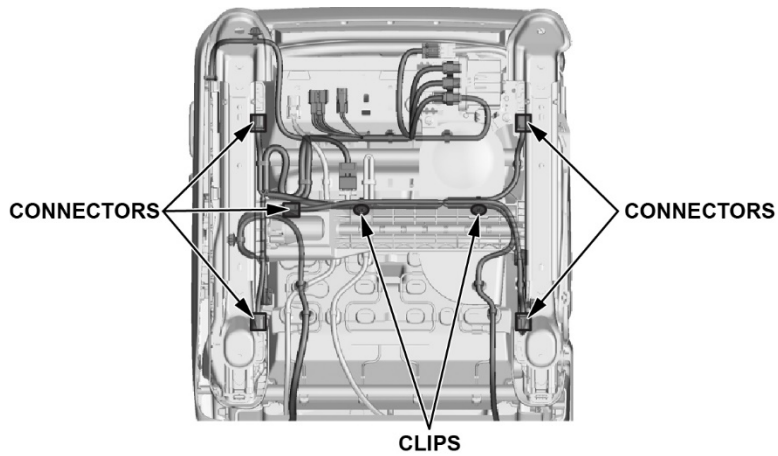
23. Connect the connectors and the clips.

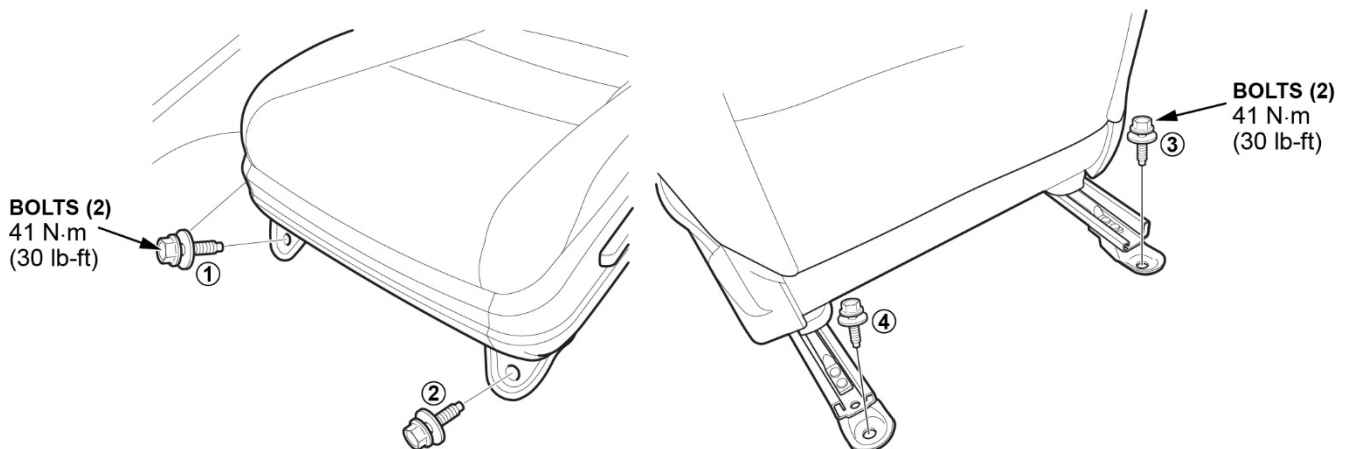
24. Install all remaining parts in the reverse order of removal.

NOTE: When installing the seat, tighten the bolts by hand first, then tighten them to the specified torque in the sequence shown.

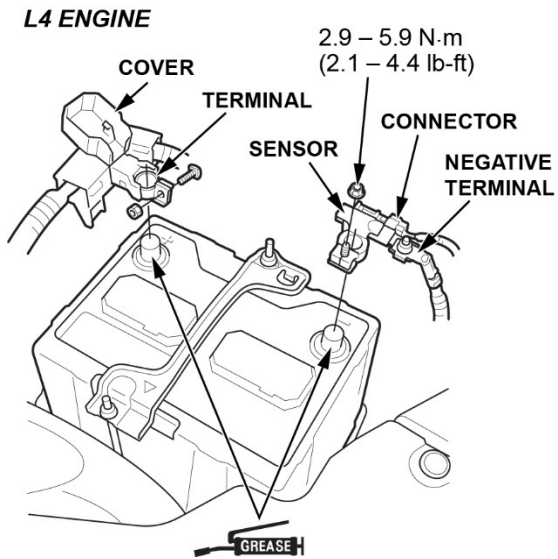
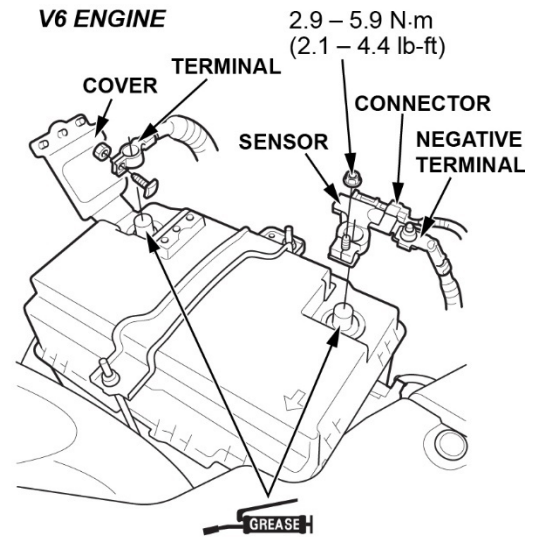
25. Connect the negative cable and the 12-volt battery sensor to the 12-volt battery.

NOTE: To protect the 12-volt battery sensor connector from damage, do not hold it when installing the negative terminal.
