March 8, 2024

Version 1

Safety Recall: 2020-22 Multi-Model Seat Weight Sensor (DTC 3000-49)**AFFECTED VEHICLES**

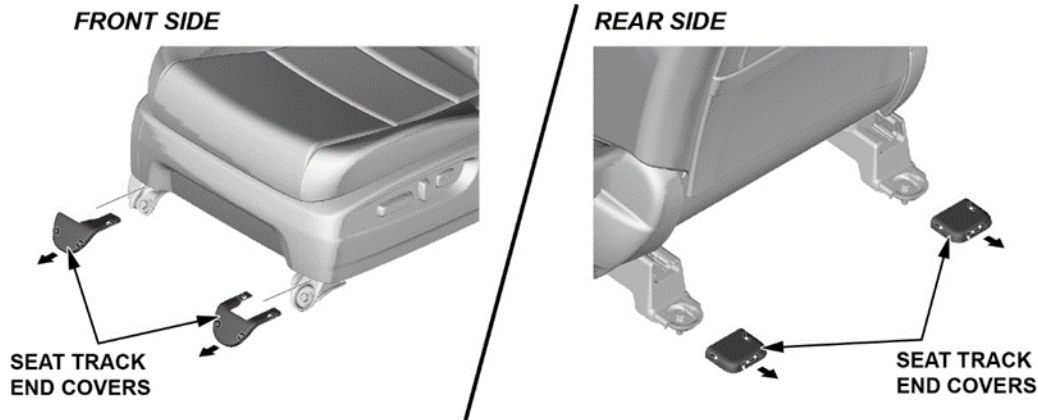
1. Check for the SRS airbag light on the dash.
2. If the airbag light is on, connect the HDS to the vehicle. Do an ALL DTC check.
3. If DTC U3000-49 is present, continue to step 4.
If DTCs other than U3000-49 are found, this service bulletin does not apply. Continue with normal troubleshooting.
4. Remove passenger seat foot covers and seat mounting bolts.

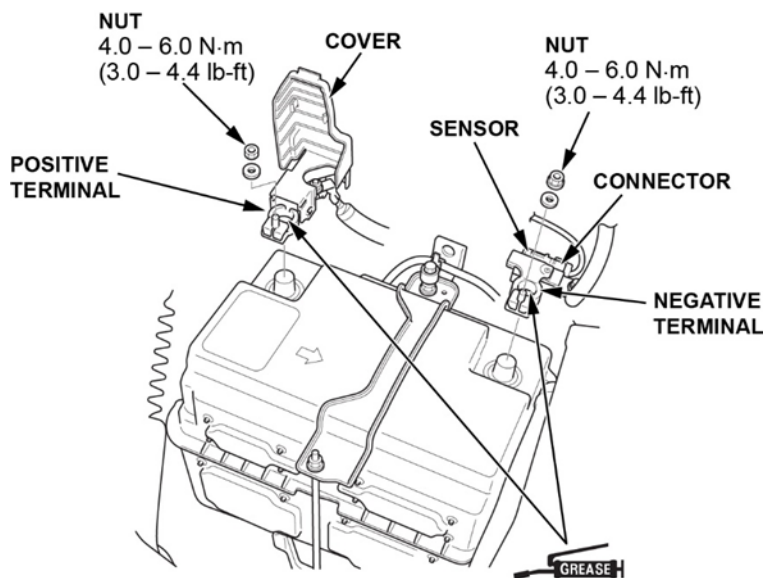
11. Disconnect the negative terminal of the 12-volt battery.

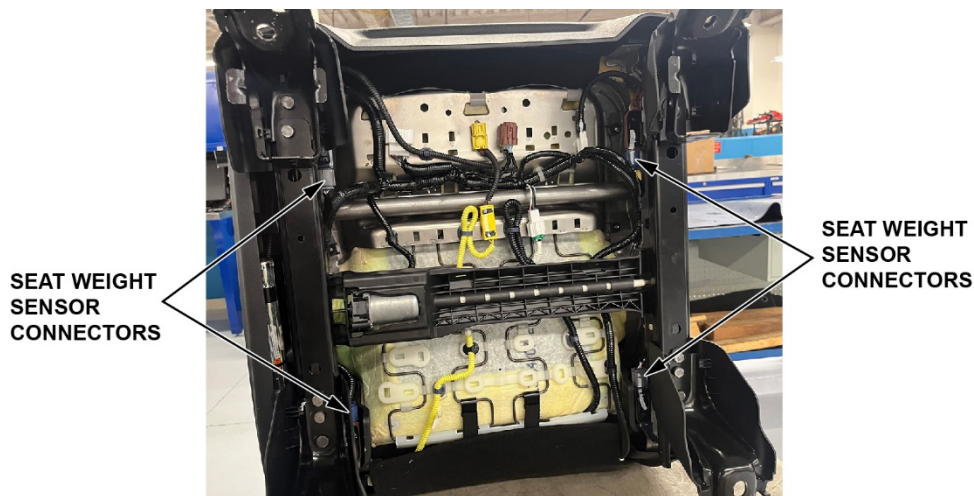
12. Tilt the seat back and disconnect the seat weight sensor connectors from the seat harness.

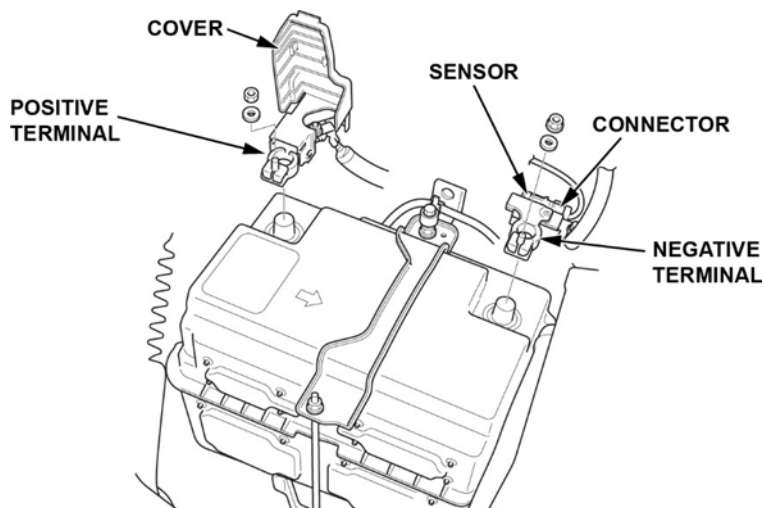
1. Disconnect the negative terminal of the 12-volt battery.

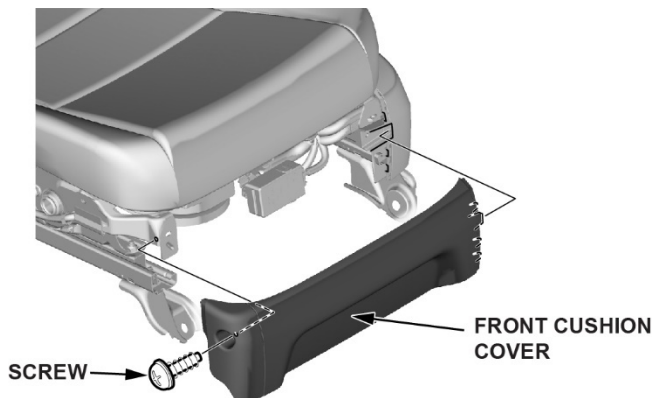
3. Lift the seat and disconnect any remaining connectors.
4. Remove the passenger's seat and place it on a clean, flat surface.
5. **With Power Seat:** Remove the front cushion cover.

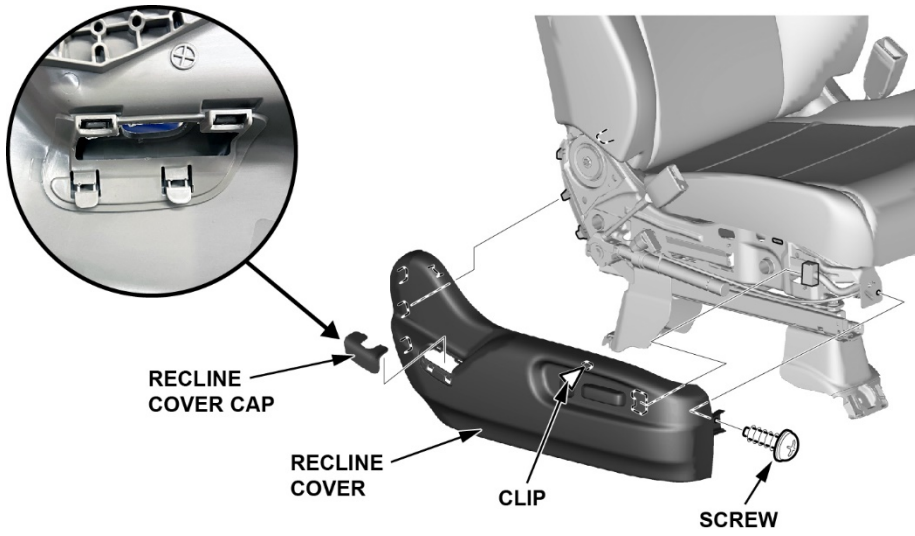
6. **With Power Seat:** Remove the front recline cover cap, then remove the recline cover.

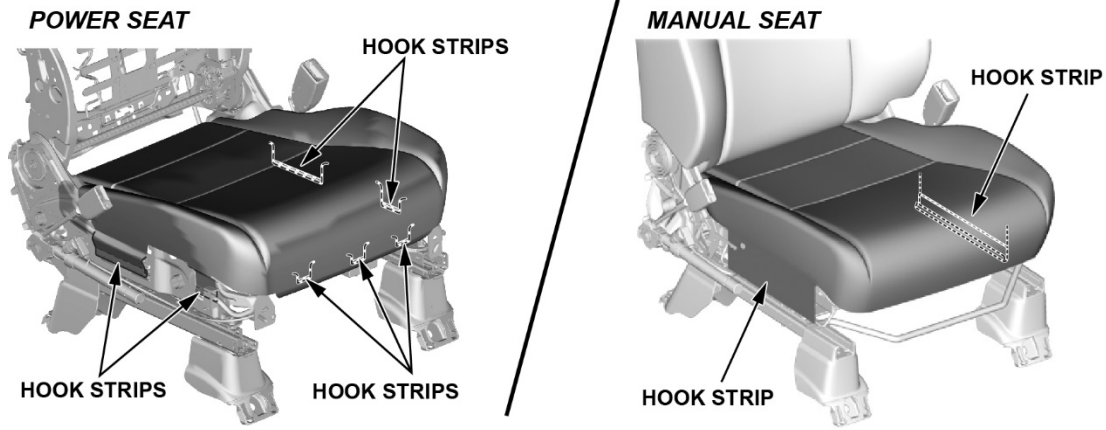
10. Release the hook strips from the seat cushion cover.

NOTE: With a ventilated seat, release the snap ring from the seat cushion blower.

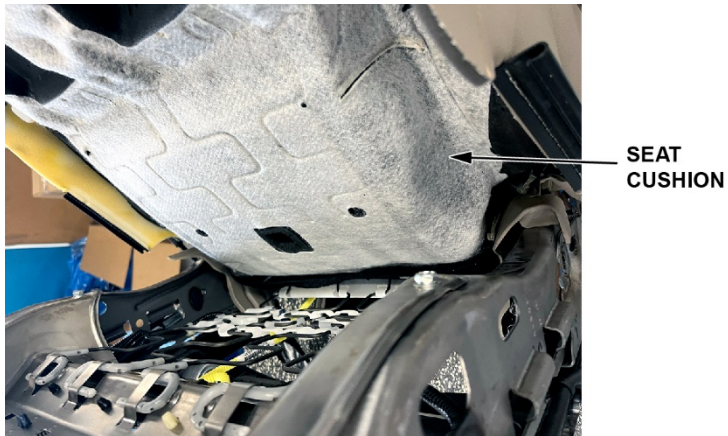
11. Gently separate the seat cushion from the seat frame.

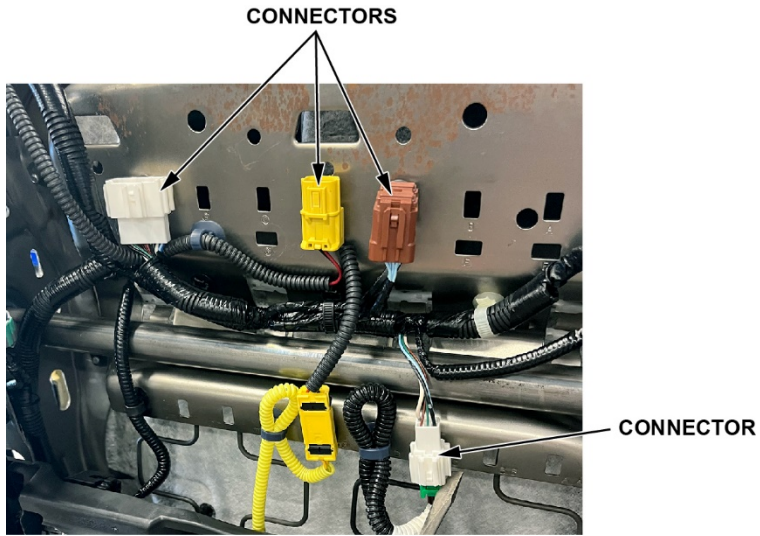
12. Disconnect the 4 connectors.

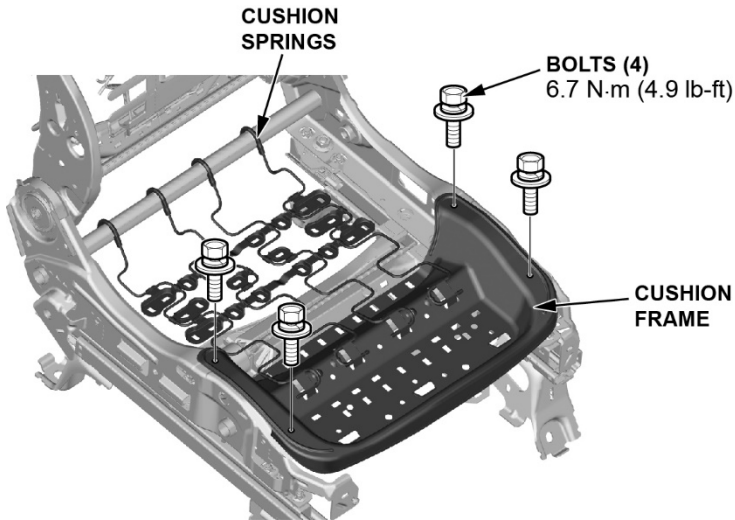
13. Remove the frame pan (4 bolts).

NOTE: Remove the cushion frame and the cushion springs as an assembly.

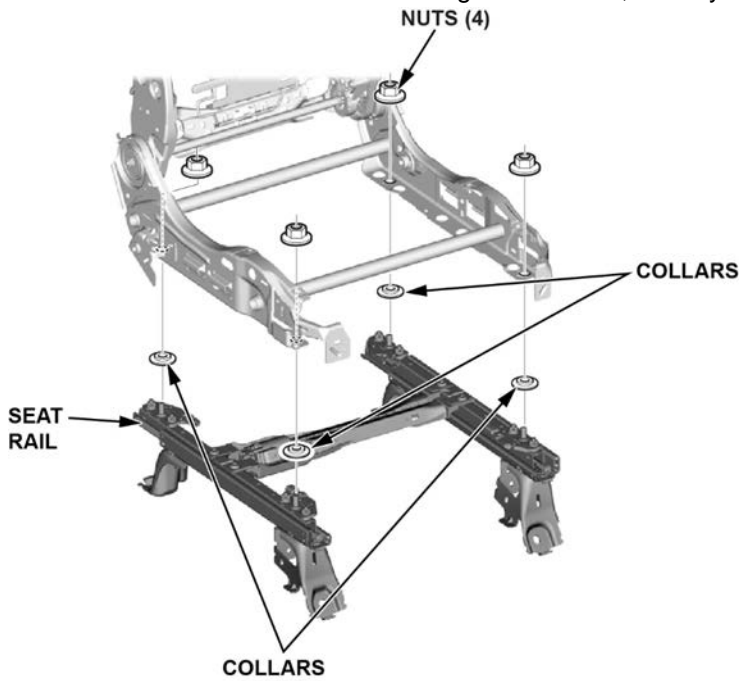
14. Adjust the trim accordingly to expose the seat rail nuts, then remove the nuts.

NOTE: Note the location of the bushings and collars, as they need to be reassembled in the same orientation.
