**Safety Recall: 2020–22 Accord Seat Weight Sensor (DTC U3000-49)**

Supersedes 24-016, dated March 19, 2024, to revise the information highlighted in **yellow**.

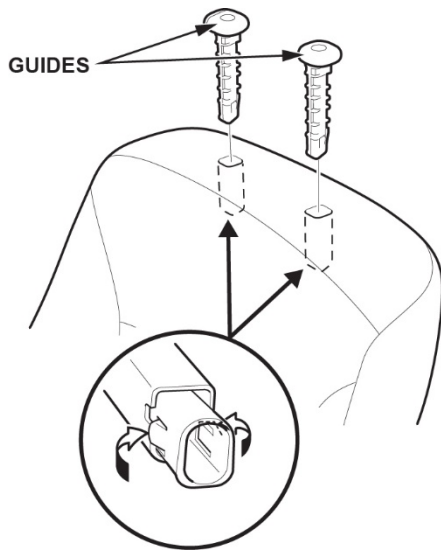
9. Remove the head restraint guides.

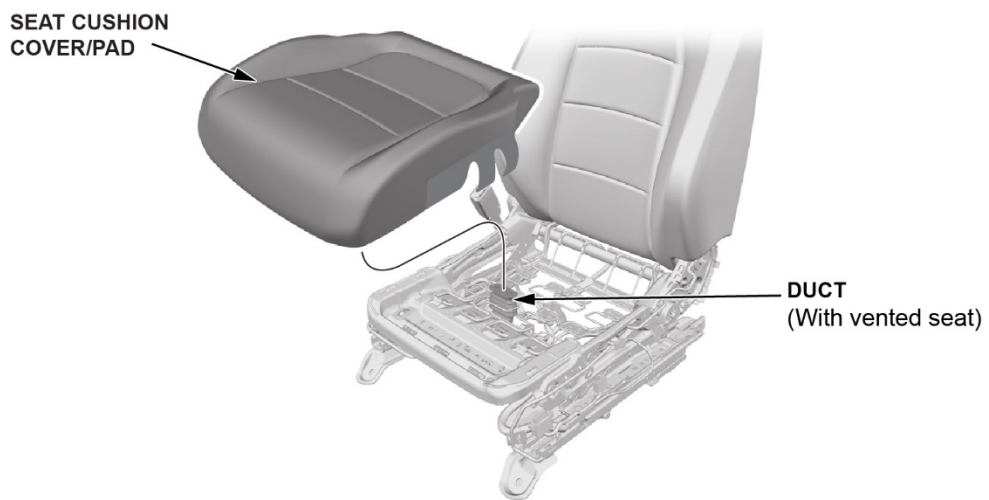
14. Remove the seat cushion cover.

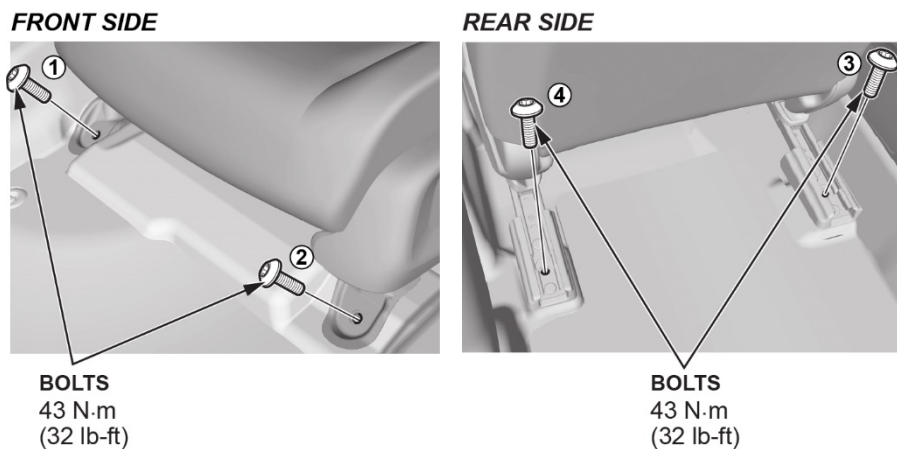
21. Install the bolts to the passenger's seat, and tighten the bolts by hand first, then tighten them to the specified torque in the sequence shown.

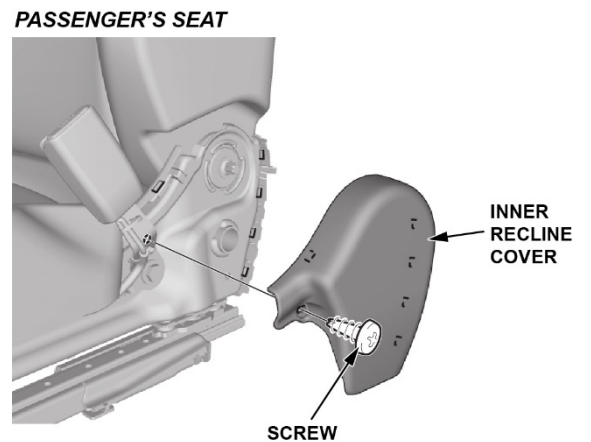
5. Remove the power seat front seat recline covers.

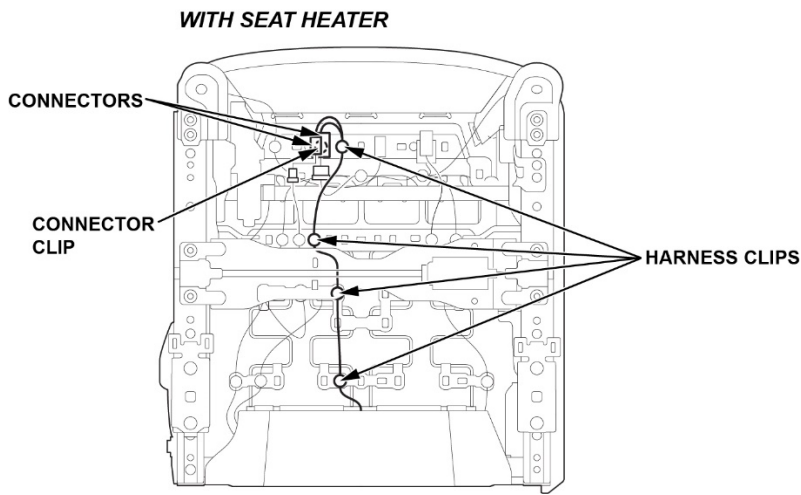
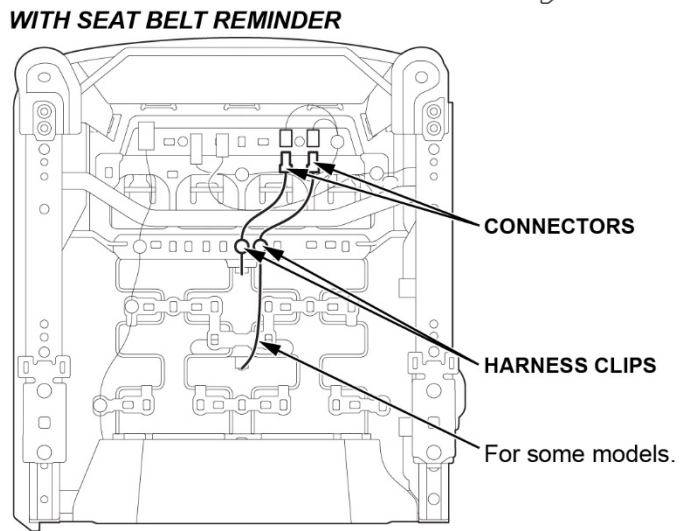
6. Disconnect the connectors.

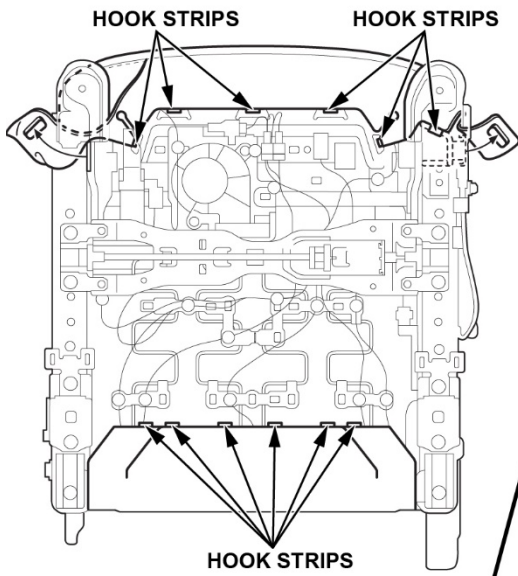
**WITH VENTILATED SEAT**

8. Release the hook strips.
