Safety Recall

Code: 20UF

Subject Suction Jet Pump

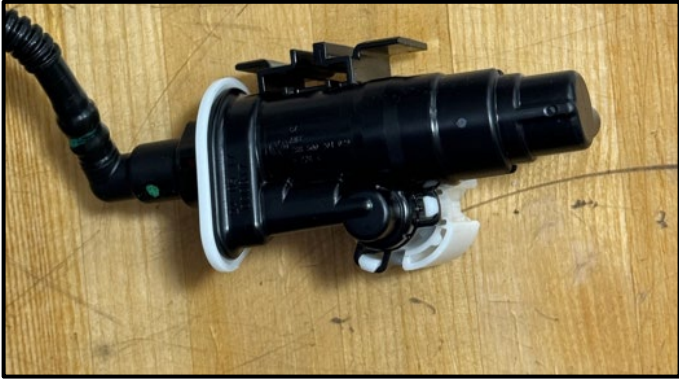
Repair Overview

- Replace suction jet pump.

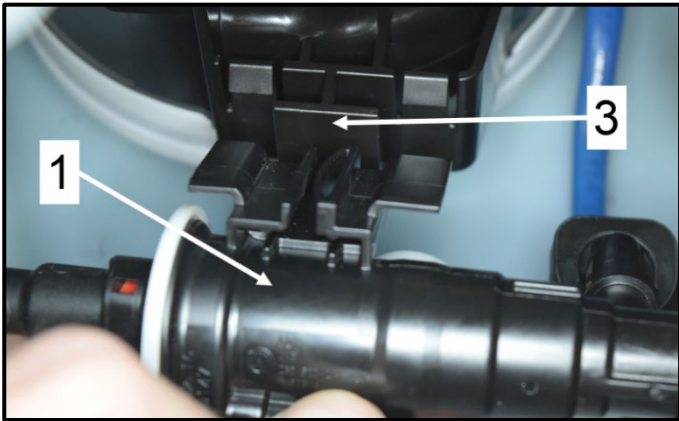
- Remove the suction pump <1> off the retainer bracket <3>:
 - Slightly rotate suction pump <1> away from the bracket <3>
 - Remove the pump <1> from the fuel tank by gently rocking it back and forth between the fingers and thumb.
 - Use caution not to damage the attached front suction line.

- Take care that the Liquid-Vapor Separator Assembly <1> does not come off of its attachment bracket when removing the Suction Jet Pump.

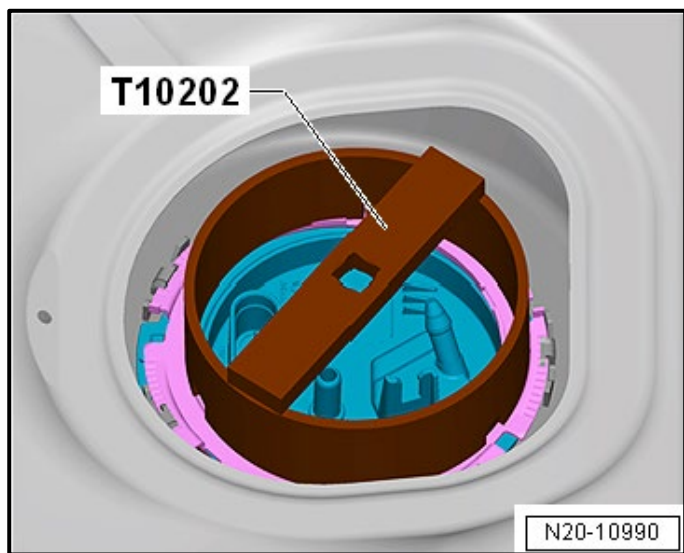
- Using the -T10202-, tighten the locking ring to 110 Nm.

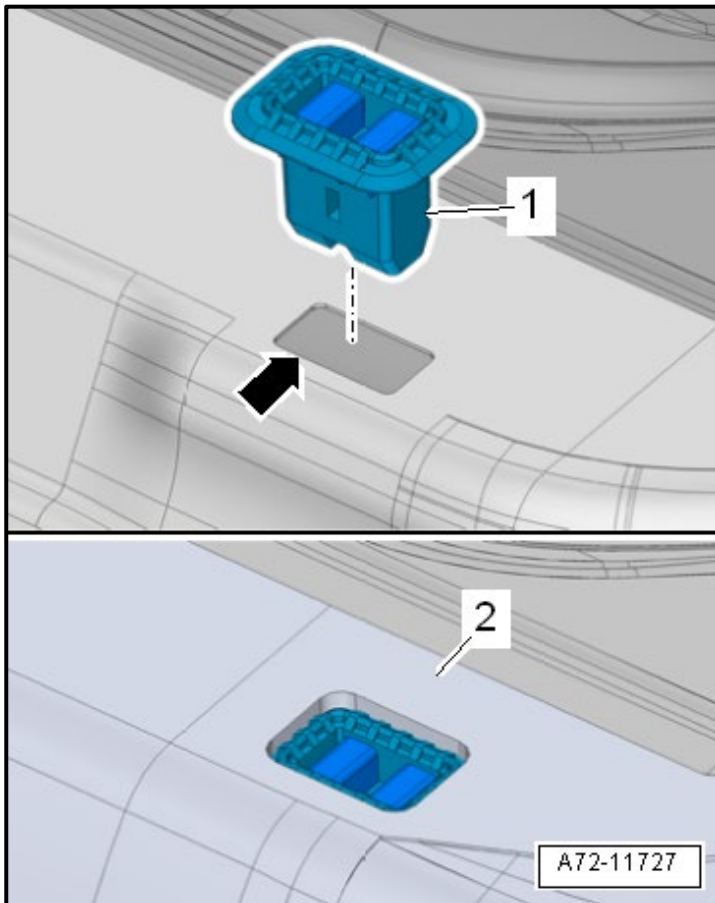
- Replace rear seat bench grommets <1>.

Part Number	Part Description
5GM-886-373	GROMMET
