SIB 33 03 24 RECALL 24V-165 Check Front Suspension Strut

2024-03-04

This Service Information Bulletin replaces SIB 33 04 24 dated Feb 4th, 2024.

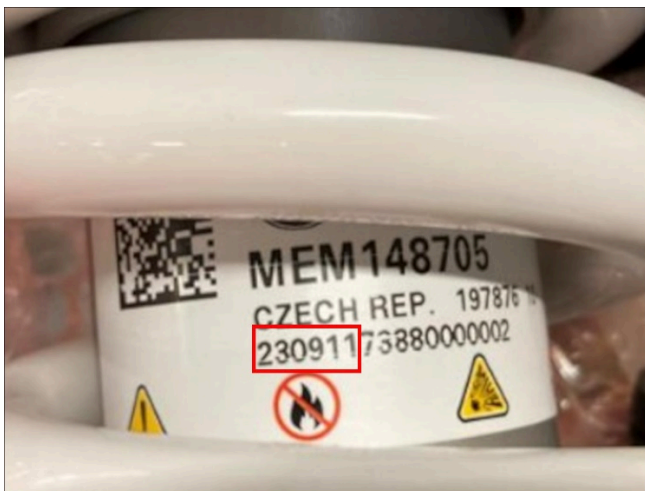
For affected K 1600 models and the R 1250 RT, the front and rear ESA suspension strut must be checked and replaced, if necessary.

Production date 230814 to 230911:

Suspension strut **must be replaced** if any of these production dates are listed on the strut in the location shown in the above figure;

(230814 / 230815 / 230816 / 230817 / 230818 / 230819 / 230820 / 230821 / 230822 / 230823 / 230824 / 230825 / 230826 / 230827 / 230828 / 230829 / 230830 / 230831 / 230901 / 230902 / 230903 / 230904 / 230905 / 230906 / 230907 / 230908 / 230909 / 230910 / 230911).

NOTE: None of the suspension struts **before** or **after** these production dates are affected.
