RECALL 24V254 / 2024-214 REMEDY INSTRUCTIONS

Make(s): AURORA & CATALINA
Model(s): MANY, SEE BELOW
Model Year(s): 2024

Concern:
The charge line may not have over-current protection.

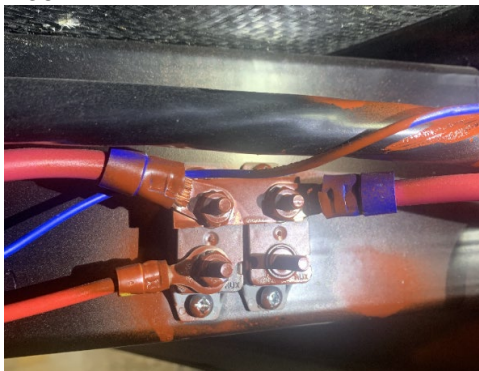
FIGURE 1

STEP 1: LOCATE THE RED “HOT” BATTERY WIRE AND TRACE IT FROM THE BATTERY AREA, PAST THE DISCONNECT, TO A SET OF MINI-BREAKERS LOCATED ON THE INSIDE OF THE A-FRAME/OR FRONT CROSS-MEMBER;

STEP 2: IF THE 6 AWG. WIRES ARE CONNECTED AS SHOWN IN FIGURE 1, MOVE ON TO THE REMEDY;

STEP 1: LOCATE THE 6 AWG. WIRE ON THE REAR POST OF THE MINI-BREAKER. LOOSEN THE NUT AND REMOVE THE WIRE/EYELET;

STEP 2: INSTALL THE NUT BACK ONTO THE POST YOU REMOVED IT FROM AND TIGHTEN DOWN, ASSURING IT IS SECURE;

STEP 3: REMOVE THE NUT FROM THE LOWER POST ON THE REAR MINI-BREAKER;

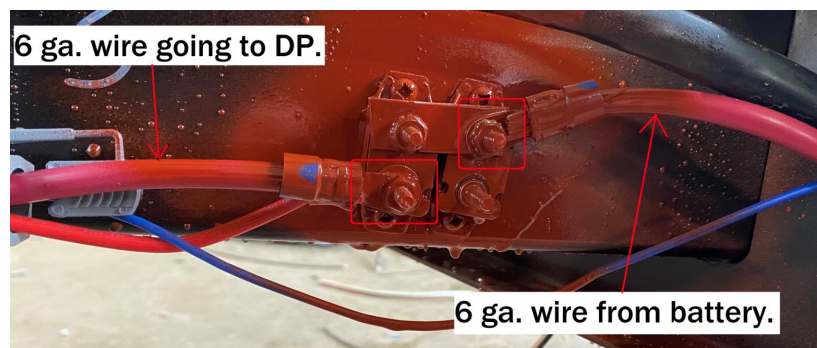
FIGURE 2

- IF THE 6 AWG. WIRES ARE CONNECTED AS SHOWN IN FIGURE 2, CLAIM THE INSPECTION, WORK COMPLETED.

- REMOVE THE SMALLER WIRE/EYELET FROM THE POST;
- INSTALL THE 6 AWG. WIRE/EYELET ONTO THE POST;
- RE-INSTALL THE SMALLER WIRE/EYELET ONTO THE POST. ROTATE THE SMALLER WIRE WHERE THE EYELET CRIMPS DO NOT OVERLAP. IF THEY OVERLAP, THEY MAY BECOME LOOSE.
- INSTALL THE NUT AND TIGHTEN, CLAMPING THE TWO WIRE/EYELETS TOGETHER, ENSURING PROPER SECUREMENT;
- THE REMEDY SHOULD NOW MATCH FIGURE 2;

STEP 4: CHECK THE TWO NUTS FOR TIGHTNESS AGAIN;

STEP 5: SPRAY THE POSTS WITH BATTERY/TERMINAL PROTECTOR;
