Recall Repair Instructions

NHTSA Recall # 24V-260

Tiffin Motorhomes Recall # TIF-138

Purpose: To provide instructions on how to deactivate the LED light rings on the Suburban gas range/oven knobs.

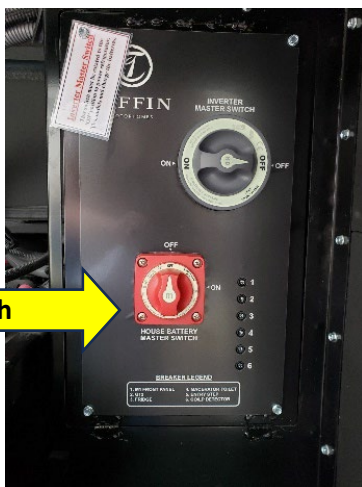
Figure 1

1. Locate the DCD panel and disconnect the 12V DC power to the coach by turning the battery switch to "off" as shown in figure 1. The location of the DCD panel is as follows:
For Allegro Open Roads 32FA, 32SA, 34PA & 36UA, last passenger side compartment.
For Allegro Open Road 36LA, first passenger side compartment.
For Allegro RED 360 33AA, 37BA & 38KA, second passenger side compartment.
For Byway 33FL, 38BL & 38CL, third drivers side compartment.
2. Follow the instructions on the following page from Suburban: **206346 Range and Slide-in Deactivate lights Instructions**. Repair instructions are also included with the recall repair kit.

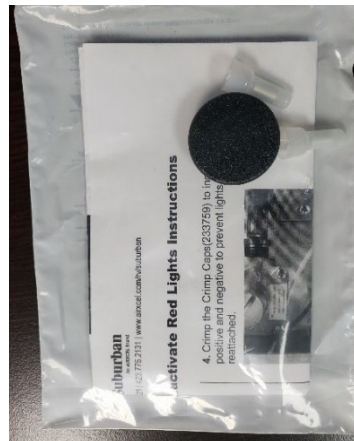
Suburban Recall
Kit 525171

Switch plug

Crimp Caps

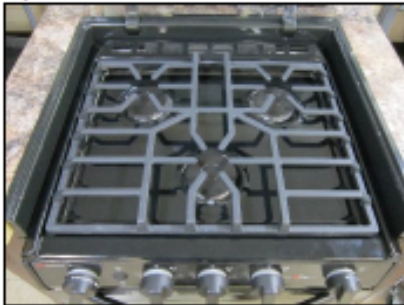
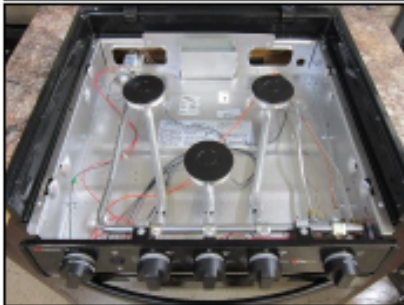
1. Disconnect 12VDC power to the range.
2. Remove the range main top by firmly pulling up at the front. Lift the main top free of the burner box clips and set aside.

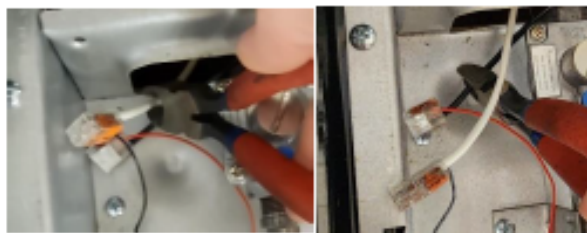
3. Locate the red and black wires that connect to the coach wiring (Coach wiring color may vary). Cut this wire directly behind the connector using a pair of electrical cutters.

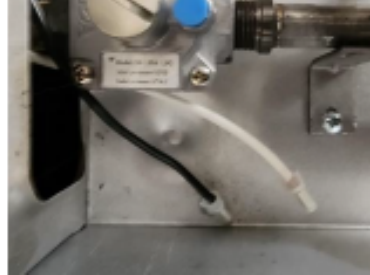
4. Crimp the Crimp Caps(233759) to incoming 12V positive and negative to prevent lights from being reattached.

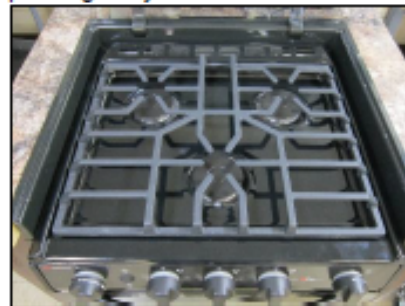
6. Replace the main top by engaging rear clips and pressing firmly on the front latch.
