Suburban Range and Slide-In Deactivate Lights

Bulletin Type:	Recall	Publication Date:	May 2024
Bulletin #(s):	24V-300 USA 2024-250 Canada	Make(s):	Starcraft
Job Code(s):	9902606	Model(s):	Starcraft GSL FW
Flat Rate(s):	9902606 .30 HR LED Backlight Deactivation	Model Year(s):	2023

SUBURBAN RANGE AND SLIDE-IN DEACTIVATE LIGHTS INSTRUCTIONS

206346 Range and Slide-in Deactivate Lights Instructions

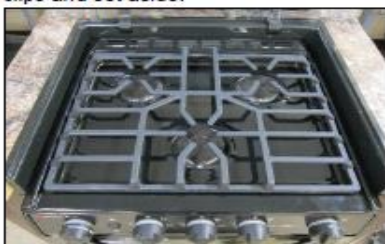
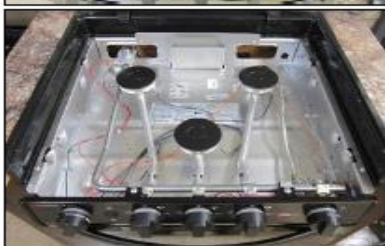
1. Disconnect 12VDC power to the range.
2. Remove the range main top by firmly pulling up at the front. Lift the main top free of the burner box clips and set aside.

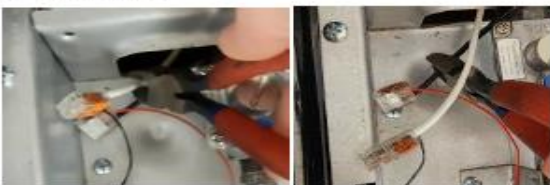
3. Locate the red and black wires that connect to the coach wiring (Coach wiring color may vary). Cut this wire directly behind the connector using a pair of electrical cutters.

4. Crimp the Crimp Caps(233759) to incoming 12V positive and negative to prevent lights from being reattached.

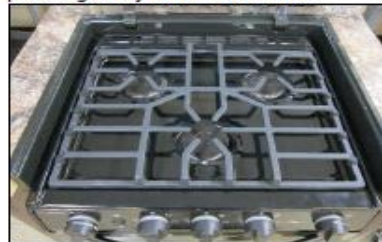
6. Replace the main top by engaging rear clips and pressing firmly on the front latch.
