Suburban Range and Slide-In Deactivate Lights

| Bulletin Type: | Recall | Publication Date: | May 2024 |

| Incident: | Suburban Range and Slide-in Lights are inoperable |

SUBURBAN RANGE AND SLIDE-IN DEACTIVATE LIGHTS INSTRUCTIONS

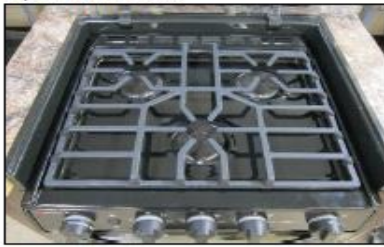
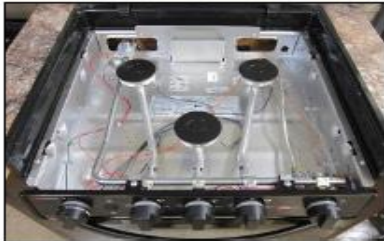
1. Disconnect 12VDC power to the range.
2. Remove the range main top by firmly pulling up at the front. Lift the main top free of the burner box clips and set aside.

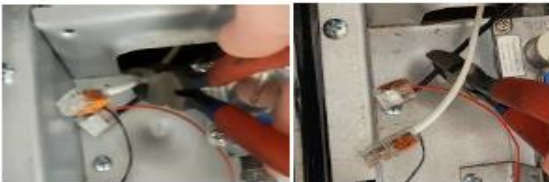
3. Locate the red and black wires that connect to the coach wiring (Coach wiring color may vary). Cut this wire directly behind the connector using a pair of electrical cutters.

4. Crimp the Crimp Caps(233759) to incoming 12V positive and negative to prevent lights from being reattached.

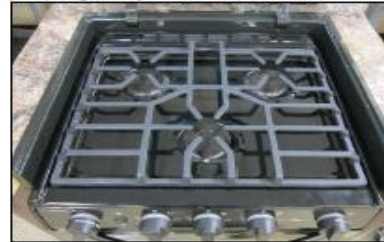
6. Replace the main top by engaging rear clips and pressing firmly on the front latch.
