RECALL 24V325 REMEDY INSTRUCTIONS

Make(s): AURORA
Model(s): ART26BHS
Model Year(s): 2024

Concern:
The breakaway switch may not be correctly wired to constant hot. This condition may lead to the failure of the brake-away switch to activate in an emergency.

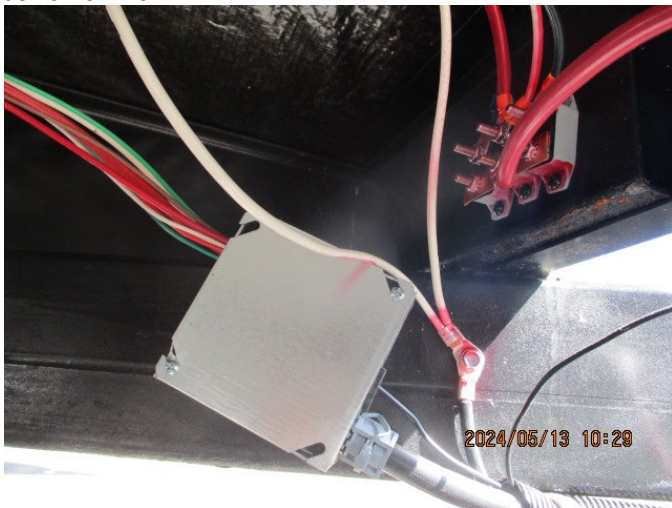
JUNCTION BOX

STEP 1: TRACE THE BLACK WIRE FROM THE BREAKAWAY SWITCH INTO THE 4"X4" JUNCTION BOX;

- FIND IT TERMINATED INTO A WAGO CONNECTOR WITH A PURPLE WIRE

STEP 2: REMOVE THE BLACK WIRE FROM THE WAGO AND PULL THE BLACK WIRE FROM THE JUNCTION BOX;

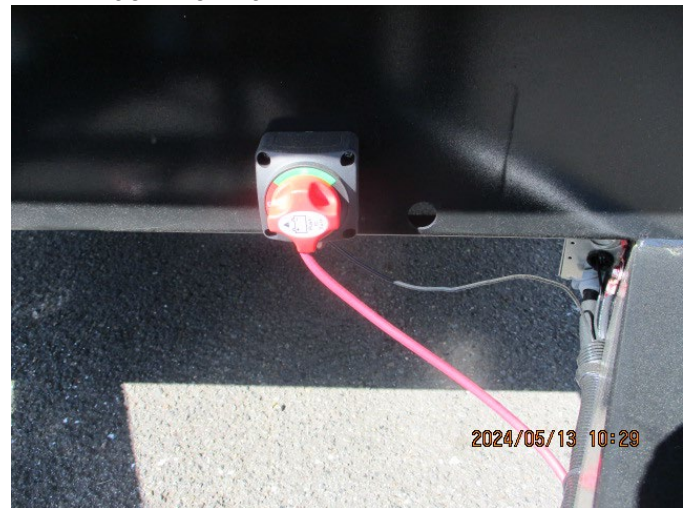
NEWLY ROUTED SWITCH

STEP 4: STRIP THE BLACK WIRE AND CRIMP THE APPROPRIETE SIZE RING TEMERINAL (THAT FITS THE BATTERY DISCONNECT STUD);

STEP 5: REMOVE THE NUT ON THE BATTERY DISCONNECT CONSTANT HOT SIDE (FROM THE BATTERY);

STEP 6: INSTALL THE BREAKAWAYS BLACK WIRE WITH NEW RING TERMINAL TO THE CONSTANT HOT (FROM THE BATTERY);

- TIGHTEN THE NUT BACK DOWN ON THE CONTACT HOT SIDE;
- REINSTALL THE BATTERY DISCONNECT SWITCH COVER;
