**Recall 24V352
Freedman Seat
Inspection/Repair**

Applicable for Chrysler Pacifica/Voyager
Side Entries manufactured w/ a
Freedman GO-ES SpaceSaver Foldway
Seat

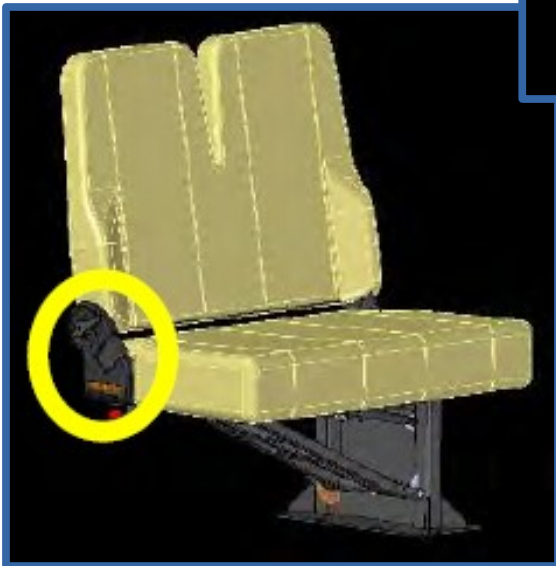
1. Bring seat back cushion from stowed position (seat back cushion is folded down against seat cushion) to first engagement point of the back lock (most upright position of the seat back cushion).

Add a piece of tape on the dump cover shroud so that it touches the handle.

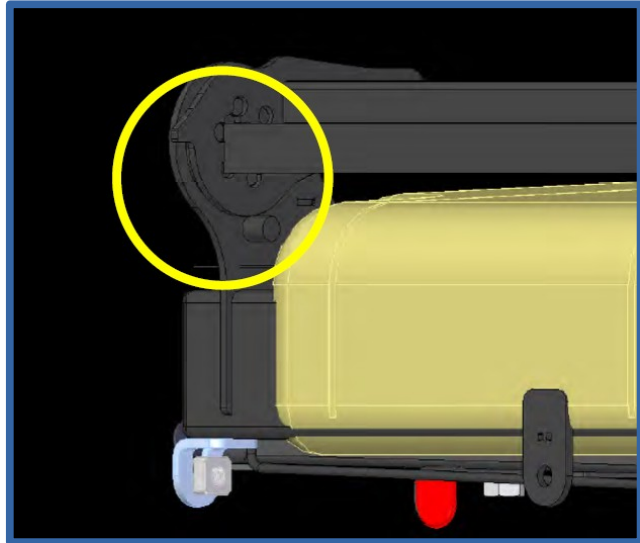
4. Fold the seat back down to the cushion to expose the stop brackets.
