# SAFETY RECALL

Date	Number	Release	Page
06.2024	SC0465	04	1(5)

## Steering Draglink AN, GR, TE

Mack Trucks has determined that certain model year 2025 AN, GR, and TE may have been built with draglinks containing a ball stud with improper heat treatment. This could result in loss of steering.

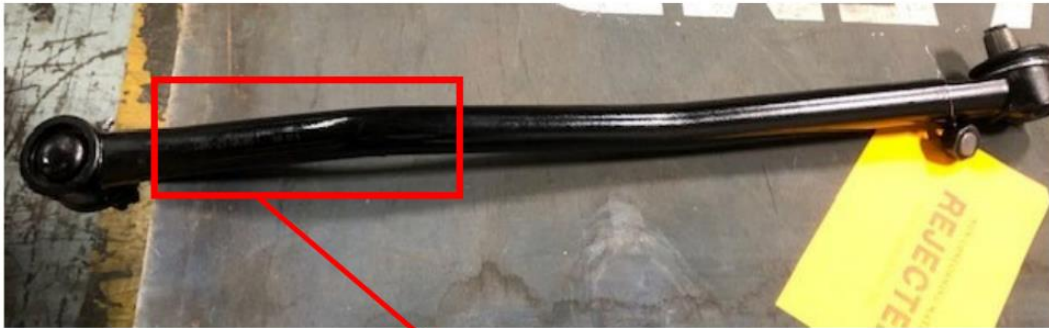
6. Locate the part number stamped or etched on the draglink.

7. Verify the part number on the draglink to the reference part number in the table below. Confirm whether the part number and build date match or not.
  - a. If the build date matches to the dates on the table, the draglink is NOK and must be replaced with a new one. Proceed to step 8.
  - b. If the build date is not on the table, the draglink is OK and the truck can be returned to service.

8. If draglink needs to be replaced, follow **Impact Procedure 6438-03-02-01 Link Rod, Replacement.**
