TECHNICAL INSTRUCTIONS

SAFETY RECALL 24TA09

CURTAIN SHIELD AIRBAGS MAY NOT DEPLOY AS INTENDED

CERTAIN 2024 MODEL YEAR GRAND HIGHLANDER AND GRAND HIGHLANDER HV

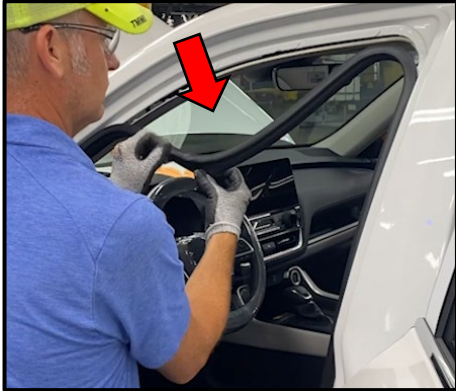
1. Fold down the Weatherstrip LH Front Door opening weatherstrip

Note: Fold it in a manner where it does not get damaged.

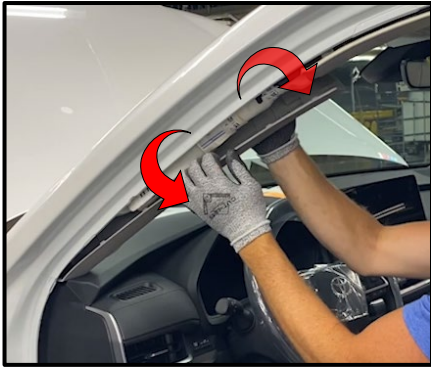
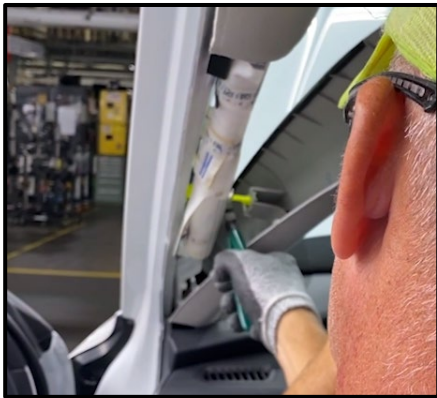
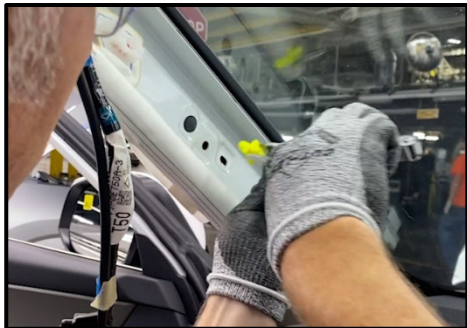
2. Remove the LH A-pillar Garnish

- a. Pull back the A-pillar garnish
- b. Cut the tether clips
- c. Remove the speaker (if applicable)
- d. Remove the 2 tether clips from the body and A-pillar and discard.

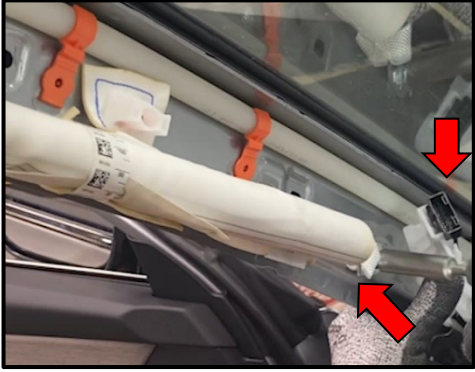
3. Remove the CSA tether bolt

- a. Remove the tether bolt and the metal tether tab from the A-pillar.

Note: Do not discard the CSA tether bolt, it will be reused during reassembly.

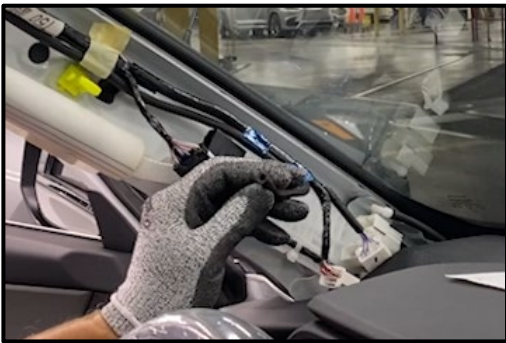
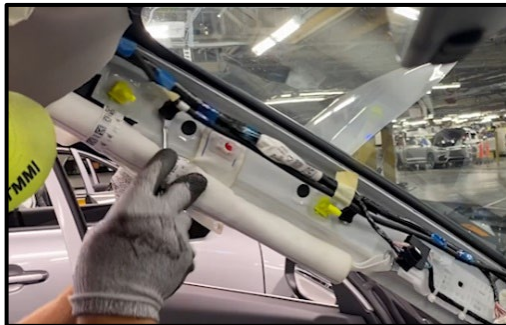
4. Disconnect the Wire harnesses, Washer fluid hose, and antenna

- a. Disconnect the wire harness connection
- b. Disconnect the washer hose and use a rag to collect any drainage during the hose disconnection
- c. Remove the 2 Antenna wire harness clips from the body

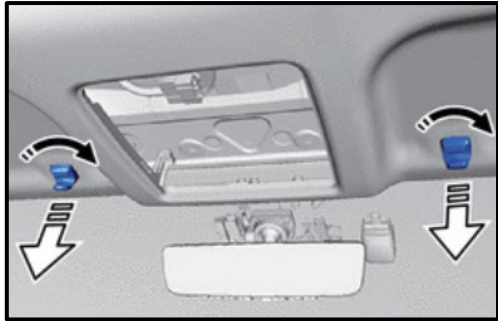
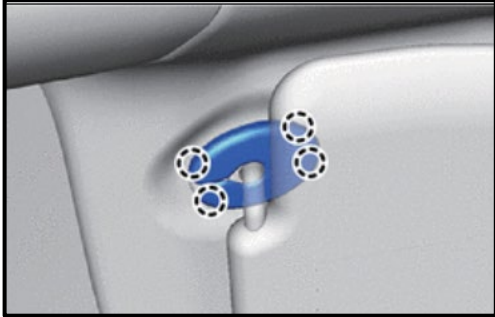
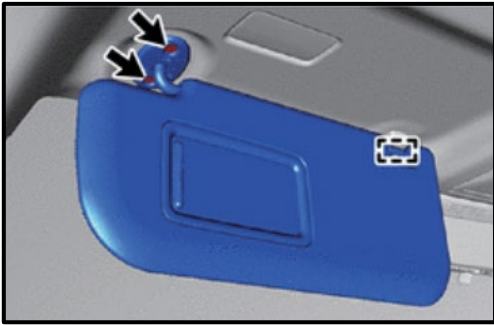
- 5. Remove the LH sun visor and sun visor holder**
- Remove the sun visor holder by twisting 45°
 - Remove the sun visor cap
 - Remove the 2 sun visor screws to remove the sun visor.

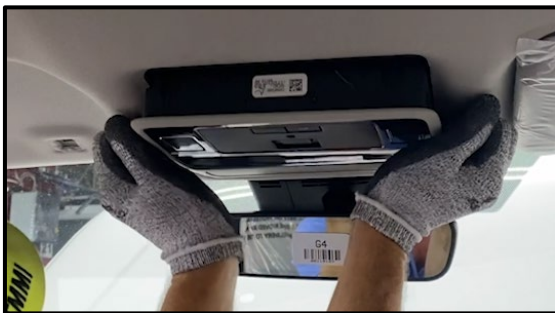
- 6. Remove the Overhead Console**
- Remove by prying up on the rear edge and disconnect the wire harness.
 - Disconnect the Sunroof wire harness (If present)

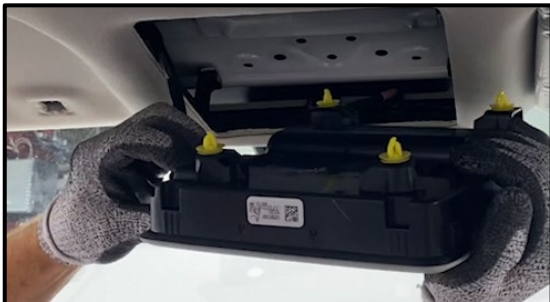
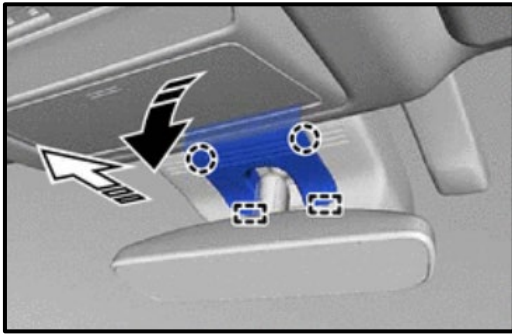
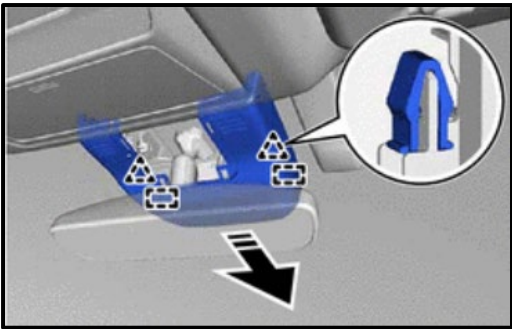
7. Remove the rear-view mirror covers and wire harness connection

- a. Remove the 2 rear view mirror covers.
- b. Remove the rain sensor cover and disconnect the wire harness (If present)

Note: Do not pull the cover the cover straight off the windshield, this will result in part damage.

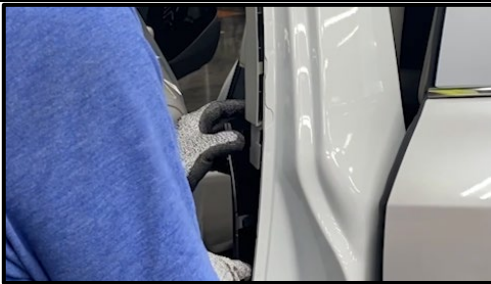
8. Loosen the LH B-pillar lower garnish

- a. Pull back the top portion of the lower B-pillar Garnish to expose the upper B-pillar clips.

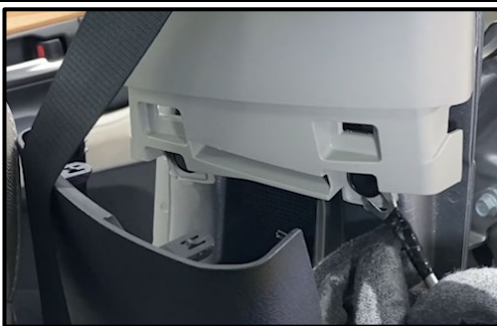
9. Remove the LH B-pillar upper garnish

- a. Remove the 2 black clips from the lower portion of the B-pillar garnish.
- b. Loosen the top portion of the B-pillar upper garnish by loosening the blue clip using a clip remover.

Note: Do not forcefully pry loose the upper B-pillar. This will result in damage to the blue clip holder.

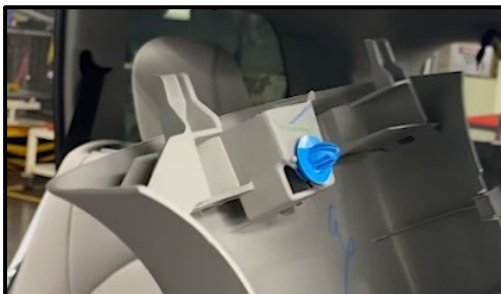
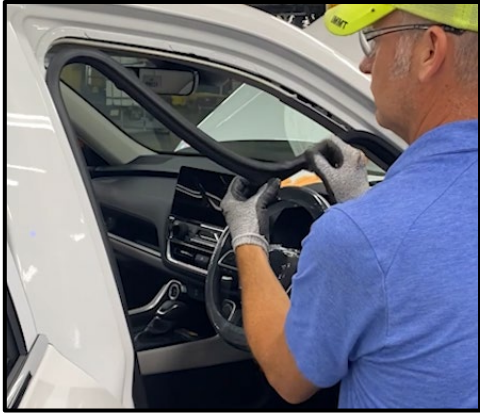
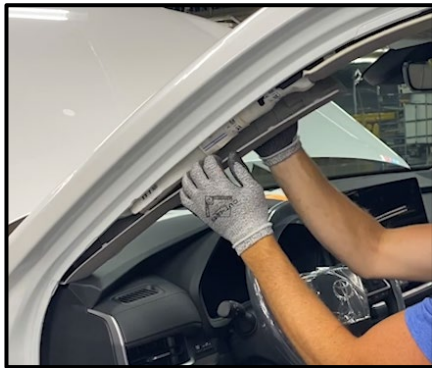
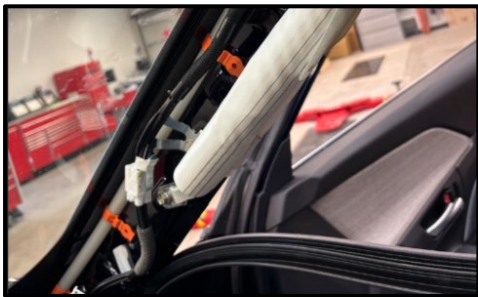
10. Move to RH Front side

- a. Fold down the upper RH weatherstrip
- b. Remove the RH A-pillar garnish
- c. Remove the RH CSA tether bolt

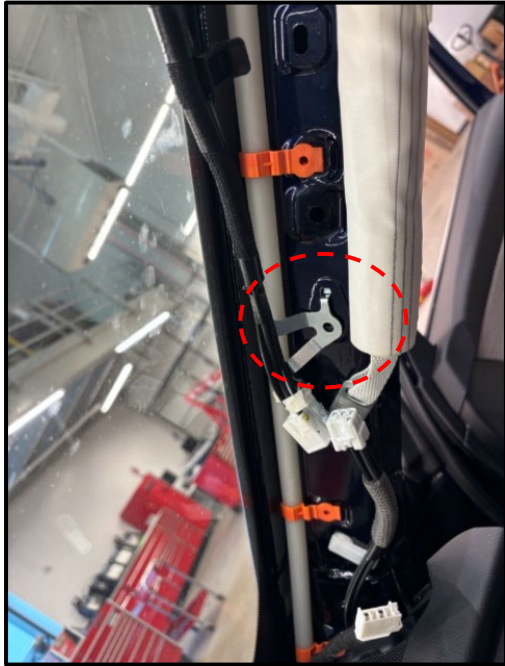
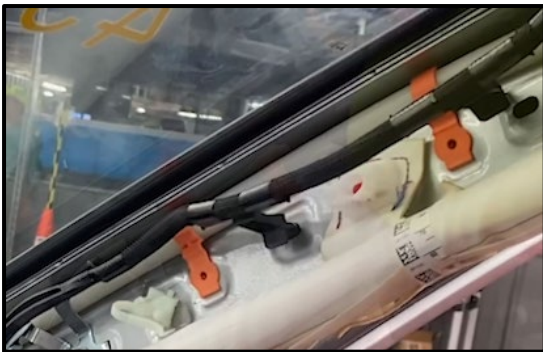
11. Remove Antenna bracket and wire harness

- a. Remove the Antenna bracket bolt.
- b. Disconnect the Antenna wire harness
- c. Remove the 2 wire harness clips from the body

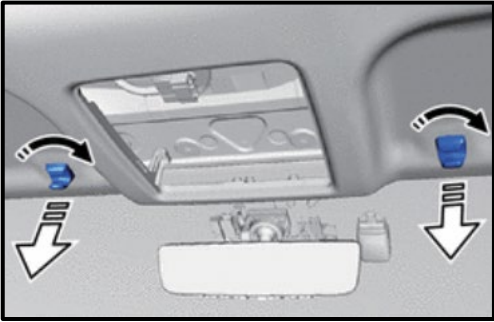
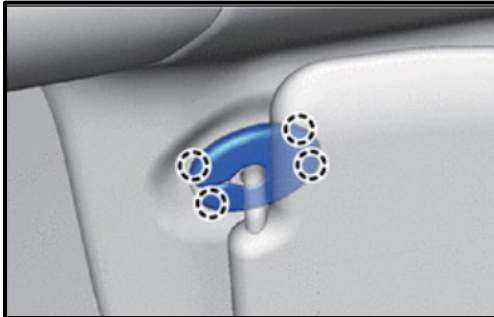
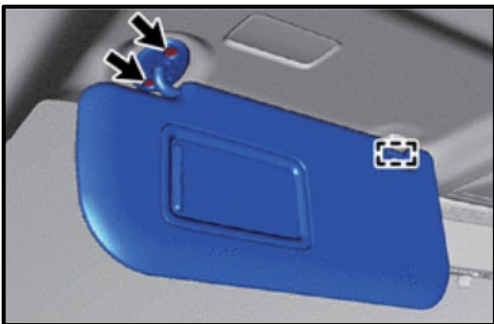
12. Remove the RH sun visor and sun visor holder

- Remove the sun visor holder by twisting 45°.
- Remove the sun visor cap.
- Remove the 2 sun visor screws to remove the sun visor.

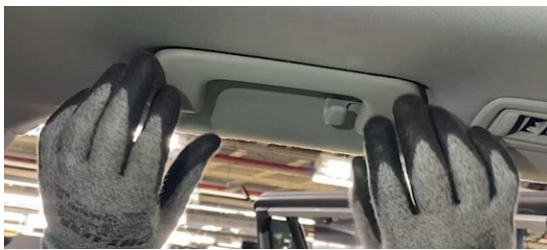
13. Remove the RH#1 Upper Assist grip.

- Remove the assist grip caps.
- Remove the Assist grip.
- Remove the assist grip clamps from the body.

Note: Use caution not to mutilate the assist grip caps when removing. (Placing tape on the tool will mitigate the risk of mutilation)

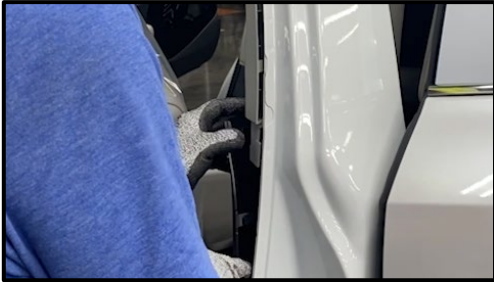
14. Loosen the RH B-pillar lower garnish.

- a. Pull back the top portion of the lower B-pillar Garnish to expose the upper B-pillar clips.

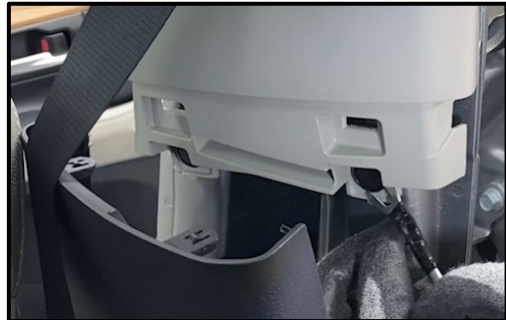
15. Remove the RH B-pillar upper garnish.

- a. Remove the 2 black clips from the lower portion of the B-pillar garnish.
- b. Loosen the top portion of the B-pillar upper garnish by loosening the blue clip using a clip remover.

Note: Do not forcefully pry loose the upper B-pillar. This will result in damage to the blue clip holder.

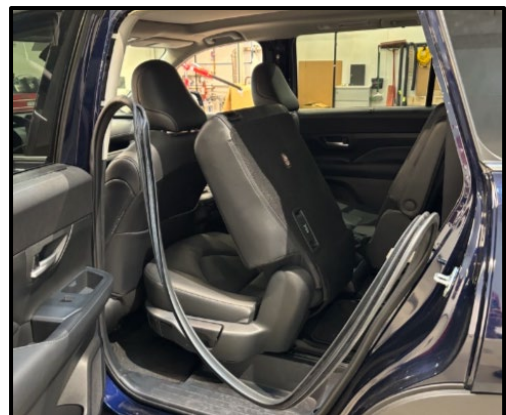
16. Fold down the Weatherstrip LH & RH Rear Door opening weatherstrip.

Note: Fold it in a manner where it does not get damaged.

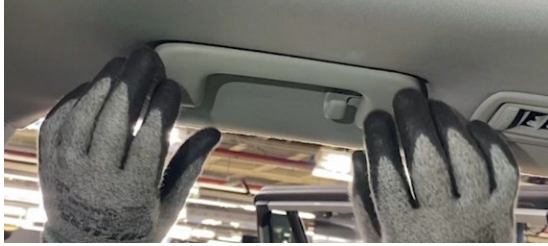
17. Remove the LH & RH Rear assist grips

- a. Remove the assist grip caps
- b. Remove the assist grip clamps from the body

Note: Use caution not to mutilate the assist grip caps when removing.

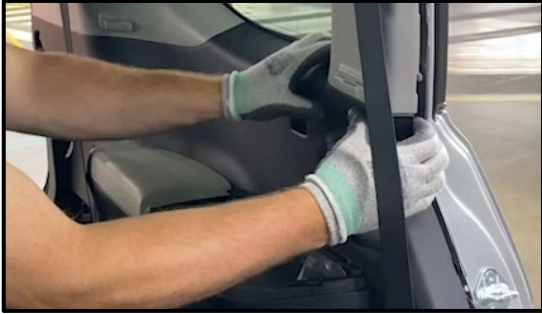
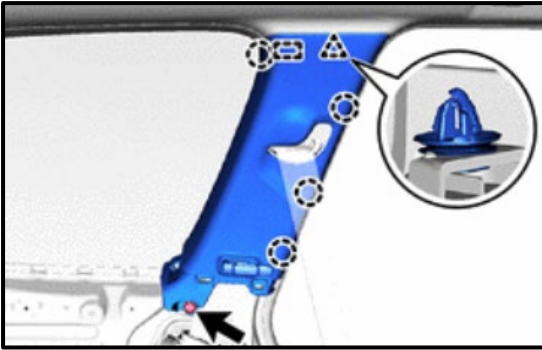
20. Unfastening the LH & RH C-pillar trim

- a. Unfasten the top portion of the lower C-pillar trim to expose the lower portion of the upper C-pillar trim.
- b. Remove the black clip on the lower portion of the upper C-pillar trim.
- c. Remove the upper C-pillar trim and let hang down out of the way.

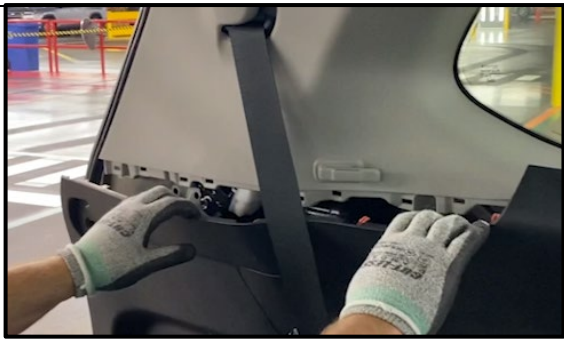
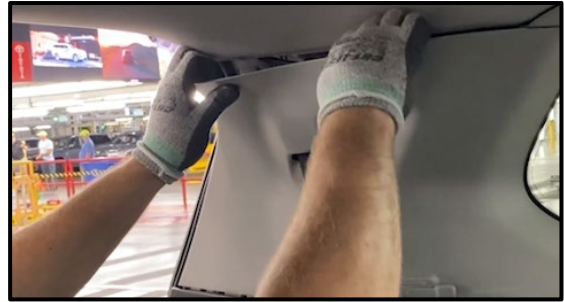
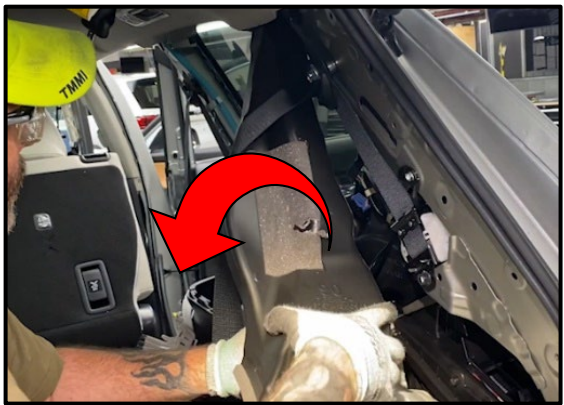
- 21. Unfastening the LH & RH Upper D-pillar trim**
- Pull back the top portion of the lower D-pillar trim.
 - Remove the Upper D-pillar trim and hang it down out of the way.
 - Remove the Rear Air duct on the RH side. **(If applicable)**

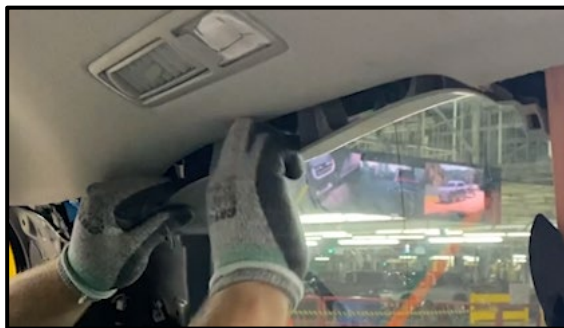
- 22. Unfastening the LH & RH Quarter window trim**
- Pull down on the Quarter window granish and let hang.
- NOTE: DO not remove the Quarter window trim, unfasten it and let it hang.**

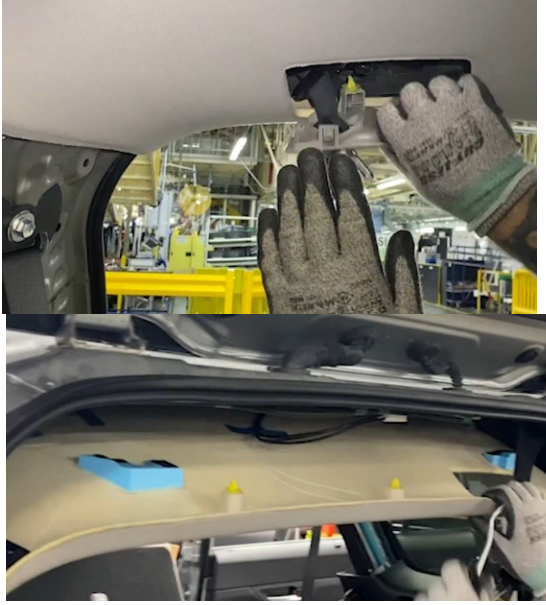
23. Rear Headliner clips and seatbelt

- a. Remove the 3rd row seatbelt trim from the headliner.
- b. Unfasten the rear headliner clips.
- c. Disconnect the rear headliner wire harness connections.

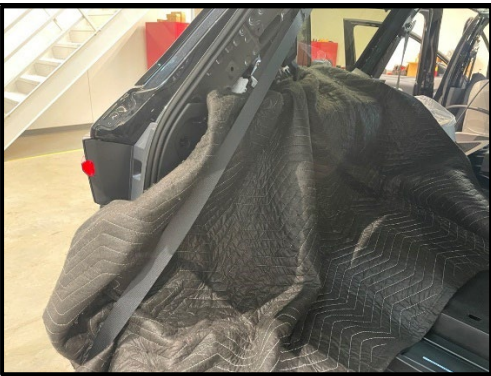
24. Mutilation prevention to D-pillar trim

- a. Place a protector/cover to the lower D-pillar trim to mitigate mutilation to the interior trims.

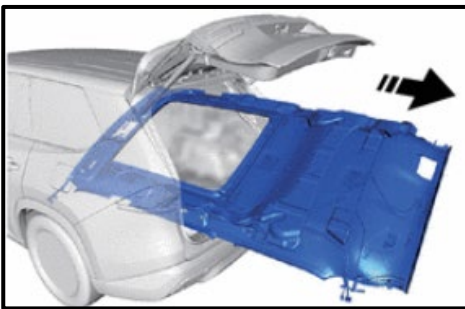
25. Headliner removal

- a. Pull down on the headliner to release it from roof.
- b. Store headliner in a manner to prevent mutilation and contaminants.

NOTE: Due to the length of the headliner it is best to use a minimum of 3 people to remove from the vehicle to prevent mutilation to the headliner.

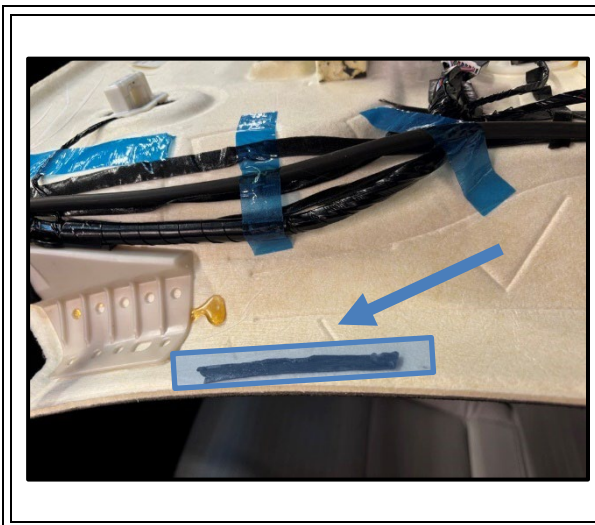
IMPORTANT STEP

31. Covering the Butyl on the LH side

- a. If the Butyl tape is present, apply the blue Nitto tape on top of the Butyl tape, completely covering the Butyl tape.

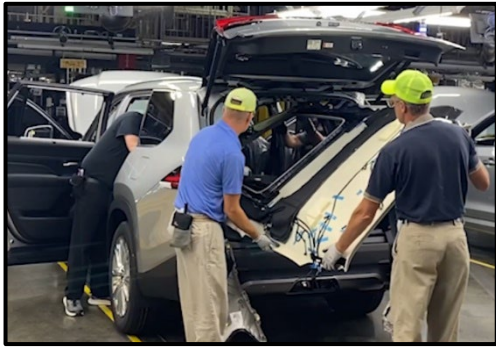
32. Reinstall the Headliner

- a. Install the headliner into the vehicle
- b. Refasten all headliner clips to the roof

NOTE: Due to the length of the headliner it is best to use a minimum of 3 people to install. This will prevent mutilation or cracking to the headliner.

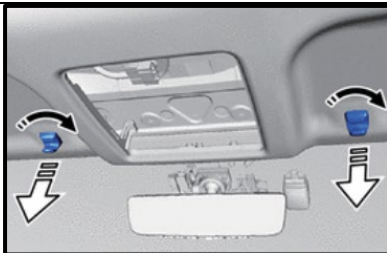
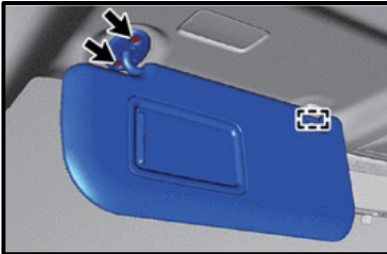
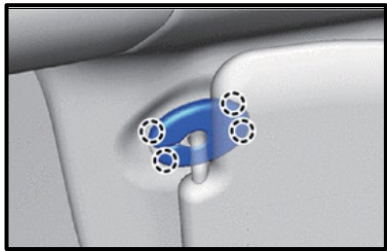
33. Reinstall the LH & RH sun visor and sun visor clips

- a. Install the sun visor clips into the body.
- b. Install the sunvisors
- c. Install the sun visor caps.

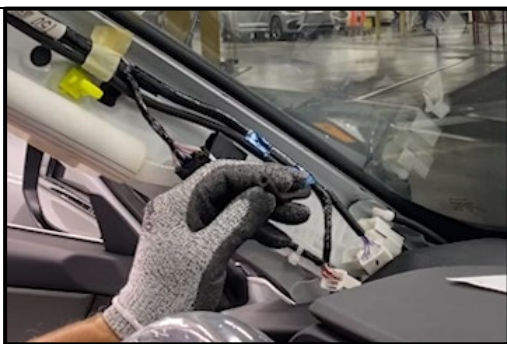
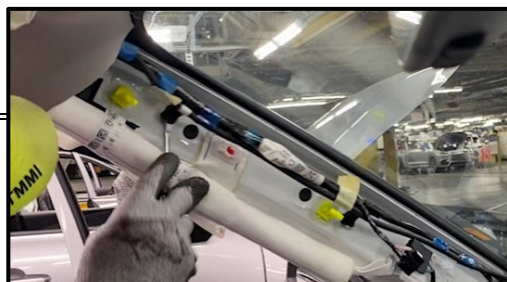
34. Wire harnesses, Washer fluid hose, and antenna Install (LH A-pillar)

- a. Connect the 2 Antenna wire harness clips to the body
- b. Connect the wire harness connection.
- c. Connect the washer hose.

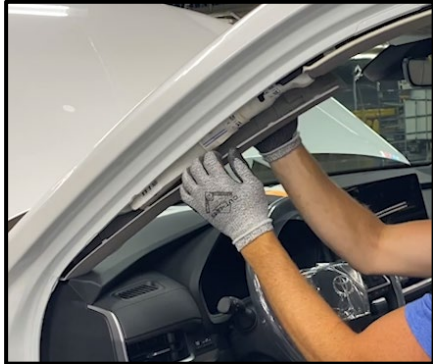
35. Reinstall the LH A-pillar garnish

- a. Install **NEW** tether clips to the the A-pillar garnish.
- b. Install the speaker into the garnish (If applicable)
- c. Line up the A-pillar garnish and install

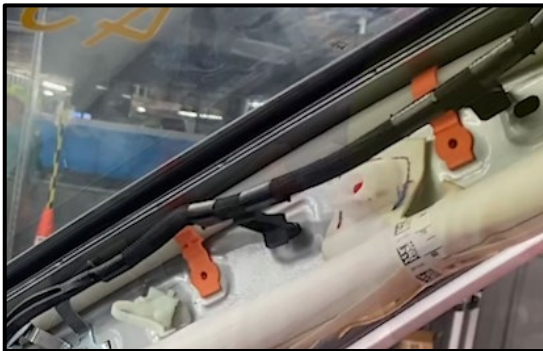
36. Wire harnesses and antenna Install (RH A-pillar)

- a. Connect the 2 Antenna wire harness clips to the body
- b. Connect the antenna wire harness connection and tighten bracket.

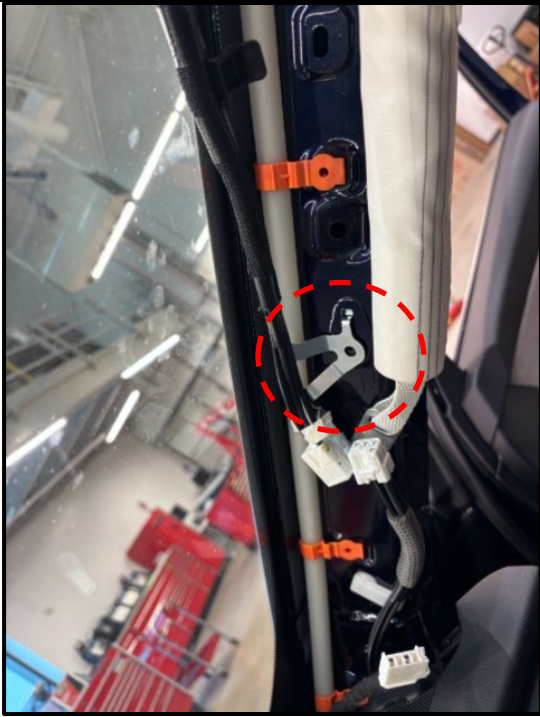
37. Reinstall the RH A-pillar garnish

- a. Install **NEW** tether clips to the the A-pillar garnish.
- b. Install the speaker into the garnish (If applicable)
- c. Line up the A-pillar garnish and install

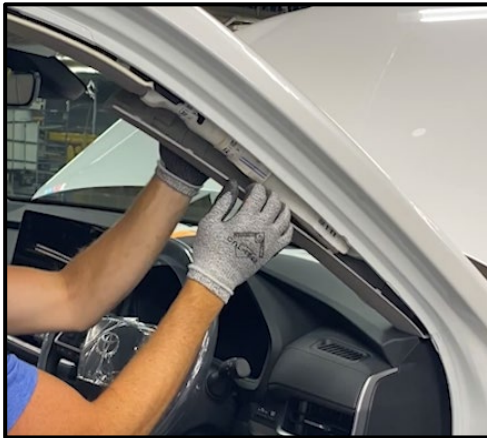
38. Reinstall the RH #1 assist grip

- a. Install the assist grip to the body.
- b. Install the assist grip caps.

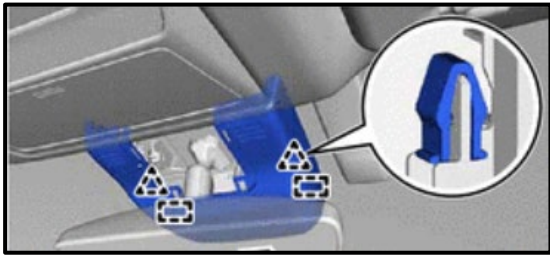
39. Reinstall the Rear view mirror covers and connections

- a. Connect all mirror connections.
- b. Reinstall all mirror covers.
- c. Connect Rain sensor (If Applicable)

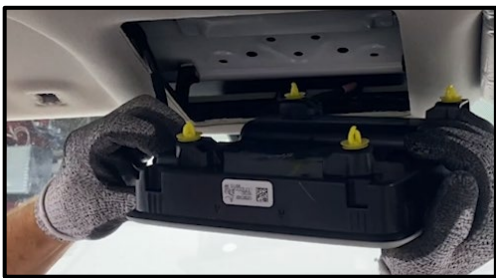
40. Reinstall the Overhead Console

- a. Connect the all wire harnesses.
- b. Install Overhead console to the body.

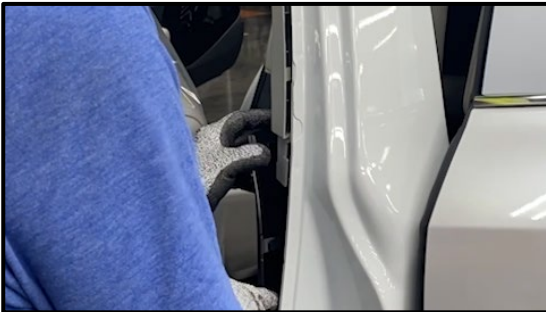
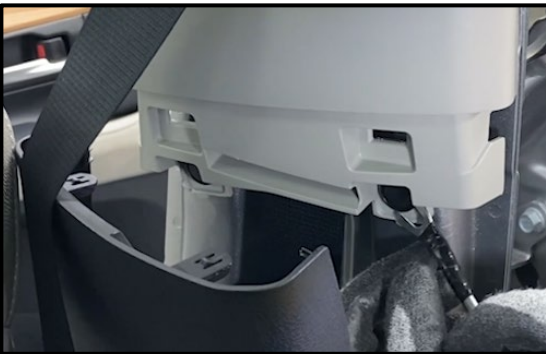
41. Reinstall the LH & RH Upper B-pillar garnish

- a. Clip in the upper B-pillar garnish
- b. Install the black clips on the lower portion

Note: Ensure the Seatbelt adjust is aligned correctly and it adjust correctly before moving to the next step.

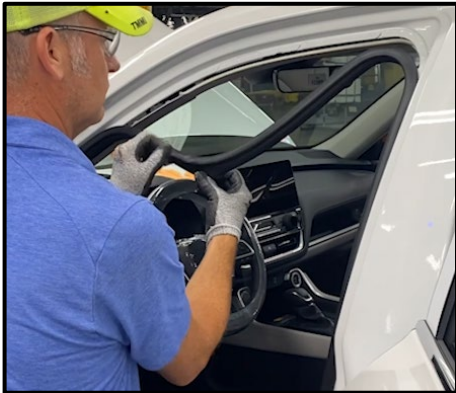
43. Reinstall the LH & RH #1 door weatherstrips.

- a. Install the door opening weatherstrips

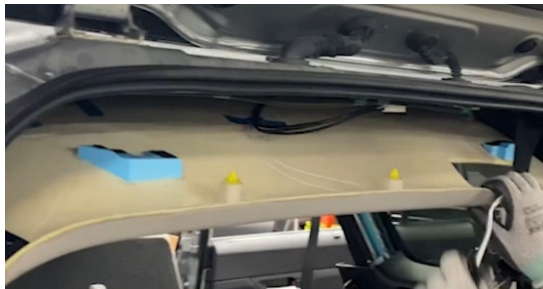
45. Install Rear headliner clips and rear wire harness/ washer hose

- a. Connect all rear wire harnesses.
- b. Install the headliner clips
- c. Connect the rear washer hose

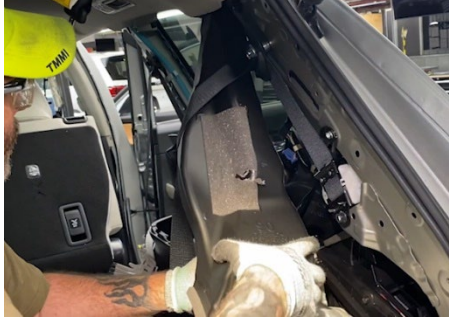
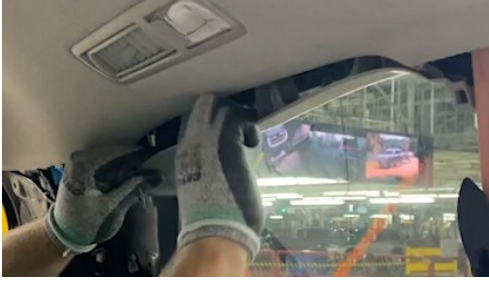
46. Install the LH & RH quarter trim and HVAC duct

- a. Install the HVAC duct on the RH side (if applicable)
- b. Install the quarter trims.

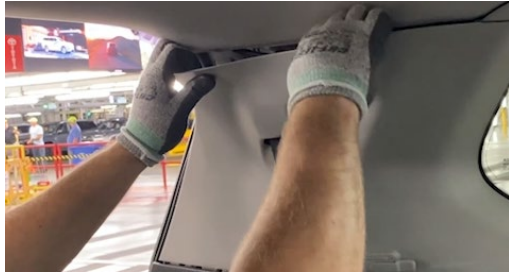
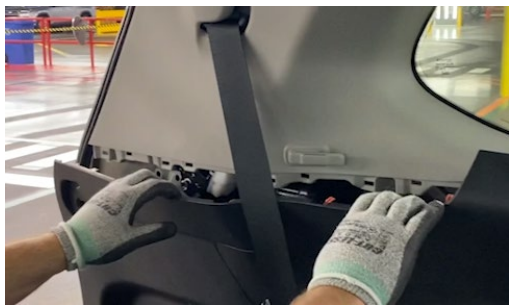
47. Install the LH & RH upper and lower D-pillar garnishes

- a. Install the upper D-pillar garnish
- b. Install the lower D-pillar garnish

NOTE: Ensure the seatbelts move freely.

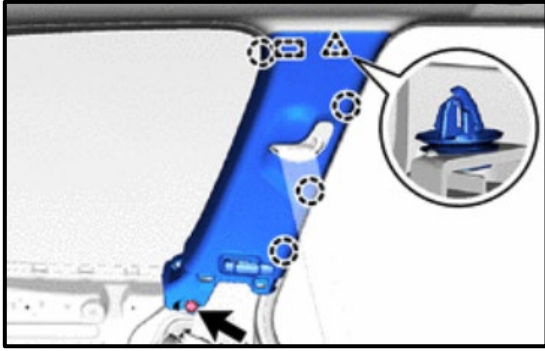
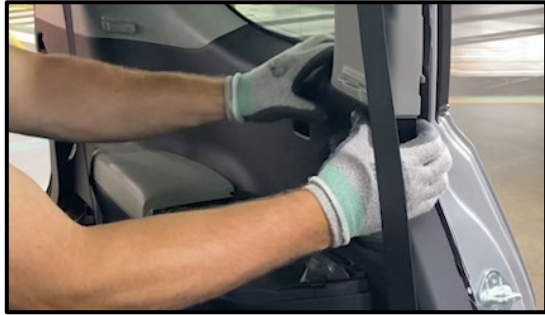
48. Install the LH & RH upper and lower C-pillar garnishes

- a. Install the upper C-pillar garnish
- b. Install the lower C-pillar garnish

NOTE: Ensure the seatbelts move freely.

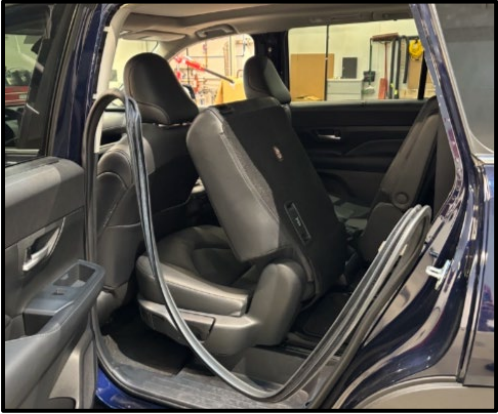
51. Install the LH & RH#2 door weather strips

- a. Install the door opening weatherstrips
