N242451330 Fuel Tank Lock Ring Not Locked

Release Date: July 2024 Revision: 01

Condition	General Motors has decided that a defect which relates to motor vehicle safety may exist in certain 2024
	model year Chevrolet Colorado and GMC Canyon vehicles. The lock ring that secures the fuel pump to
	the fuel tank assembly may not have been fully locked during assembly by the supplier. In certain high-
	speed crash conditions, a fuel tank lock ring that is not fully locked may come loose and allow fuel
	spillage. If spilled fuel comes in contact with an ignition source, there is increased risk of a fire.
Correction	Dealers will inspect and, if necessary, fully lock the fuel tank lock ring.

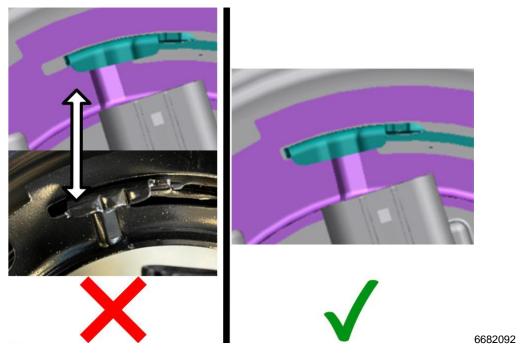
- 2. Inspect the Fuel Sender Lock Retainer.
 - a. If the Fuel Sender Lock Retainer is fully seated to the Fuel Tank, no further action is required.
 - b. If the Fuel Sender Lock Retainer is NOT fully seated to the Fuel Tank, proceed to Step 3.
