**July 3, 2024**

## Noncompliance Recall: 2024 CR-V Hankook Tire Inspection

### AFFECTED VEHICLES

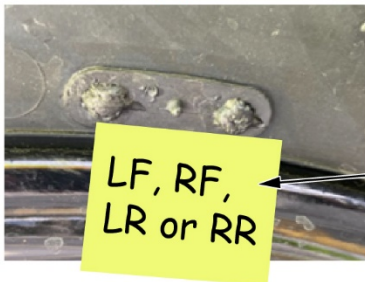
**NO GOOD** ❌

**NOTE**  
Indicate which  
tire the photo  
refers to.

- Put a note with the location of the tire on the rim below the tire with the missing TIN date code and take a photo. For example, Left-Front: LF, Left-Rear: LR, Right-Front: RF, Right-Rear: RR.
- Go to **REPAIR PROCEDURE** and replace all four tires.

1. Replace all four tires.
2. Send back the replaced tires (4) along with a copy of the repair order to AHM WPI at this address:
