SAFETY RECALL

Plug-in Hybrid Electric Vehicle Fires

Reference: 73B / NHTSA 24V-536

2017 - 2018 (RU) Chrysler Pacifica
Plug-In Hybrid Electric Vehicles (PHEV)

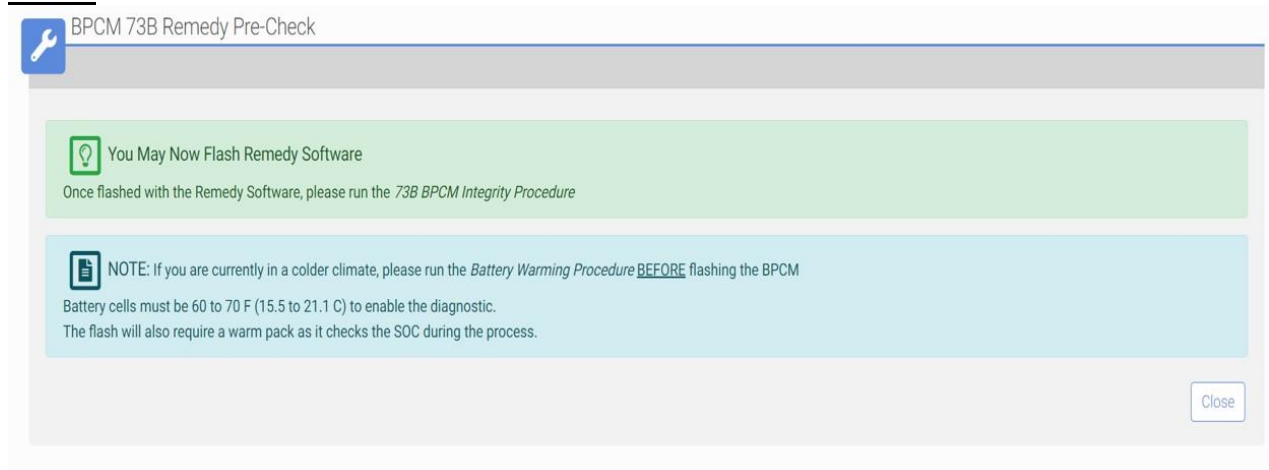
PASS

11. One of the following 2 screens will be displayed once the Pre-Check Procedure has finished.

- **PASS:** Proceed to **Section B. BPCM Warming Procedure.**
- **FAIL:** Proceed to **Section D. High Voltage Battery Pack Removal Procedure.**

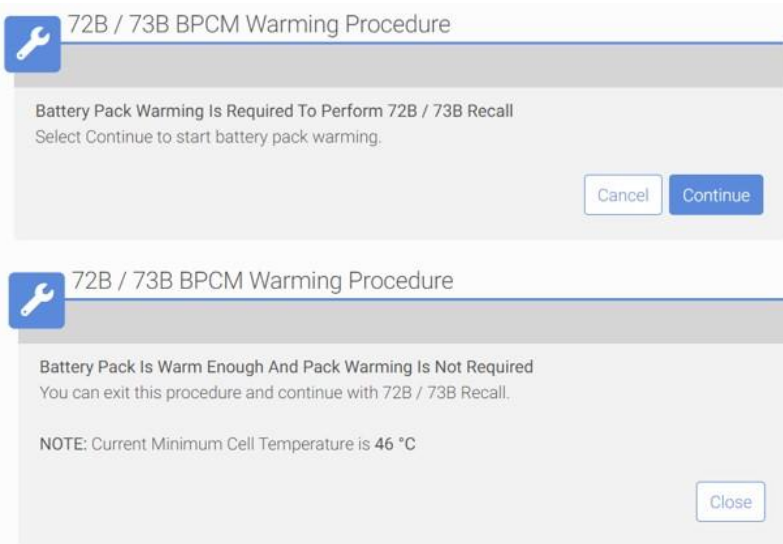
9. Within BPCM, select “**System Tests**” then select “**BPCM Warming Procedure**” then select “**Continue**”.

NOTE: Ensure the vehicle hood is open and remains open or the BPCM warming procedure will abort.

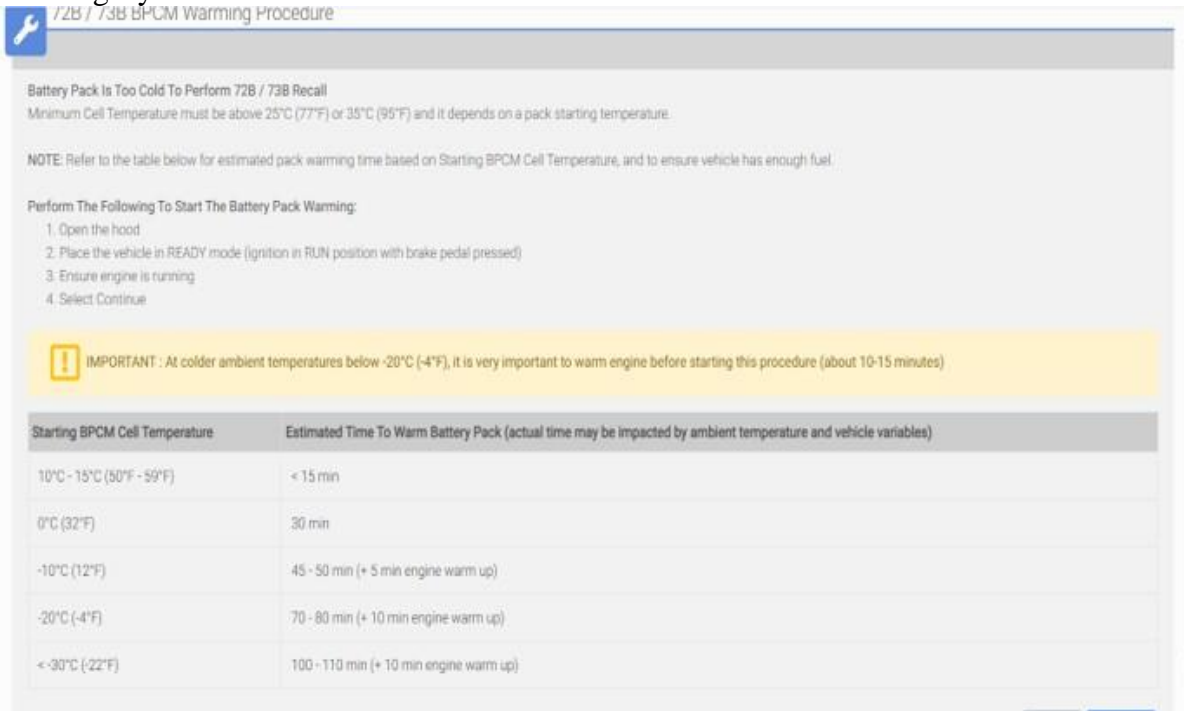
10. Follow the wiTECH screen instruction steps to perform the BPCM warming procedure if directed, otherwise proceed to Section C. Battery Pack Control Module (BPCM) Software Update and BPCM Integrity Procedure.

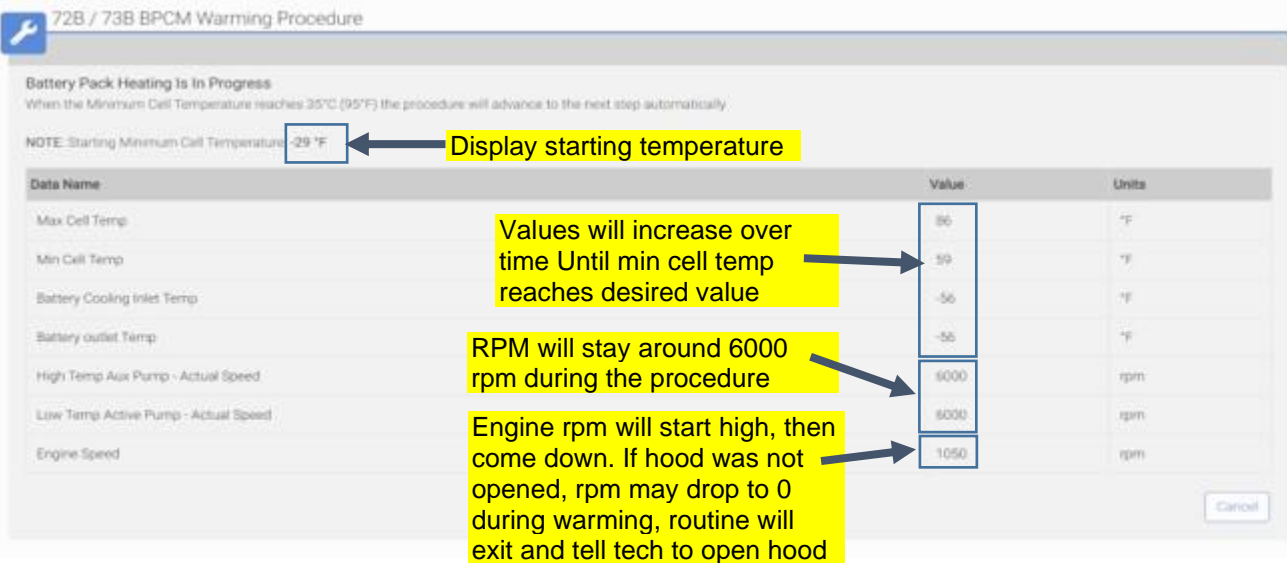
11. BPCM cell warming period duration will require separate technician time punch. BPCM cell warming duration will be recorded and traced by wiTECH 2. Individual punch time must reflect actual BPCM cell warming period or claim will be rejected or charged back to dealership.
12. The following data will be displayed during the warming procedure.

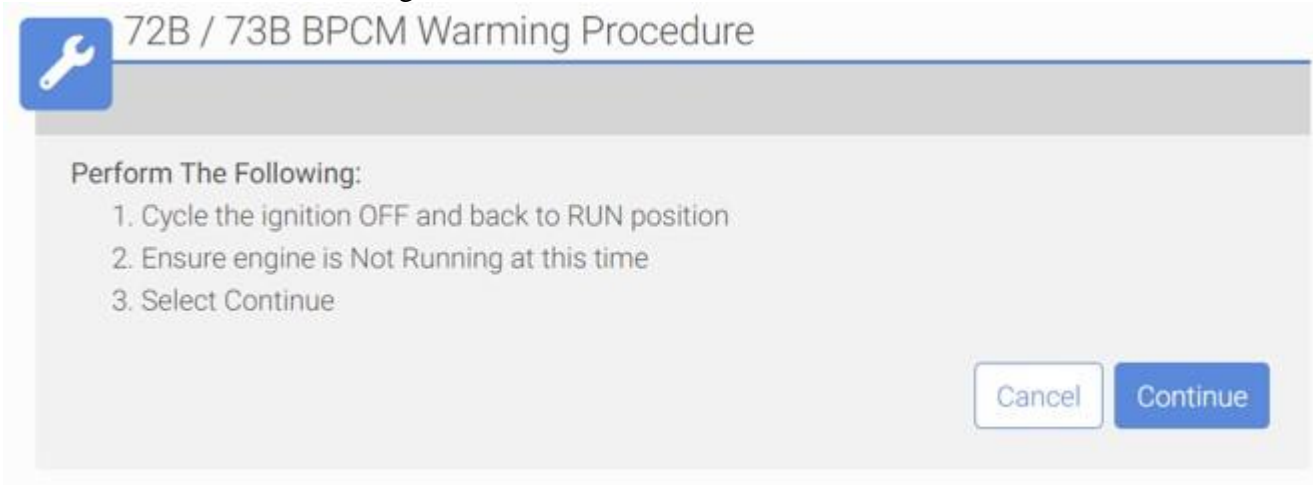
- 13. The following will be displayed once warming procedure has completed. Perform the steps listed on the screen before continuing.

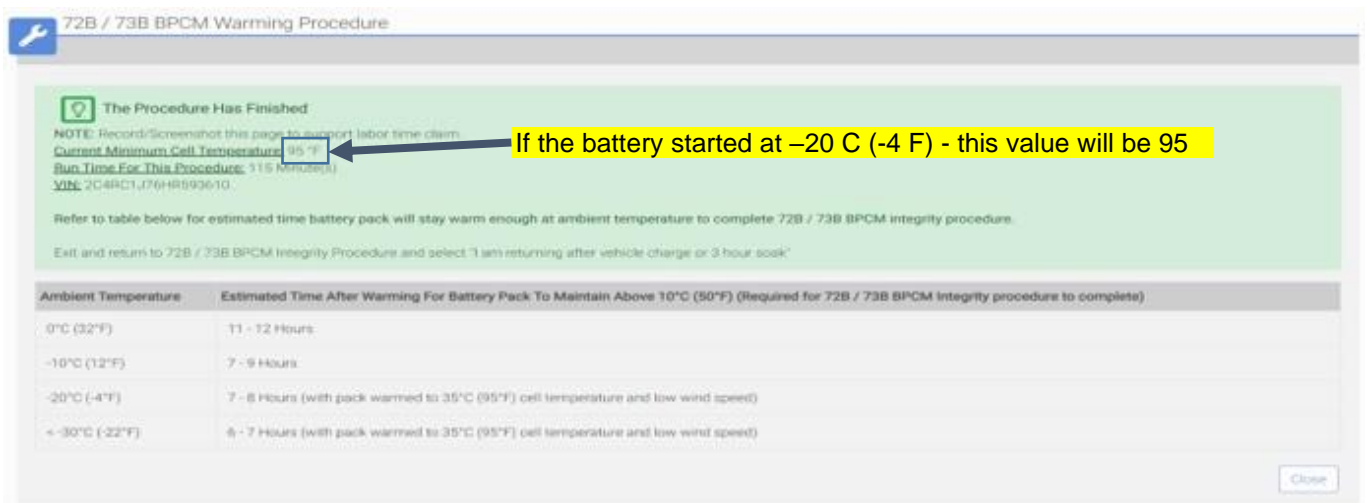
- 14. One of the following 3 screens will be displayed once the warming procedure has finished.

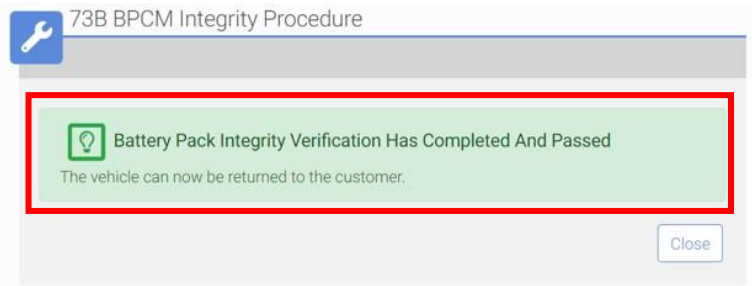
ALERT: This recall procedure REQUIRES you to reach the below screen message within the BPCM Integrity Procedure before returning the vehicle to a customer:

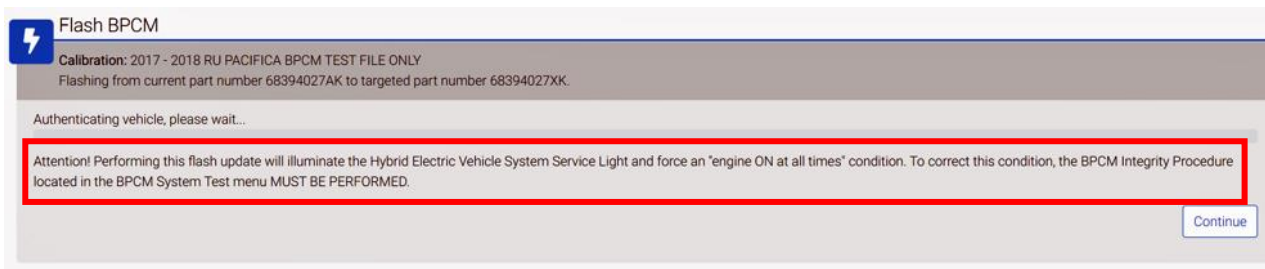
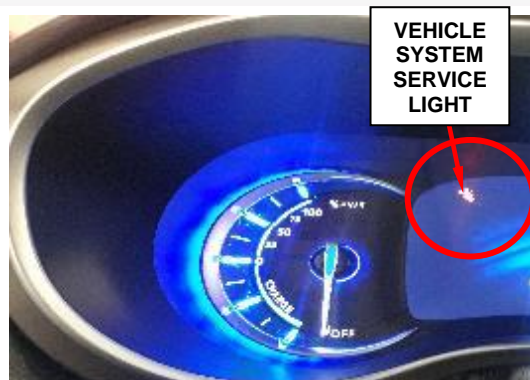
Figure 1 – Service Light

ALERT: Performing the BPCM flash will illuminate and continuously flash the Hybrid Electric Vehicle System Service lamp located in the instrument panel cluster. Every step in the 73B BPCM Integrity Procedure MUST be completed in order to turn the flashing service lamp off.

Do not return the vehicle to the customer if the service lamp is flashing. (Figure 1).

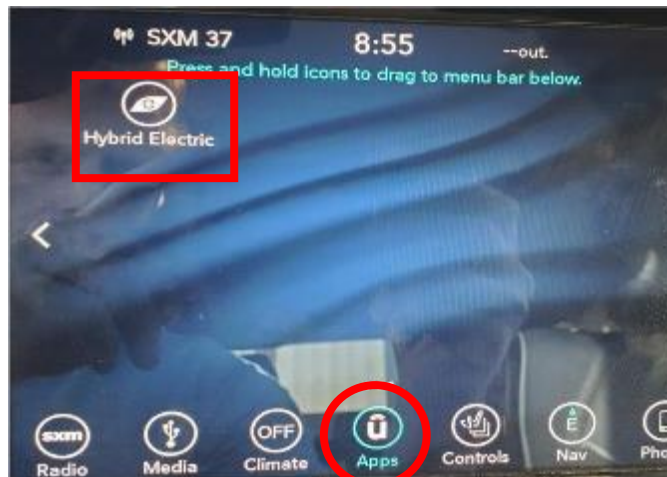
Figure 1 – Apps Display Screen

15. Select “Apps” then “Hybrid Electric” on the display (Figure 1).

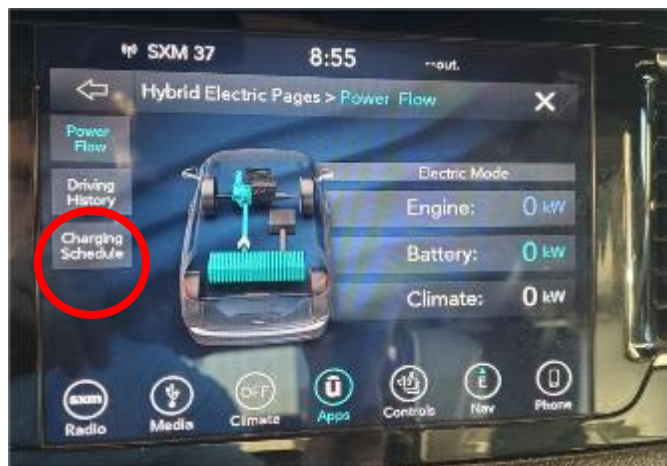
Figure 2 – Charging Schedule Display

16. Select “Charging Schedule” (Figure 2).

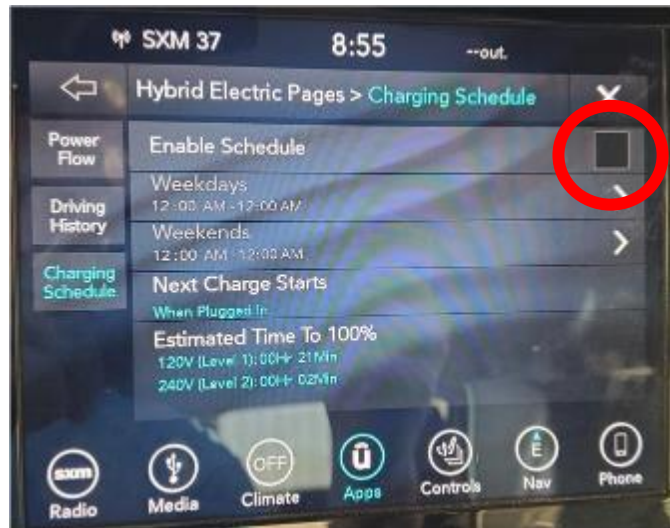
Figure 3 – Enable Schedule Screen

17. Verify the “Check Mark” is **NOT** selected in the “Enable Schedule” box (Figure 3).

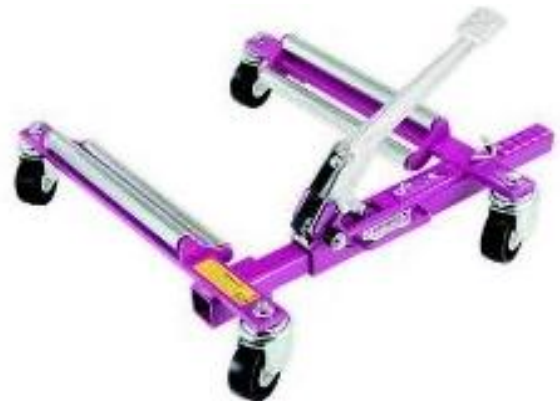
Figure 4 – Lift, Wheel Jack Dolly

CAUTION: If charging indoors is unavoidable (not preferred). Do not leave the vehicle unattended while charging. If any smoke is observed coming from the underbody, unplug the charge cable and, if safe to do so, slide the Lift, Wheel Jack Dolly under both front wheels (See Figure 4 and 5) elevate the vehicle and push it outside away from buildings and other vehicles. Call your local fire department immediately.

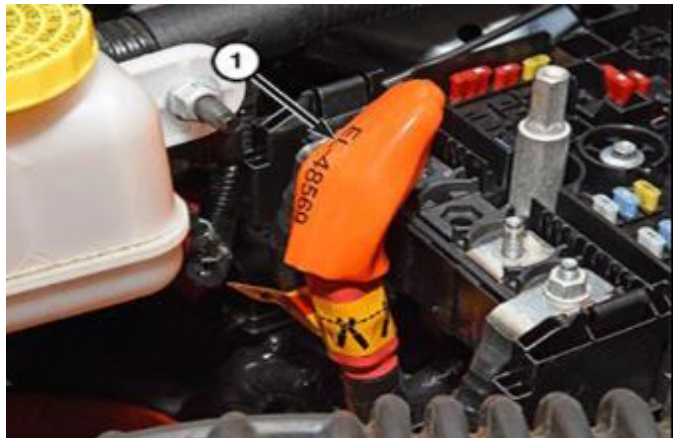
Figure 6 – Battery Cable

6. Disconnect the B+ battery cable (1) from the 12-volt Power Distribution Center (PDC) (Figure 6).
7. Isolate the battery cable terminal with Cover, Protective 10084

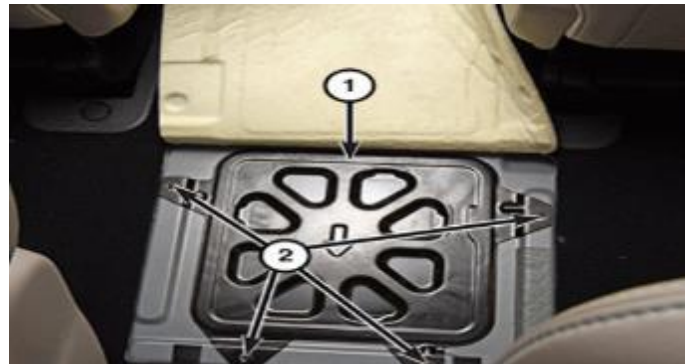
Figure 7 – MSD Access Cover

8. Lift the carpet away from the high-voltage MSD floor access cover.
9. Remove the four screws (2) and remove the high-voltage MSD access cover (1) (Figure 7).
10. Depress the lever release latch (2) firmly. With the latch fully depressed, rotate the lever (1) upward. The lever will stop at the 45° position (Figure 7).

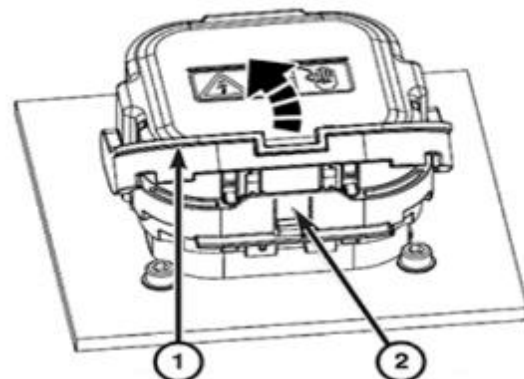
Figure 8 – MSD Locking Tab

11. Again, depress the locking tab (2) and continue to rotate the lever to the end of travel (90° position) (Figure 8).
12. Pull straight back on the plug lever (1) to disengage and remove the high-voltage manual service disconnect from the receptacle (Figure 9).

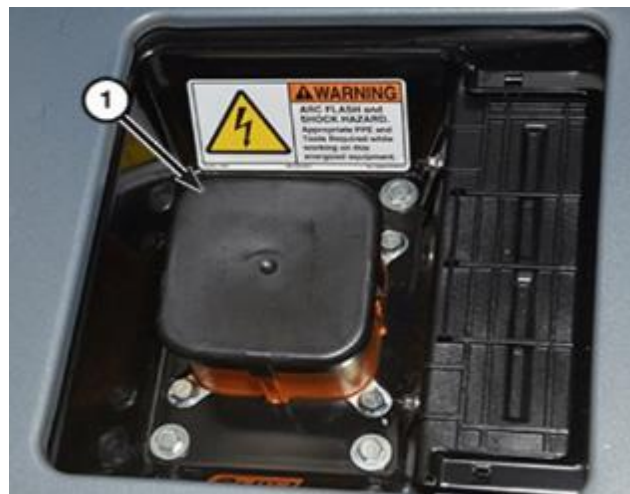
Figure 10 – MSD Cover

13. Cap the receptacle on the high-voltage battery with the [Covers, HEV Battery Terminal 2035100082](#) (1) to prevent foreign objects from entering (Figure 10).

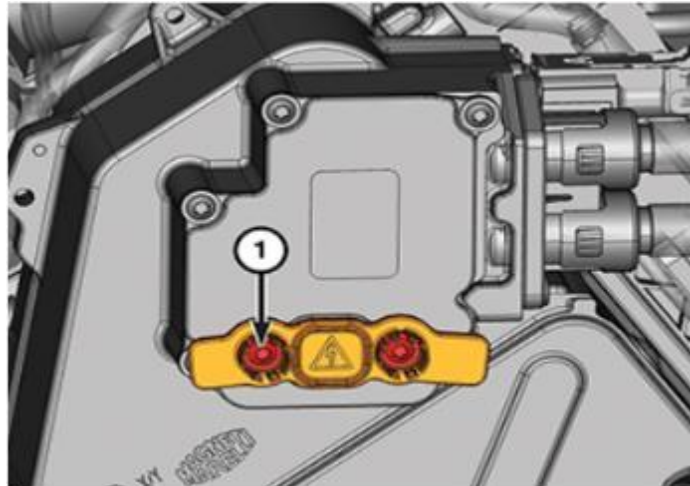
Figure 11 – Power Inverter Module

14. Loosen two captive screws (1) and remove the single High Voltage Inter-Lock (HVIL) connector from the Power Inverter Module (PIM) cover (Figure 11).

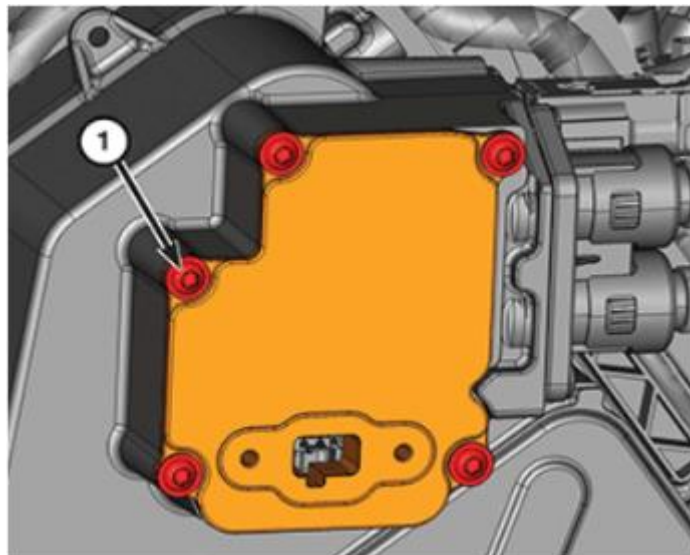
Figure 12 – PIM Cover

15. Loosen five captive screws (1) and remove the PIM cover (Figure 12).

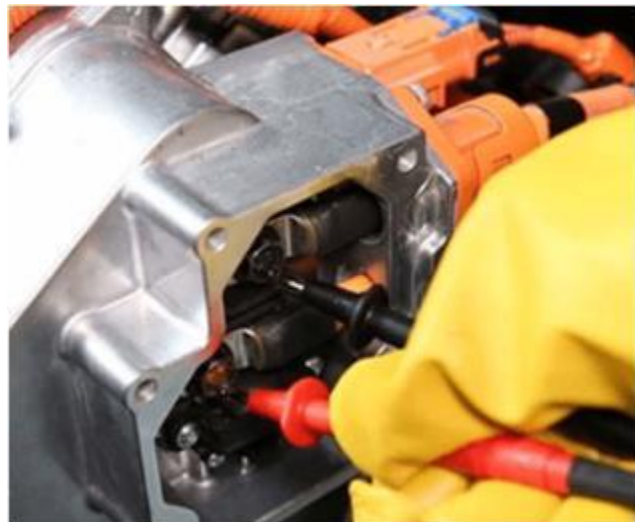
Figure 13 – Voltage Measurement

17. The measured voltage should be near 0 volts (Figure 13).
- If the voltage measured is near 0 volts, it is safe to work on the high-voltage components with the exception of the high-voltage battery internal components.

- If the voltage is greater than 0 volts, an internal condition exists within the high-voltage battery that is preventing it from being powered down. Do not attempt to carry out repairs on any of the vehicle's high-voltage components or wiring. Perform the **HIGH VOLTAGE LOSS OF ISOLATION TEST PROCEDURE** (Refer to 08 - Electrical/Standard Procedure)

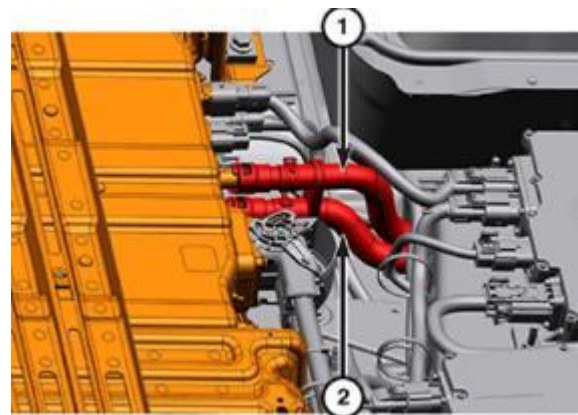
Figure 14 – Coolant Hoses

19. Raise and support the vehicle.
20. Remove the engine belly pan, charger belly pan, battery belly pan and rear suspension belly pan.
21. Using suitable hose-pinching pliers, clamp-closed the coolant inlet (1) and outlet (2) hoses near the high-voltage battery (Figure 14).

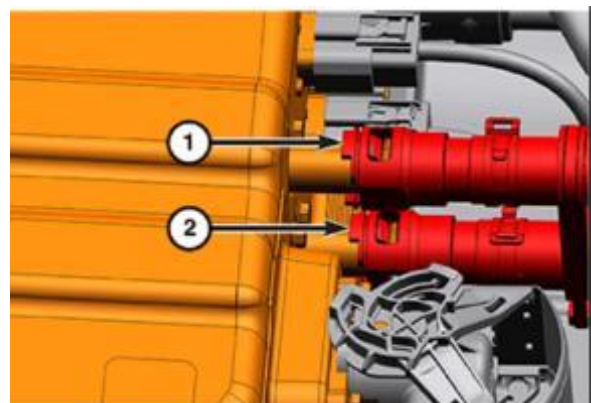
Figure 15 – Quick Connect Couplings

22. Place a suitable coolant recovery container under the coolant inlet and outlet hoses.
23. Disengage the quick-connect couplings and carefully remove the coolant inlet (1) and outlet (2) hoses from the high voltage battery (Figure 15).

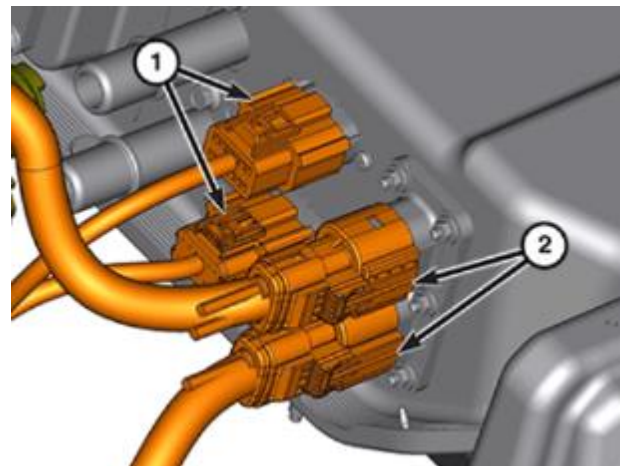
Figure 17 – Wire Harness

25. Cap the nipples on the high-voltage battery with the [Covers, HEV Battery Terminal 2035100082](#) and plug the coolant hose ends.
26. Disengage the two wire harness retainers (2) from the high-voltage battery (Figure 16).
27. Unlock and disconnect the Power Inverter Module (PIM) high-voltage wire harness connector (1) from the high-voltage battery. Cap the connector on the high-voltage battery with the [Covers, HEV Battery Terminal 2035100082](#)
28. Unlock and disconnect the low-voltage wire harness connectors (1) from the high-voltage battery (Figure 17).
29. Unlock and disconnect the On-board Charging Module (OBCM) and Electric Coolant Heater (ECH) high-voltage wire harness connectors (2) from the high-voltage battery.
30. Cap the connectors on the high-voltage battery with the [Covers, HEV Battery Terminal 2035100082](#).

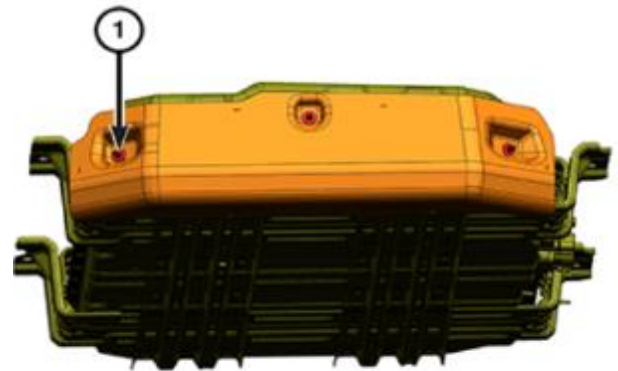
Figure 19 – Heat Shield

33. Remove the eight bolts and remove the high-voltage battery from the vehicle.
34. Remove the nuts (1) and the heat shield from the high-voltage battery (Figure 19).

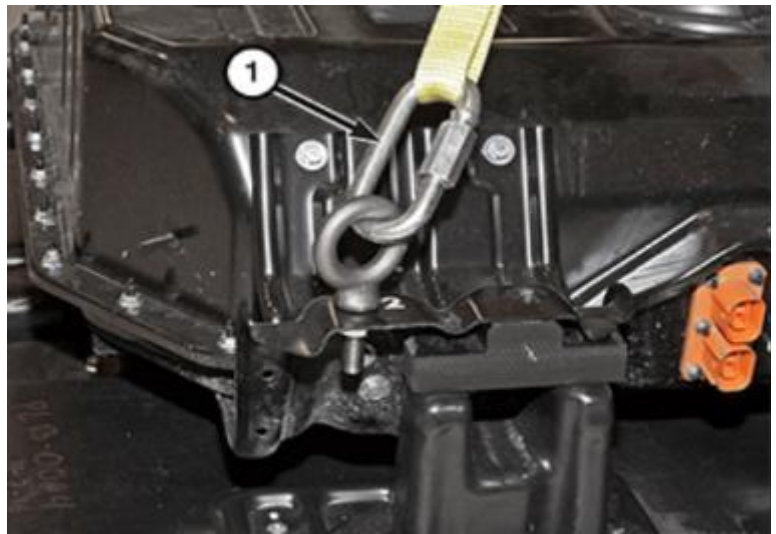
Figure 20 – Lift Straps

35. Install the [Lift Straps, HV Battery 2035200080](#) (1) and remove the high-voltage battery pack from the lifting device. Place the high-voltage battery pack in the shipping container or in a suitable storage location (Figure 20).

- The Manual Service Disconnect (MSD) from this battery must be retained and returned with the battery.
- All coolant must be removed from the battery. Use a shop air supply hose connected to the battery coolant inlet port. Adjust the air pressure regulator to not exceed 100 kPa (15 psi) and force the coolant from the battery coolant outlet port.
- All coolant ports and electrical connections must be capped.

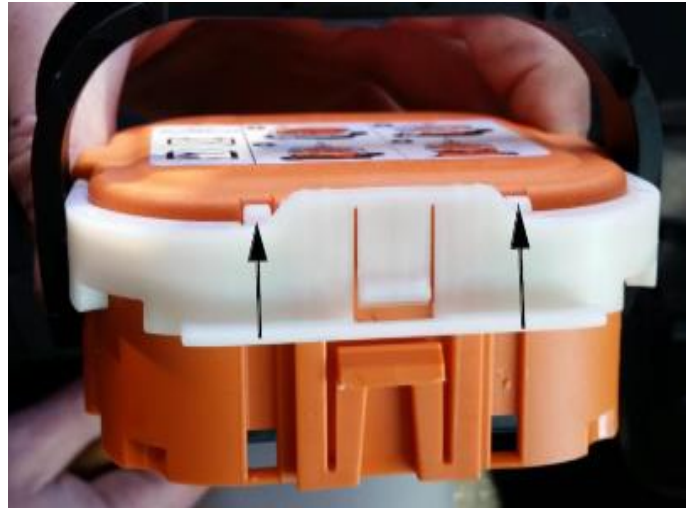
Figure 21 – MSD Position

16. Position the white sleeve in the full upright position for installation of the MSD to verify proper engagement as shown (Figure 21).

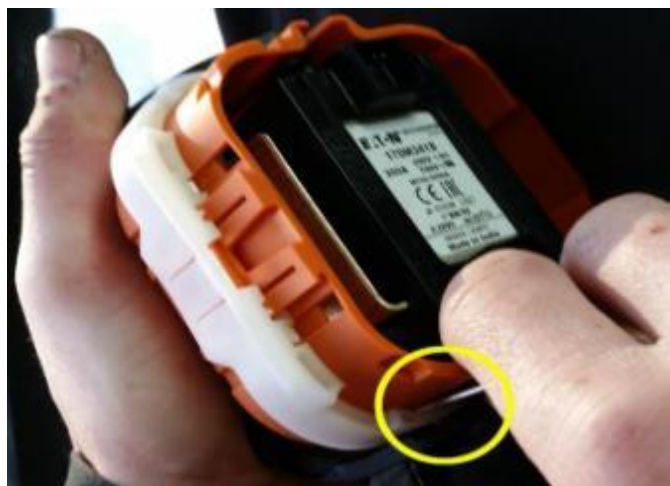
Figure 22 – White Sleeve

NOTE: If necessary, use a small screwdriver to loosen and guide the white sleeve to the full upward position as shown (Figure 22).

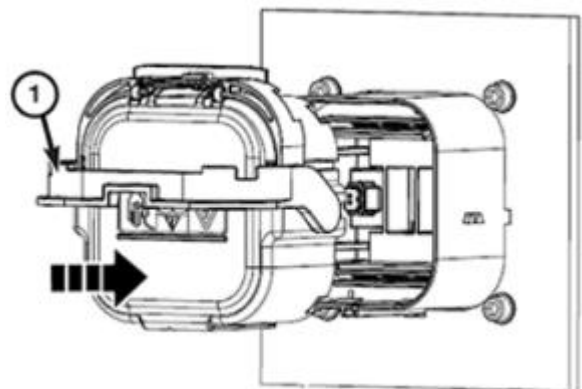
Figure 24 – MSD Lever

NOTE: With the high-voltage MSD properly aligned with the receptacle, the lever (1) will be released and allowed to rotate to the lock position (Figure 24).

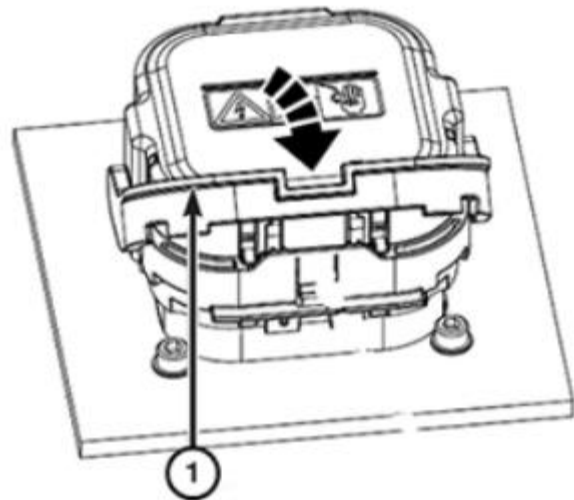
Figure 25 – MSD Lever Locking

20. Rotate the lever (1) while maintaining a slight force on the high-voltage MSD. The lever will engage the receptacle and draw the high-voltage MSD down onto the receptacle as the lever is rotated.

21. Rotate the lever (1) downward until it is fully engaged and locked by the lever release latch (2). An audible “click” will be heard as the lever latches into position. Gently pull the high-voltage MSD upward to ensure that it is fully seated in the receptacle and locked. If the MSD is able to be removed, repeat steps 16 – 21 (Figure 25).
