# RECALL

## R24DC: FMVSS 221 Noncompliance: Joint Strength – Insufficient Roof Rivet Quantity

**Models Affected:** Certain 2019-2023 Vision and All American buses

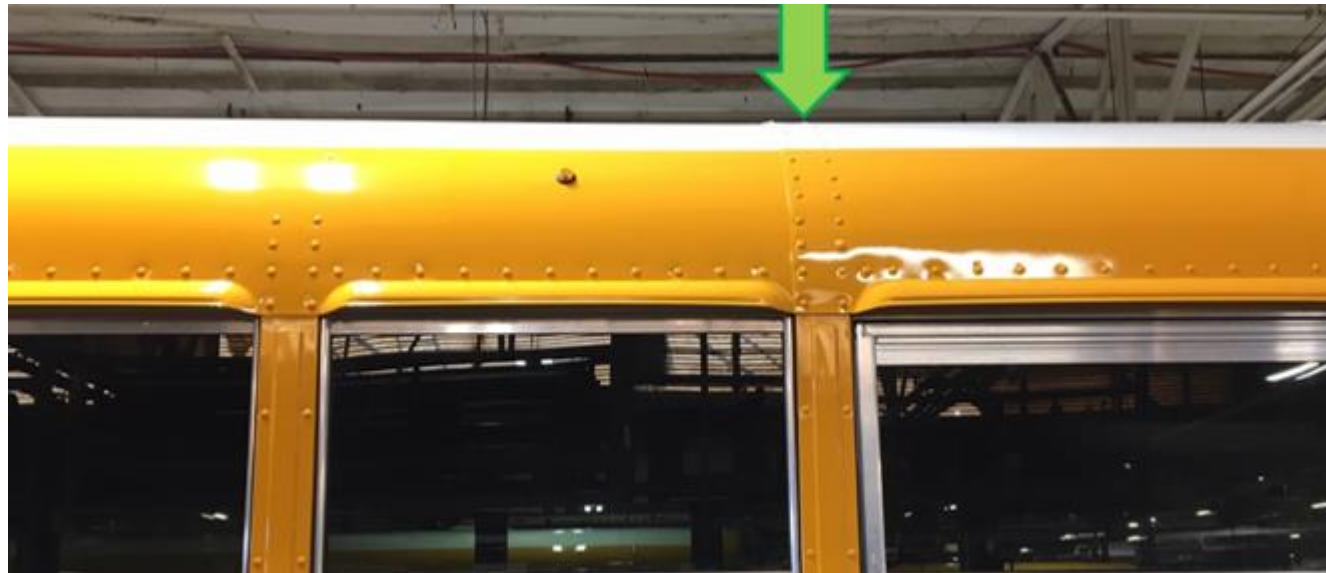
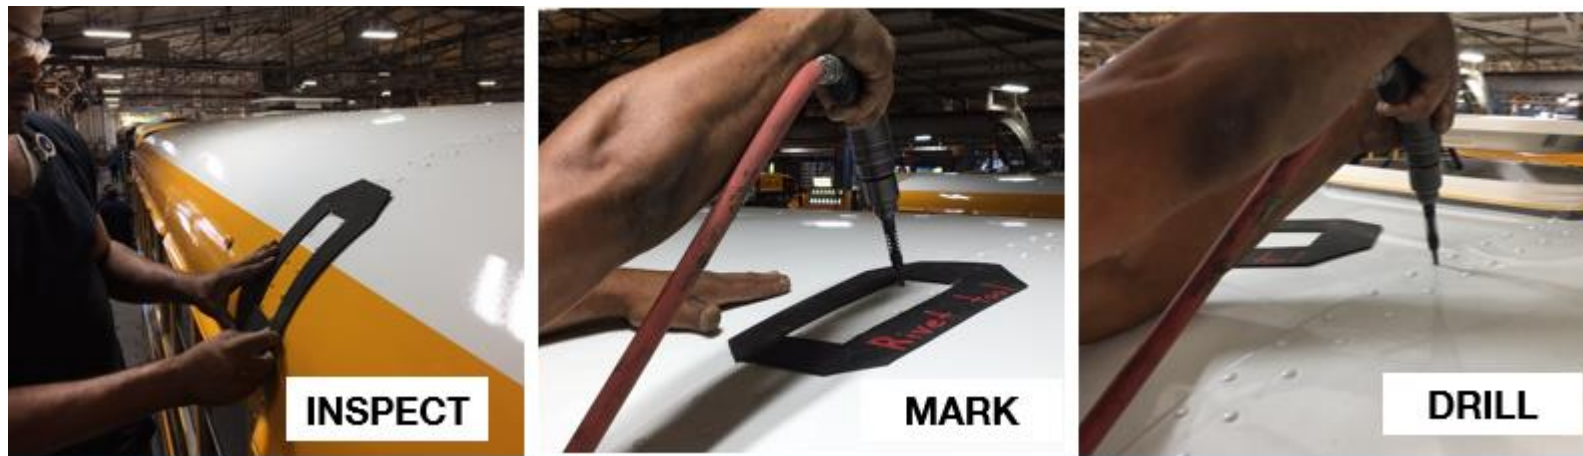
3. Inspect rivet spacing at each roof sheet joint. Roof sheet joints are assembled with two rows of rivets. Joint must have a minimum of six rivets in an eight inch segment. The full length of the roof sheet joint, including the top of the bus, must be inspected and corrected, if needed.

- a. Place the supplied rivet spacing template over the joint and parallel to the edge of the roof sheet, allowing roof rivets to be exposed through the opening in the template, as shown.

- b. Move the template from one side of the roof sheet towards the center of the roof.
  - c. If a segment in the roof joint contains less than six rivets, additional rivets are required. Mark each area that requires additional rivets.

- d. If one rivet is required; add a rivet equally spaced between the two rivets with the largest space in this section.
  - e. If additional rivets are required; add additional rivets between the largest spaces until a minimum of six (6) rivets have been added in the eight (8) inch segment.
