RECALL 24V563 / 2024-433 REMEDY INSTRUCTIONS

Make(s): CHEROKEE
Model(s): CKT200G-89
Model Year(s): 2025

Concern:
A fastener may have penetrated the microwave's interior cabinet, exposing the screw to the microwave.

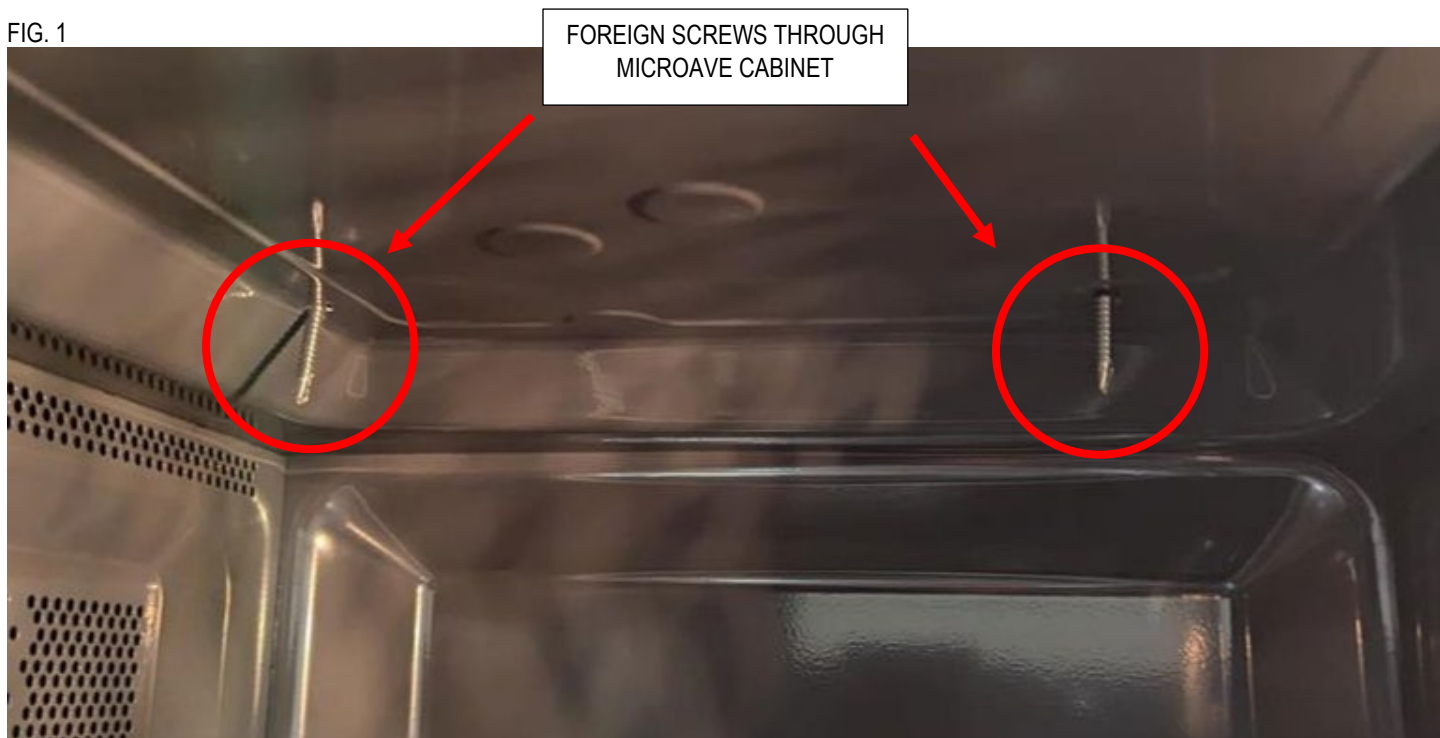
FIG. 1

STEP 2: LOOK AT THE TOP OF THE INTERIOR OF THE MICROWAVE AND LOOK TO SEE IF ANY SCREW(S) ARE PRESENT (FIG. 1);

STEP 1: REMOVE THE MICROWAVE FROM CABINET AND DISCARD APPROPRIATELY;

STEP 2: REPLACE MICROWAVE WITH A NEW MICROWAVE;

STEP 3: TEST MICROWAVE FUNCTIONALITY;
