| REFERENCE: | Nova Bus Manuals |
| RS N°: | MQR 7621-2869 |
| NHTSA RECALL N°: | 24V-564 |

| SUBJECT: | Driver's Door Glazing |

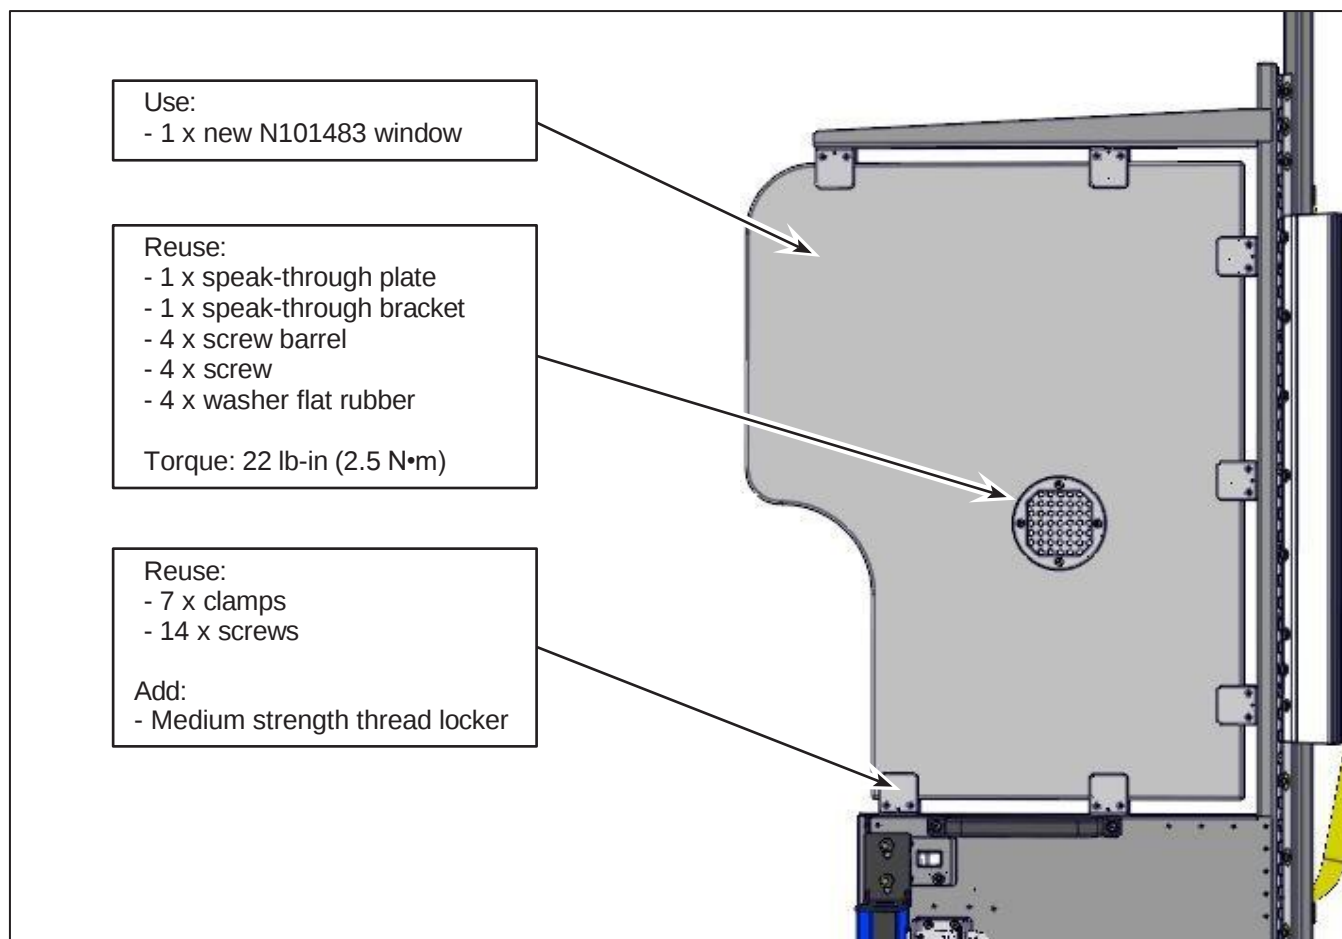
Figure 1 - Driver's Door Window Replacement

| JUSTIFICATION: | The driver's door plastic glazing is not compliant with FMVSS 205. |

- 1.3. Remove the existing speak-through from the driver's door window (Figure 1). Note its orientation and keep all parts.
- 1.4. On the inside of the driver's door, for each of the 7 clamps, unscrew the 2 screws to release the window. Remove only the first part of the clamp. Discard the window, keep the clamps and screws. **Note:**

- 1.5. Install the new N101483 door window on the clamps with the removed screws. Apply medium strength threadlocker Loctite 243 or equivalent to the screws and tighten. Note: keep the protective film on the window during installation.

- 1.6. Reinstall the speak-through supports with the 4 screws, 4 shoulder screws and 4 flat washers in rubber on the window. Tighten the 4 screws to 22 lb-in (2.5 N•m). Note: overtightening will damage the speak-through supports.
