NHTSA: 24V-618
Transport Canada: TC2024-479
Winnebago Towable: CAM0000038

Safety Recall:
 Non-GFCI Outlet Installed – Minnie 2500FL

Safety Recall:
 Non-GFCI Outlet Installed – Voyage 3438RK - 3235RL - 3538RK Models

Safety Recall:
 Non-GFCI Outlet Installed – Access 25ML

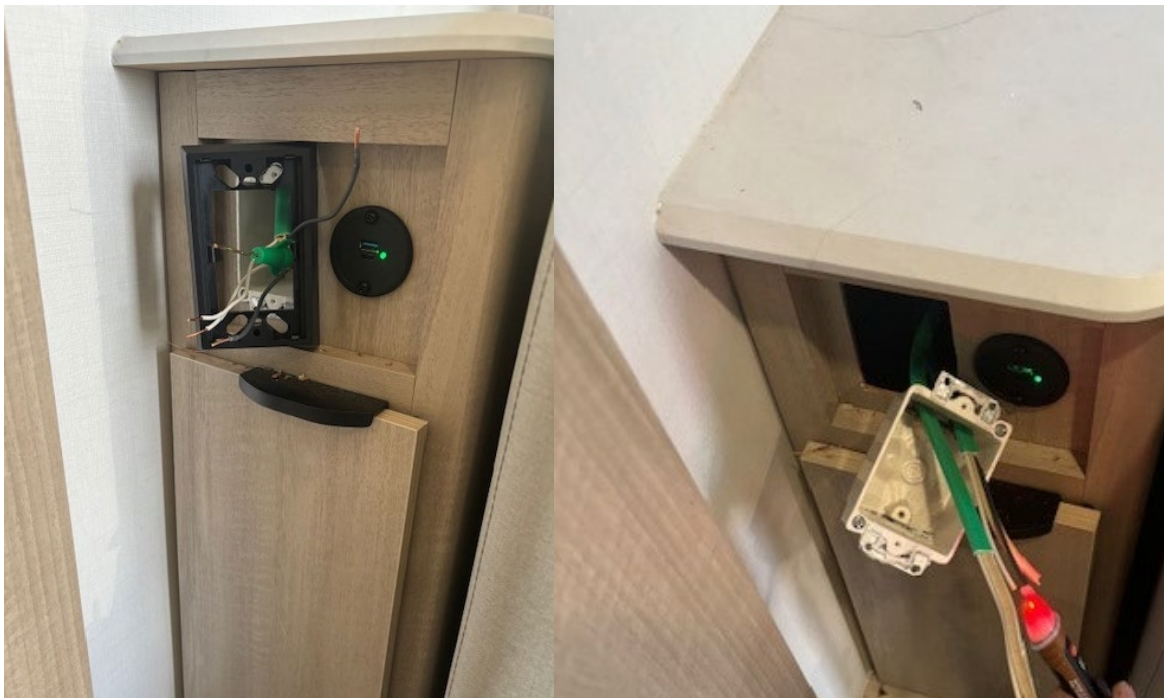
- 1) Check receptacles with GFCI tester.
- 2) Disconnect shore power & turn off battery disconnect switch **OR** turn off number #10 Breaker (General)
- 3) Remove receptacle from hole. (see print on next page for both locations)

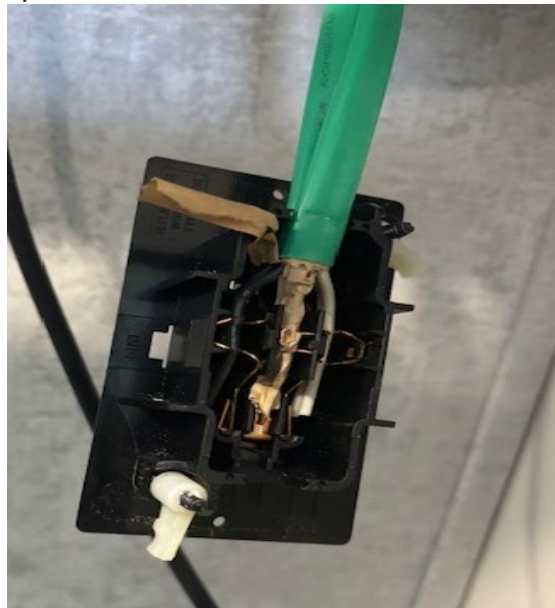
6) Cut Romex in half, if necessary.

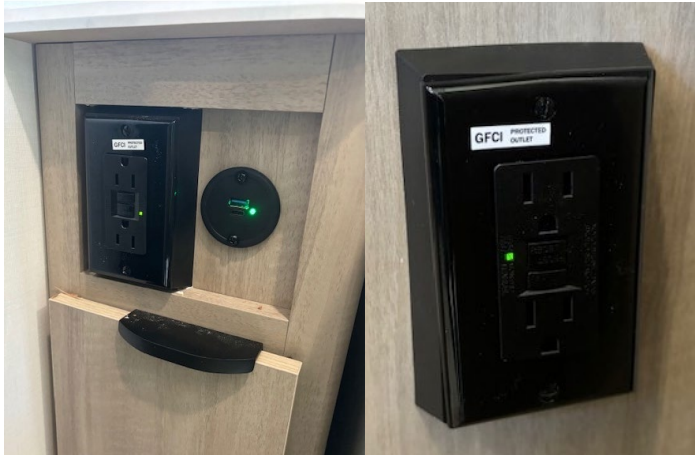
- 7) Insert Romex ends through the back side of the electrical box pulling around 6" out the front of the box.
- 8) Install electrical box into new hole size.
- 9) Install new receptacle & cover plate.

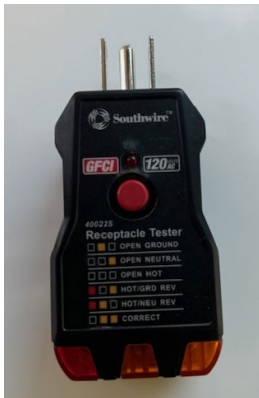
- 10) Turn power back on and test receptacle.

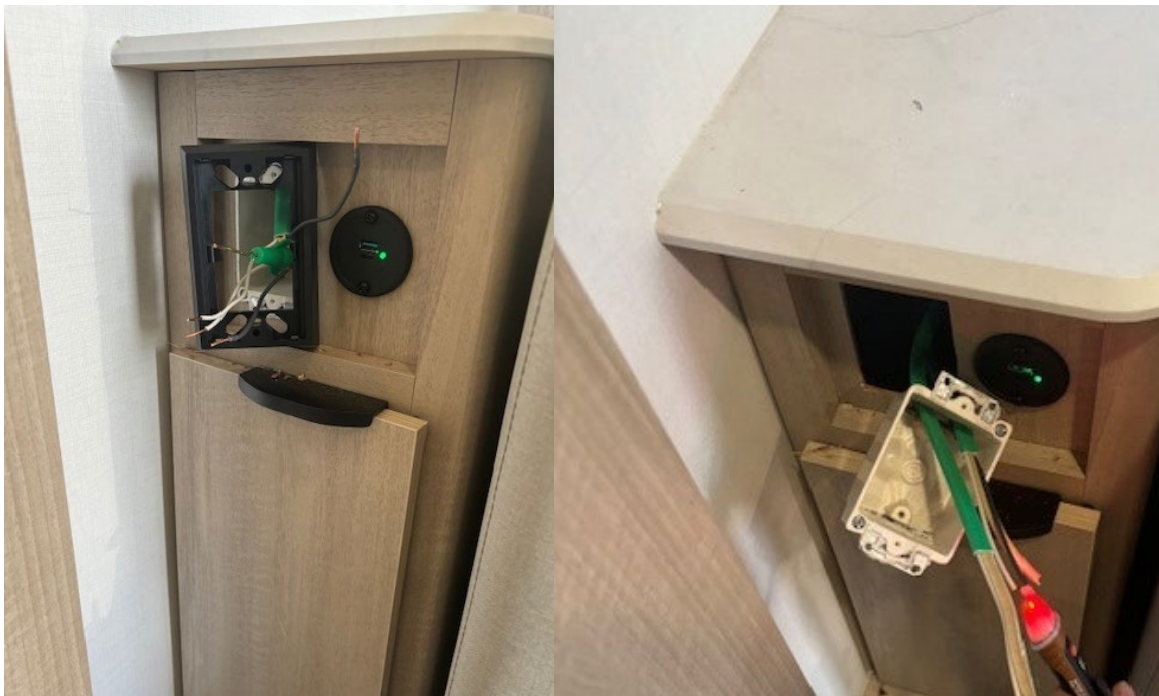
- 1) Check receptacles with GFCI tester.
- 2) Disconnect shore power & turn off battery disconnect switch **OR** turn off number #10 Breaker (General)
- 3) Remove receptacle from hole. (see print on next page for all 3 locations)

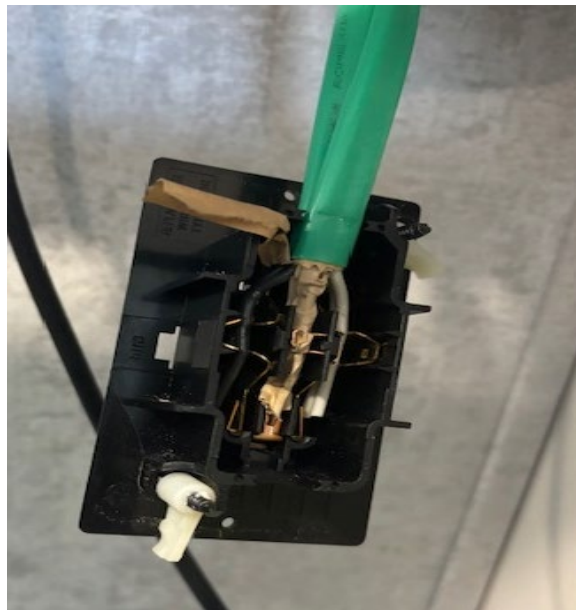
5) Cut Romex in half, if necessary.

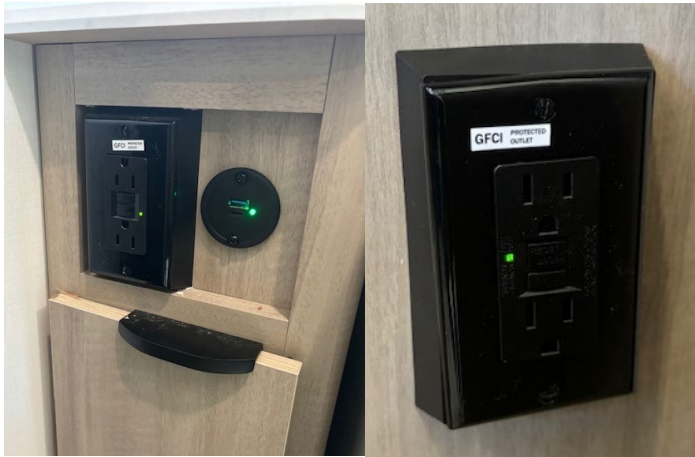
- 6) Insert Romex ends in through the back side of the electrical box pulling around 6" out the front of the box.
- 7) Install electrical box into new hole size.
- 8) Install new receptacle & cover plate.

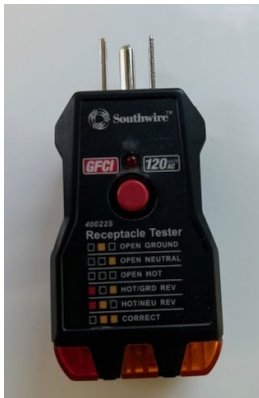
- 9) Turn power back on and test receptacle.

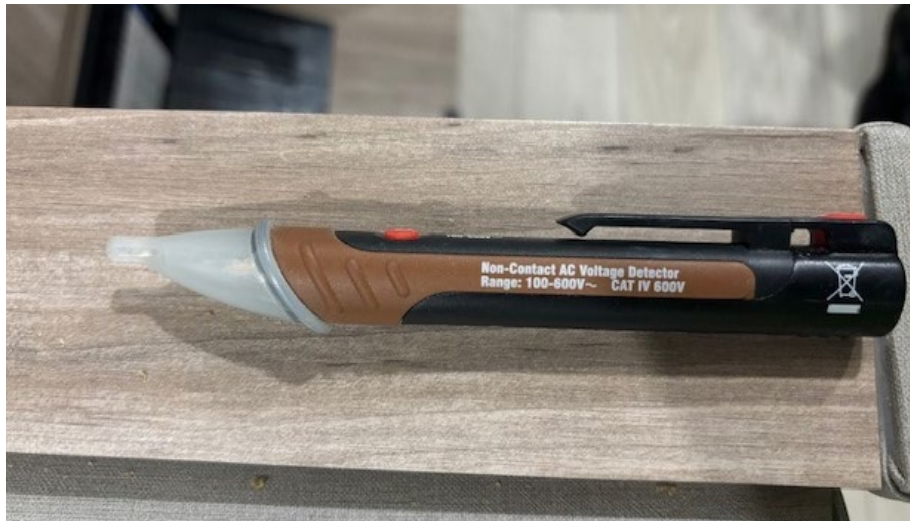
- 1) Check receptacles with GFCI tester.
- 2) Disconnect shore power & turn off battery disconnect switch **OR** turn off #4 Breaker (Slide-Box)
- 3) Remove receptacle from hole. (see prints on the following pages for location information)
- 4) Reconnect shore power & turn on battery disconnect switch **OR** turn on number #4 Breaker (Slide-Box)
*Make note of hot line for receptacle install with non-contact AC Voltage Detector and **REPEAT STEP 2.**

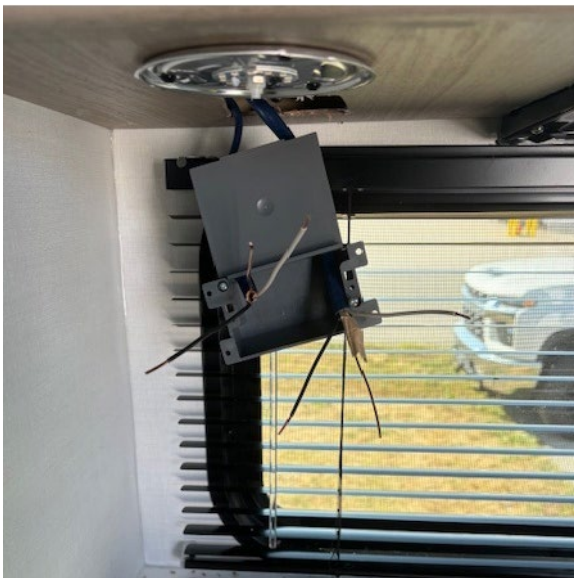
- 5) Change hole size to $2\frac{1}{2}'' \times 3\frac{3}{4}''$.
- 6) Cut Romex in half.
- 7) Insert Romex ends in through the back side of the electrical box pulling around 6'' out of the front of the box.

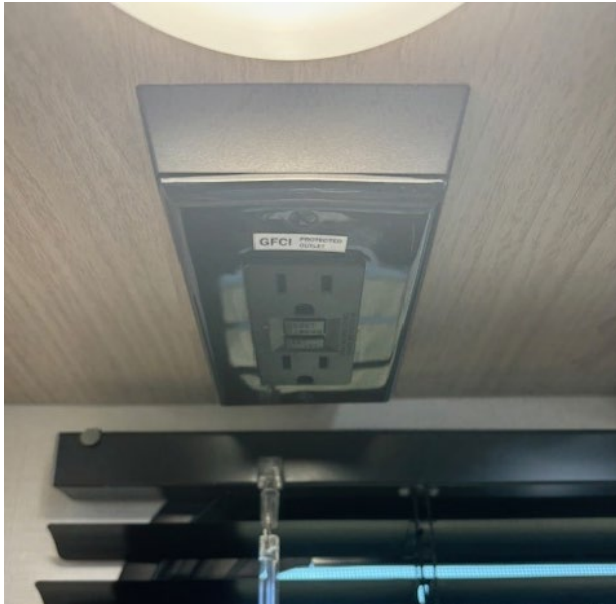
9) Install new receptacle & cover plate.

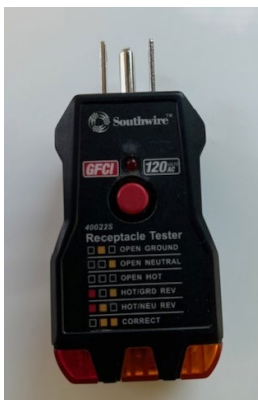
10) Turn power back on and test receptacle.

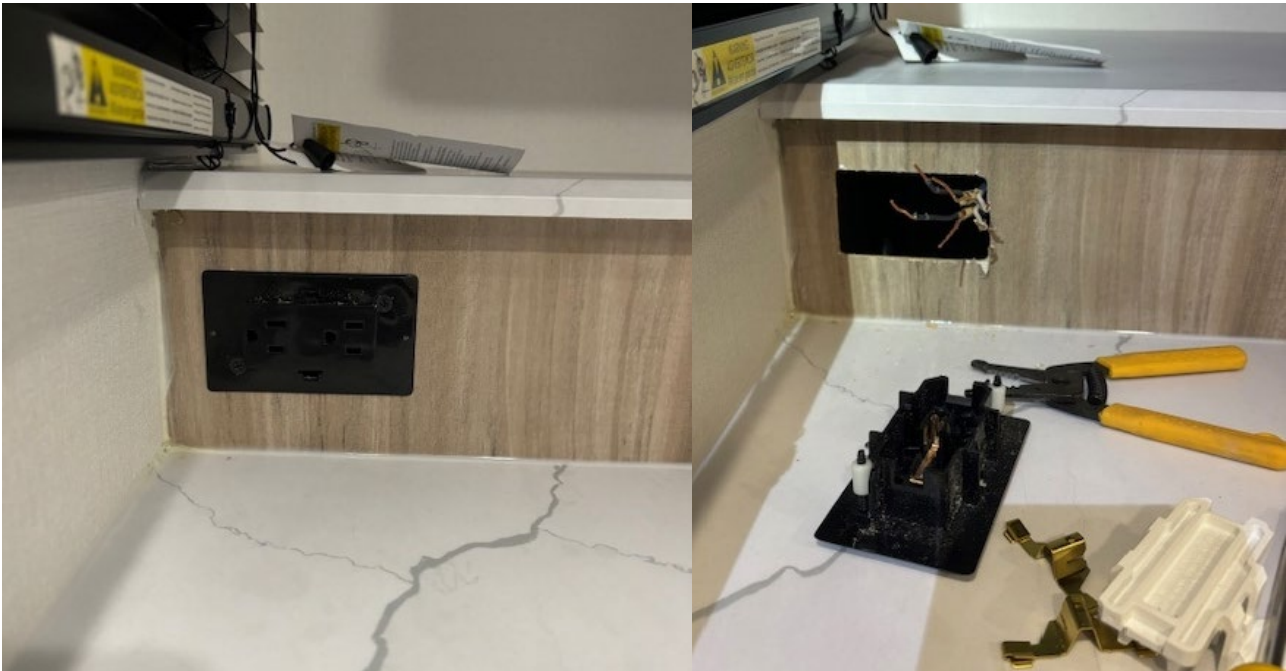
- 1) Check receptacle with GFCI tester.
- 2) Disconnect shore power & turn off battery disconnect switch **OR** turn off number #4 Breaker (Slide-Box)
- 3) Remove receptacle from hole. (see print on next page for location information)

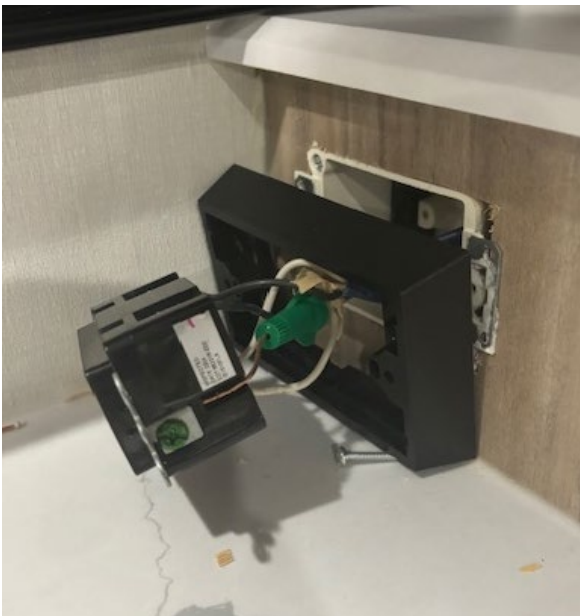
7) Insert Romex ends in through the back side of the electrical box pulling around 6" out the front of the box.

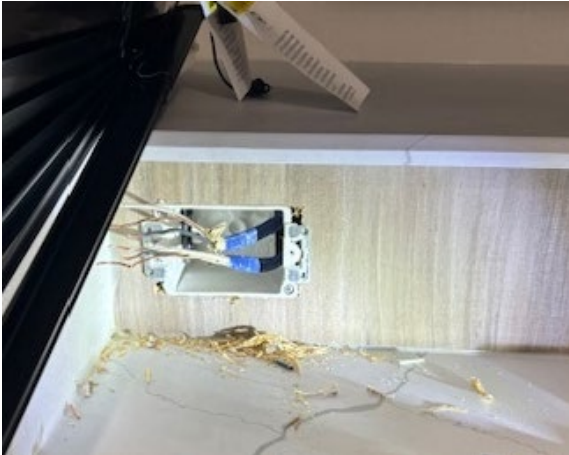
8) Install electrical box into new hole size.

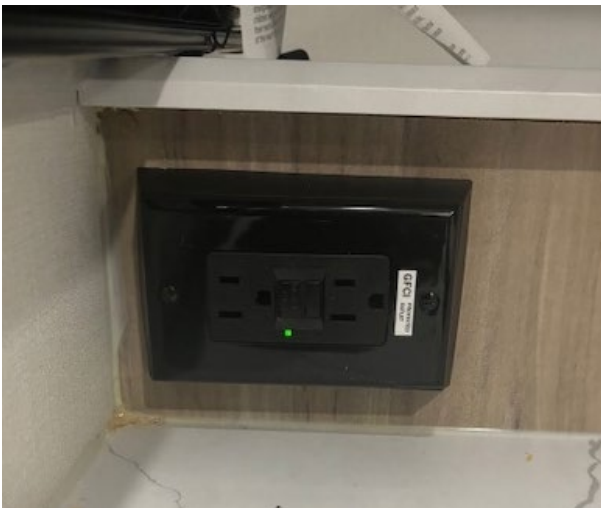
9) Install new receptacle & cover plate.

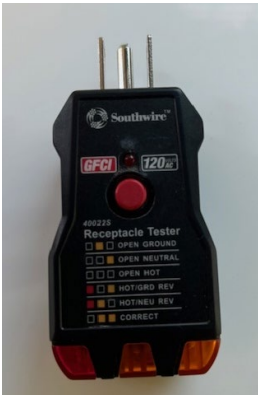
10) Turn power back on and test receptacle.
