Thor Motor Coach Recall Repair Instructions

Recall #	24V-666 2024-520		
Description/Title:	2024 Transit LP Heatshield		
Affected Product Line(s):	Certain MY 2024 Palladium & Talavera motorhomes		
Service Campaign # :	RC000314		
Repair Code:	Inspect with Repair: TMCRC80501V	Document Date:	MM/DD/YYYY
Time Allowed:	Inspect with Repair: 1.0	Document Revision:	A

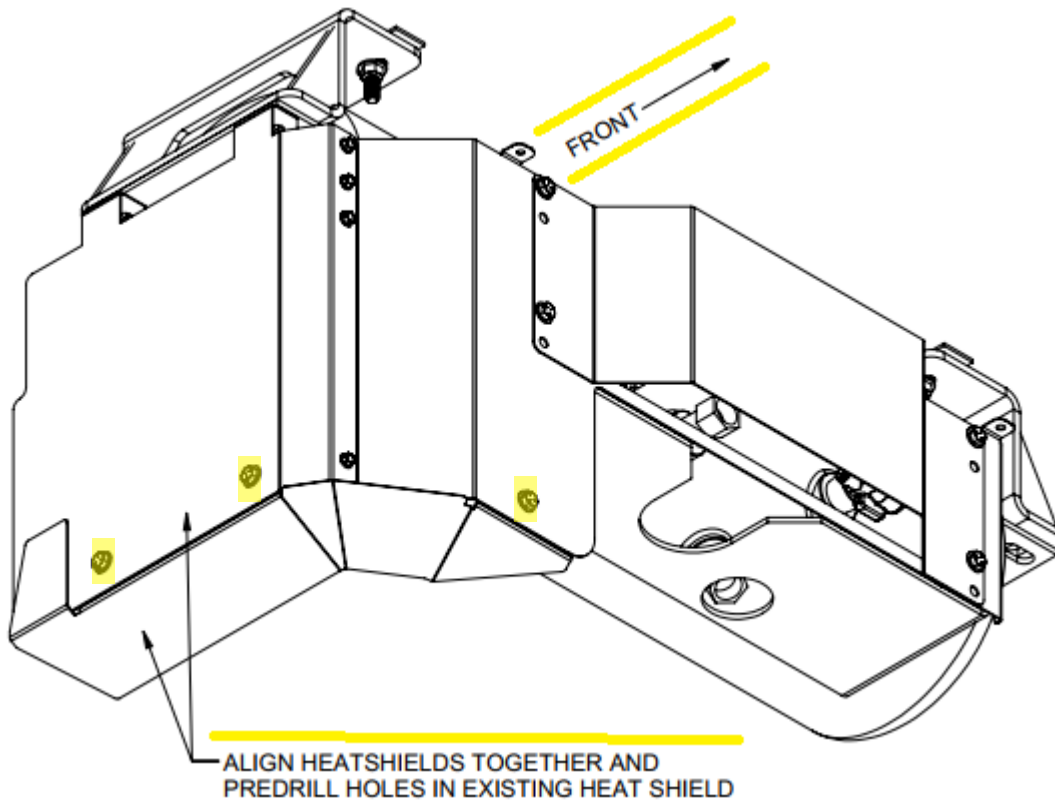
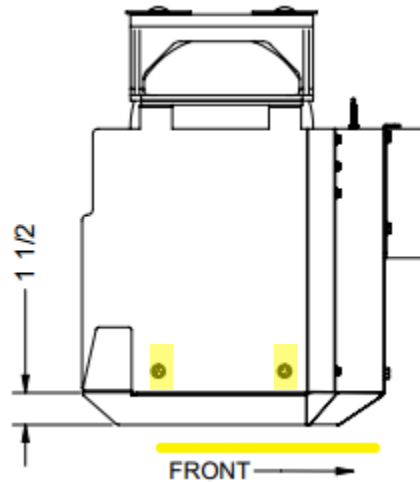
1. Align heatshields together and predrill holes in existing heatshield

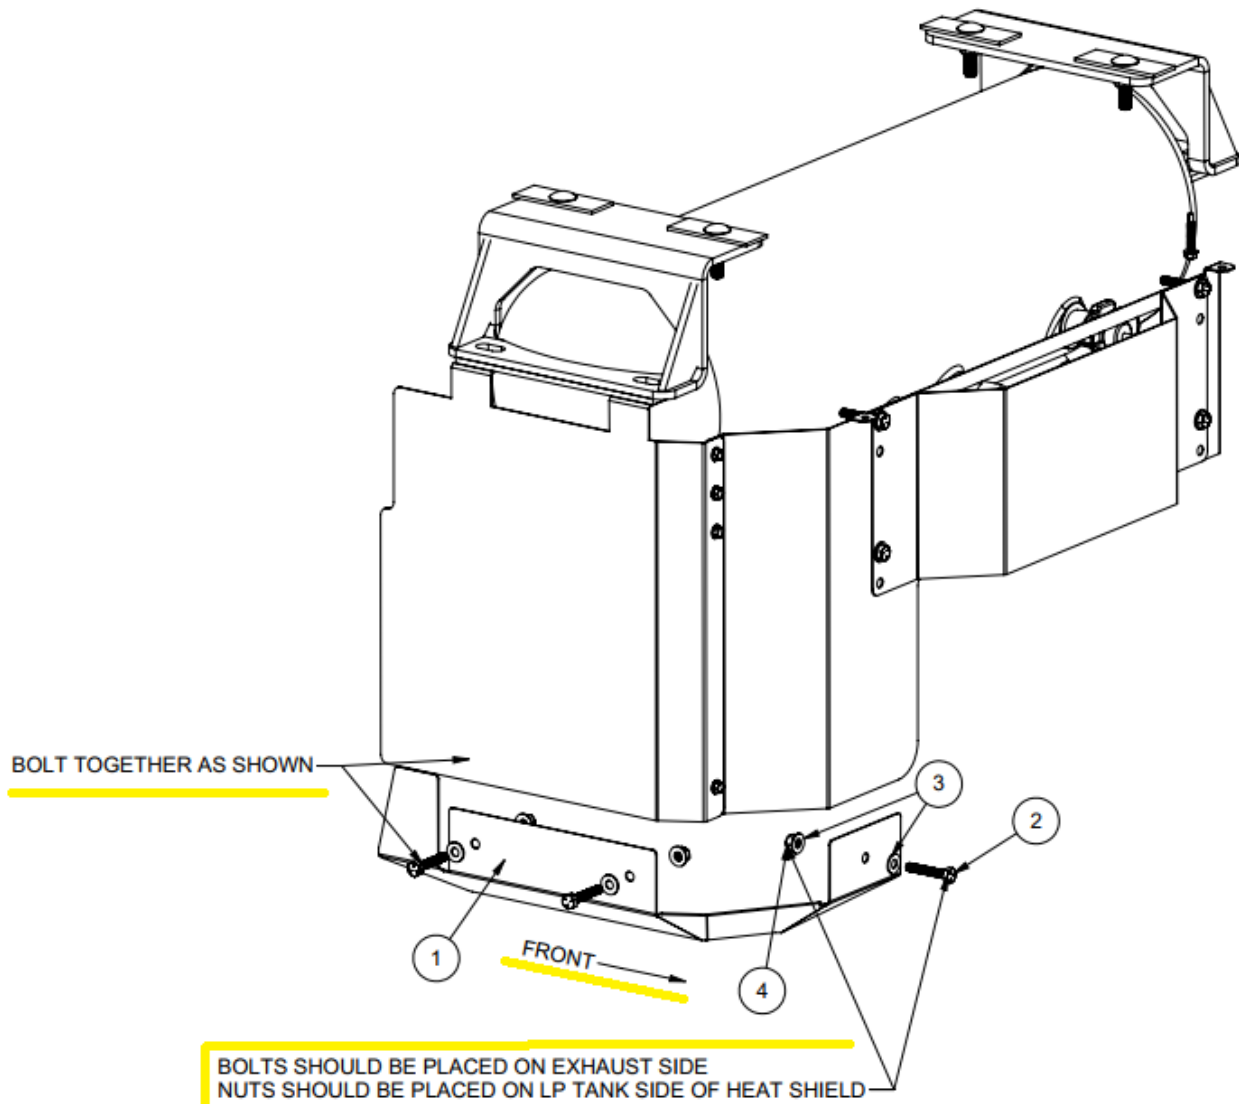
2. Bolt (#2) together on exhaust side, nuts (#4) to be placed on LP tank side of heat shield (#1).

BOM		
NO	QTY	DESCRIPTION - W x L (GRAIN)
1	1	HEAT SHIELD, LP TANK (TFM8895)
2	3	BOLT, HEX 1/4-20 x 1-1/2 GRADE 5
3	6	WASHER, .25 SCREW SIZE SS (0184253)
4	3	LOCKNUT, 1/4-20 NYLON INSERT

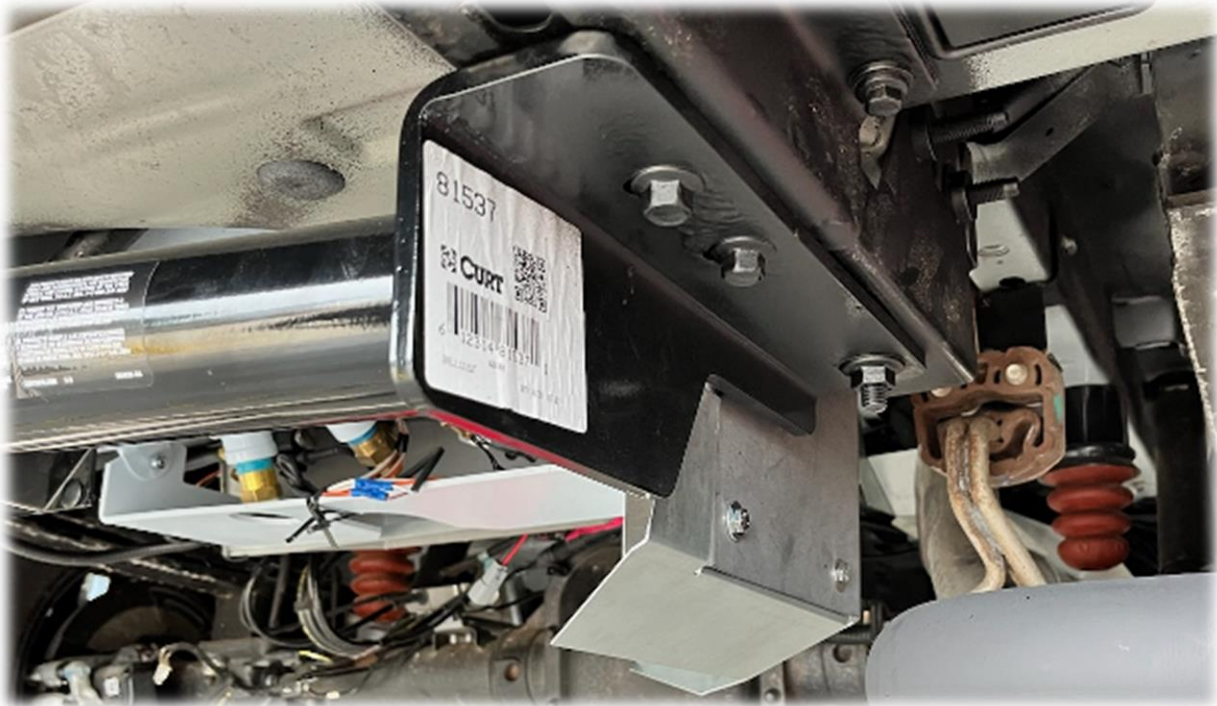
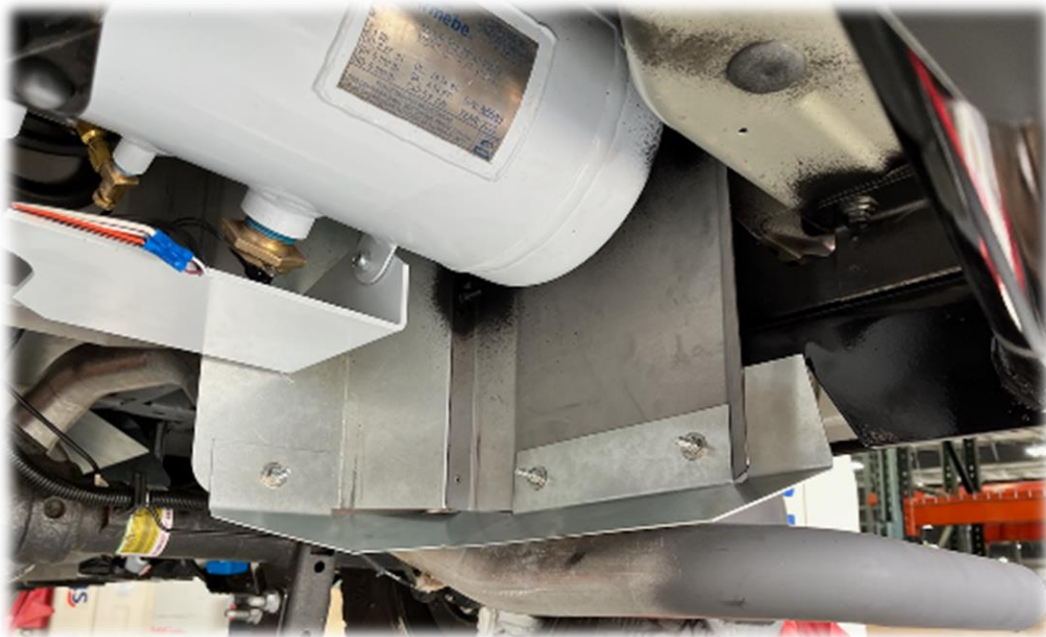
It has been discovered that on Certain MY 2024 Palladium and Talavera Motorhomes, the LP tank heat shield is the incorrect size.
