**Table 3. Part Numbers**

| Part No. | Item Description |
|---|---|
| 91500119 | Kit, Recall 0186, Regulator Wiring |

## Repair Procedure:

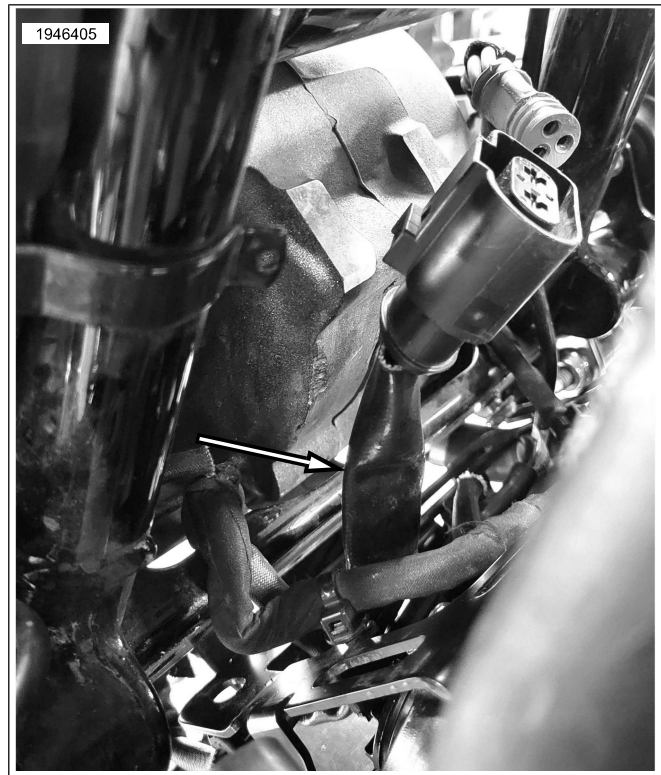
**Figure 1. Inspection Area**

1. Remove left saddlebag. See service manual.
2. Remove left side cover. See service manual.
3. Remove main fuse. See service manual.
4. Remove radiator shroud.
  - a. With vehicle on jiffy stand, turn forks left.
  - b. Pull radiator shroud straight forward.
5. Remove engine guard.
  - a. Loosen screws.
  - b. Remove screws.
  - c. Remove engine guard.
6. Disconnect coolant temperature sensor connector [98].
7. Remove coolant bottle from mounting bracket and reposition.
8. Remove cooling system bracket lower screws.
9. See Figure 1. Lean cooling system bracket forward toward front fender.

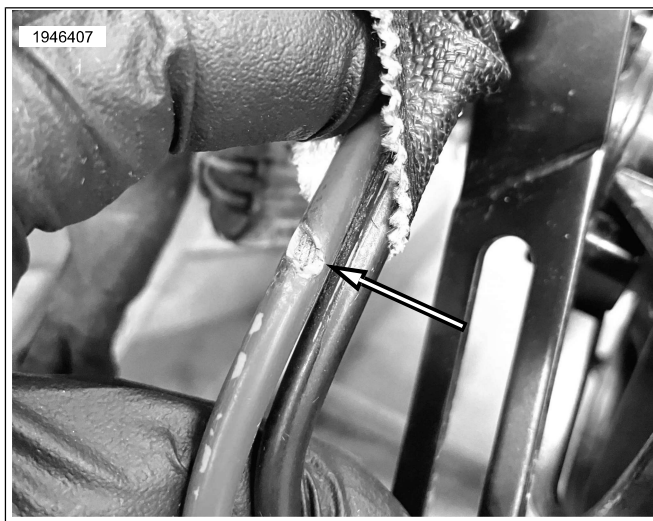
**Figure 2. Exposed Wire**

1. Inspect voltage regulator harness for damage to the wiring. Damage to the wrap or wire insulation with no exposure of the metal wires does not require the recall repair kit to be installed.
  - a. If damage or exposure to the metal wiring is **NOT** found continue to step 2.
  - b. See Figure 2. If damage or exposure to the metal wiring **IS** found continue to Repair Procedure When Wire Damage and Exposure is Found section.

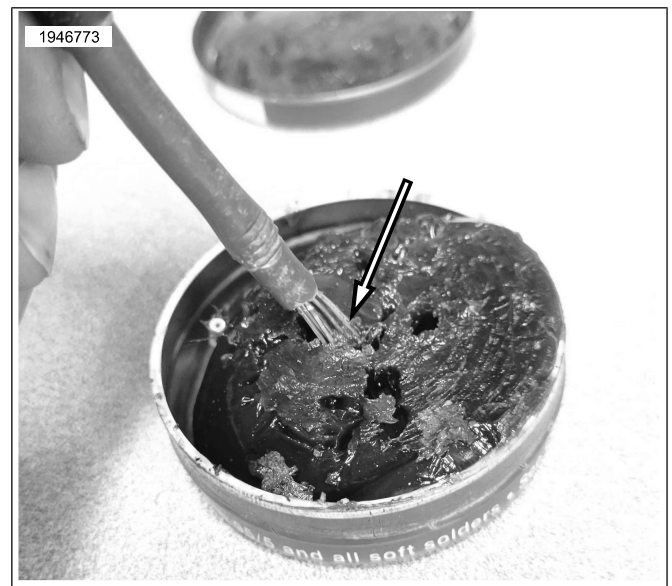
**Figure 15. Prep 1: Apply Flux to Stripped Wire**

- c. See Figure 15. **PREP 1:** Apply flux to end of mechanically gripped wire.

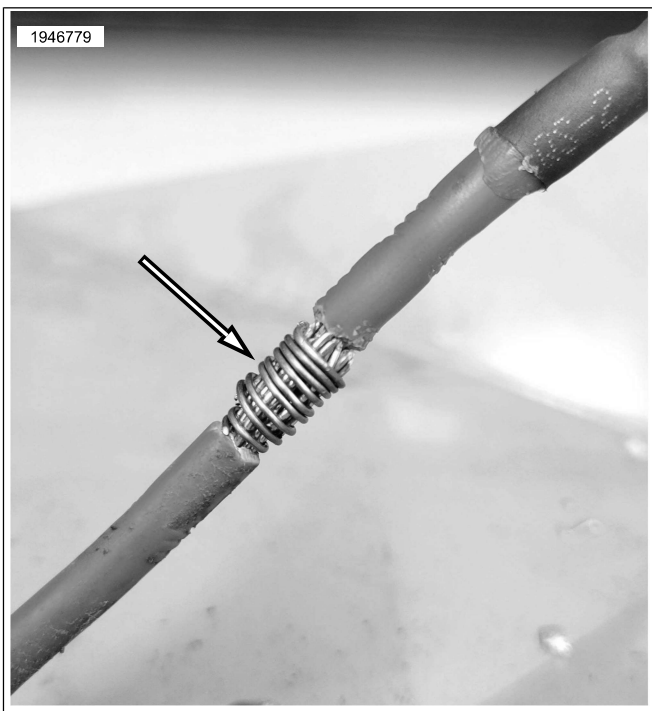
**Figure 17. Prep 3: Wrap Joint with Thin Gauge Wire**

- e. See Figure 17 or Figure 18. **PREP 3:** Wrap joint with thin gage wire **OR** wire ring.

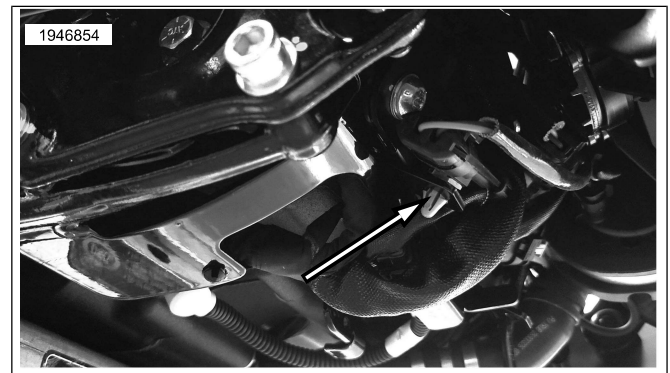
**Figure 24. Anchored Cable Strap**

15. See Figure 24. Seat anchored cable strap into frame tab.

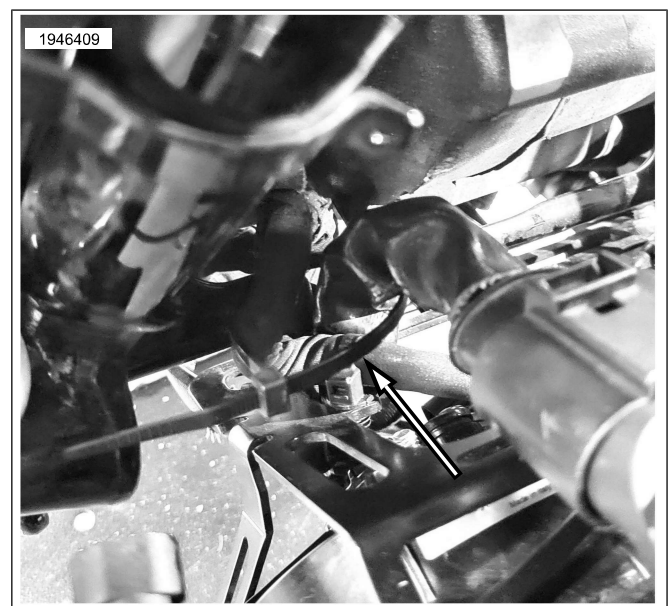
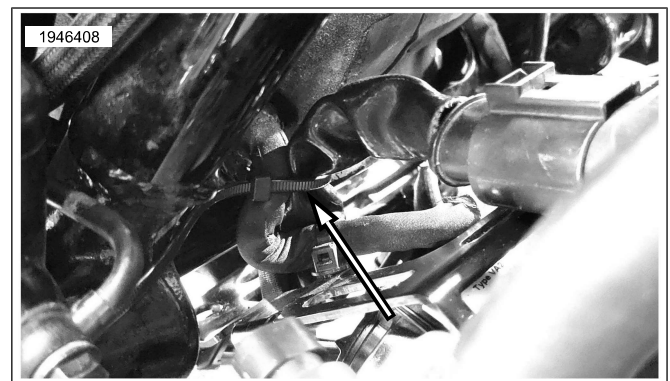
**Figure 25. Loose Cable Strap**

16. See Figure 25 and Figure 26. Secure voltage regulator harness into position with cable strap around regulator harness and coolant pump harness in location shown.
