**Table 3. Part Numbers**

| Part No. | Item Description |
|---|---|
| 91500119 | Kit, Recall 0186, Regulator Wiring |

## Repair Procedure:

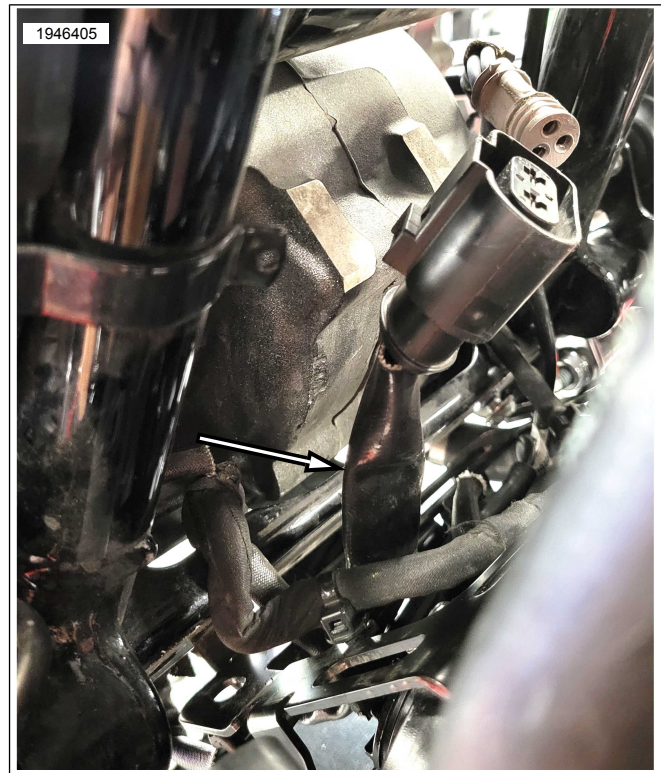
**Figure 1. Inspection Area**

1. Remove left saddlebag. See service manual.
2. Remove left side cover. See service manual.
3. Remove main fuse. See service manual.
4. Remove radiator shroud.
  - a. With vehicle on jiffy stand, turn forks left.
  - b. Pull radiator shroud straight forward.
5. Remove engine guard.
  - a. Loosen screws.
  - b. Remove screws.
  - c. Remove engine guard.
6. Disconnect coolant temperature sensor connector [98].
7. Remove coolant bottle from mounting bracket and reposition.
8. Remove cooling system bracket lower screws.
9. See Figure 1. Lean cooling system bracket forward toward front fender.

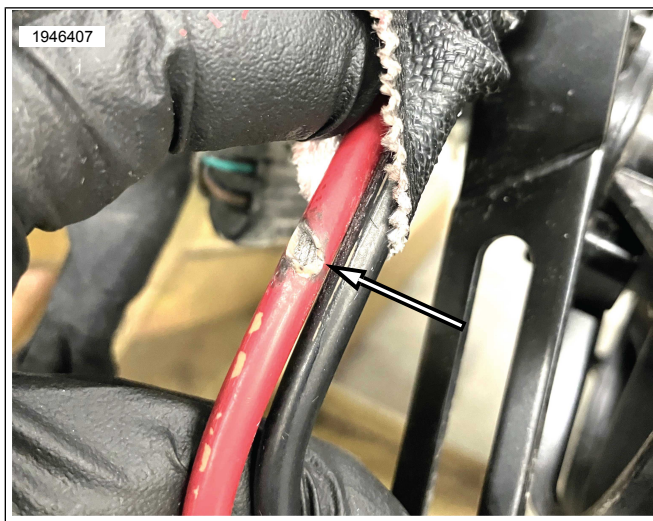
**Figure 2. Exposed Wire**

1. Inspect voltage regulator harness for damage to the wiring. Damage to the wrap or wire insulation with no exposure of the metal wires does not require the recall repair kit to be installed.
  - a. If damage or exposure to the metal wiring is **NOT** found continue to step 2.
  - b. See Figure 2. If damage or exposure to the metal wiring **IS** found continue to Repair Procedure When Wire Damage and Exposure is Found section.

#### **Repair Procedure When Wire Damage and Exposure is Found**

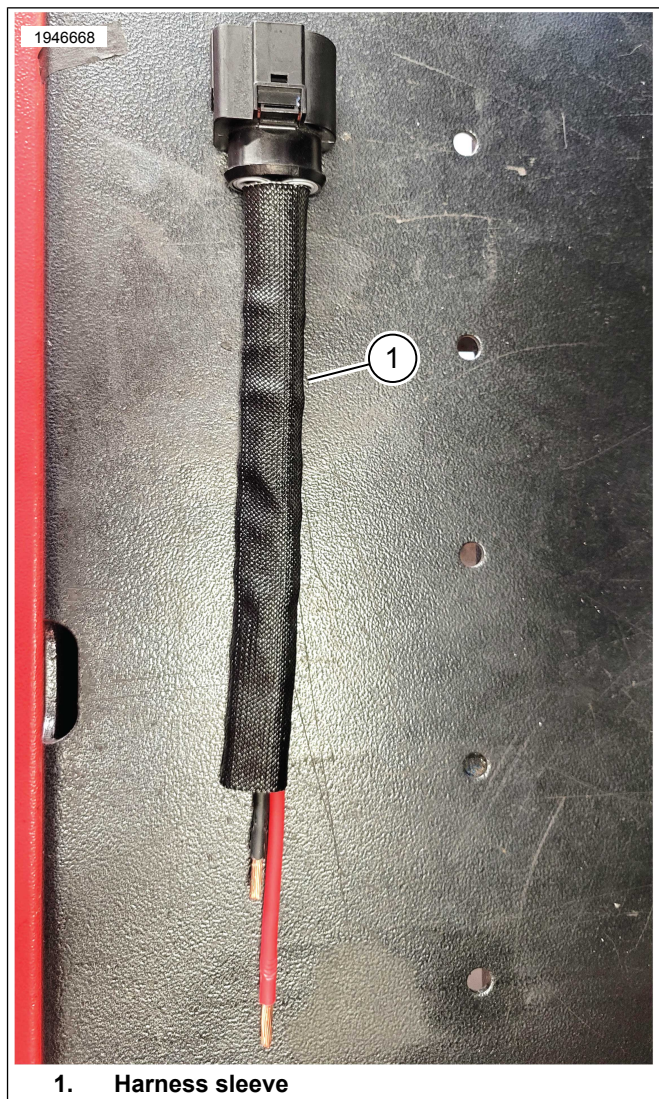
**Figure 11. Wire Harness Sleeve**

1. Harness sleeve

See Figure 10 and Figure 11. Confirm both new heat shrink sleeves from the recall kit are loosely placed on each wire and harness sleeve is positioned over both wires of new DC lead prior to soldering in the new regulator lead harness.
