# Safety Recall

## N242453720 Loose Front Seat Belt Buckle Bolt

**Release Date:** October 2024

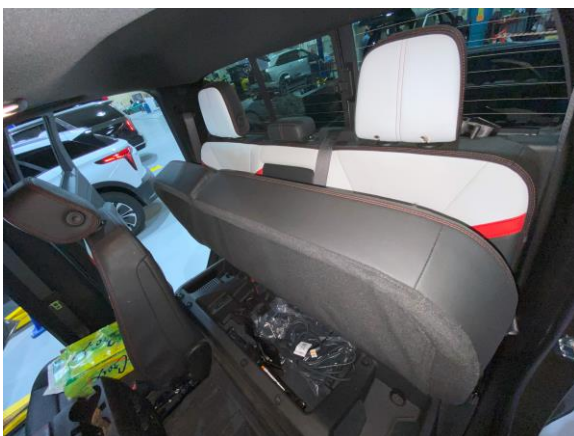
6732319

1. Fold Up Both the LH and RH Rear Seat Cushion.

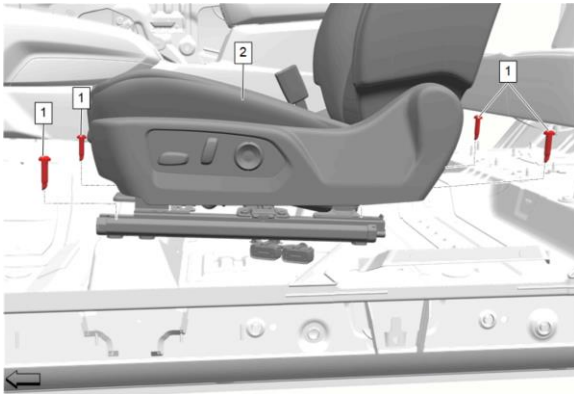
6160519

**Note:** Removal of the Front Seats from the vehicle is NOT necessary for this repair.

2. Remove the four LH Front Seat Fasteners (1) and move the seat (2) rearward.

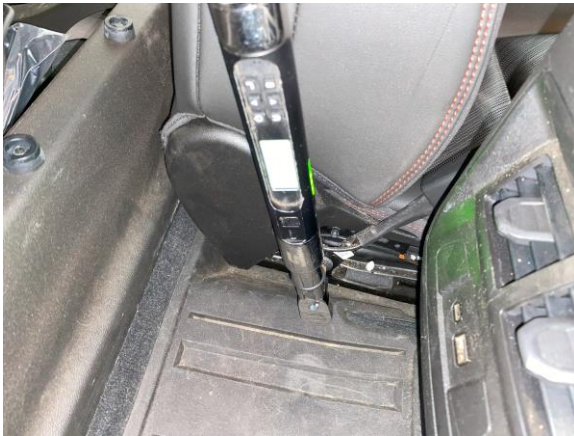
6732324

3. Torque the LH Front Seat Belt Buckle Fastener to 45 N•m (33 lb ft).

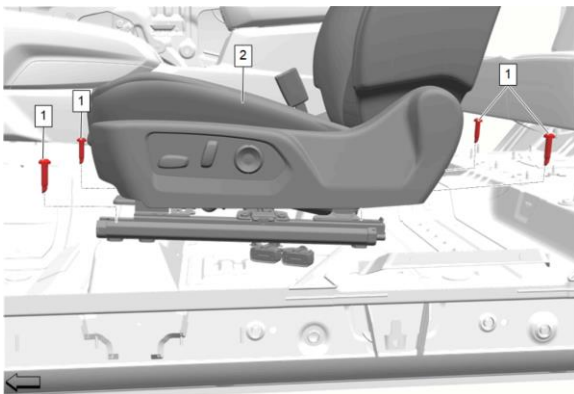
6160519

4. Reposition the LH Front Seat. Torque the Front Seat Fasteners to 45 N•m (33 lb ft).

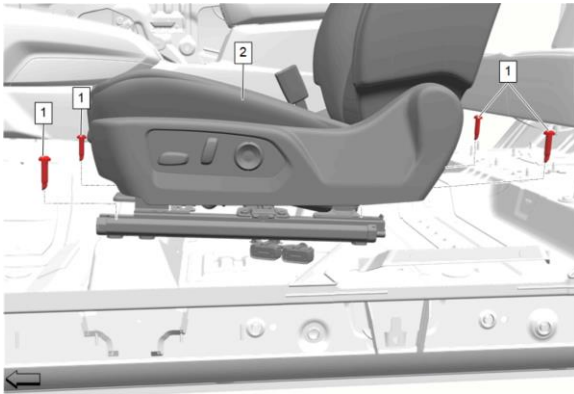
6160519

**Note:** Removal of the Front Seats from the vehicle is NOT necessary for this repair.

**Note:** Left side shown, right side similar.

5. Remove the four RH Front Seat Fasteners (1) and move the seat (2) rearward.

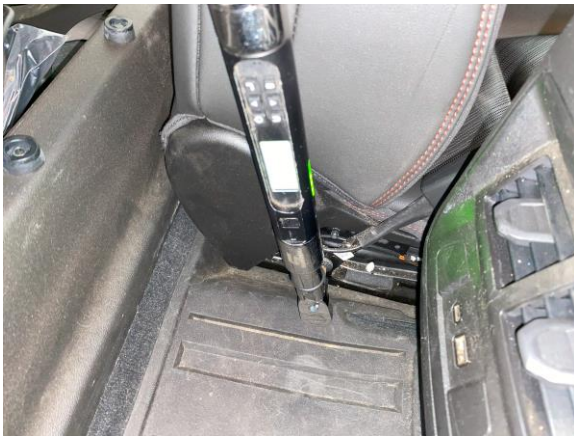
6732324

**Note:** Left side shown, right side similar.

6. Torque the RH Front Seat Belt Buckle Fastener to 45 N•m (33 lb ft).

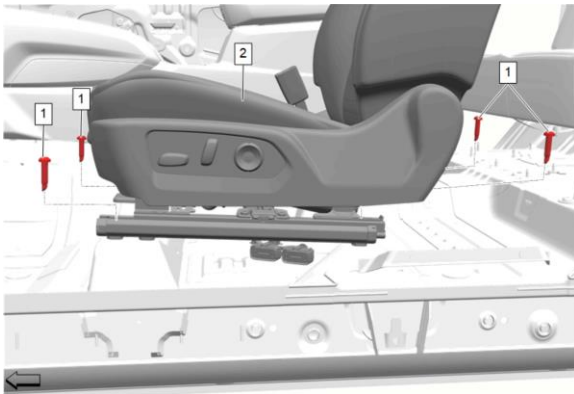
6160519

**Note:** Left side shown, right side similar.

7. Reposition the RH Front Seat. Torque the Front Seat Fasteners to 45 N•m (33 lb ft).
8. Return the LH and RH Front Seats to their original positions.
9. Return the Rear Seat Cushions back to their original position.
