# Recall Campaign Bulletin

Campaign No. 2024100007, December 2024

SUBJECT: **Model S-Class (223 platform)**  
**Model Year 2021 – 2023**

## **Update Engine Control Unit Software – Wave 2**

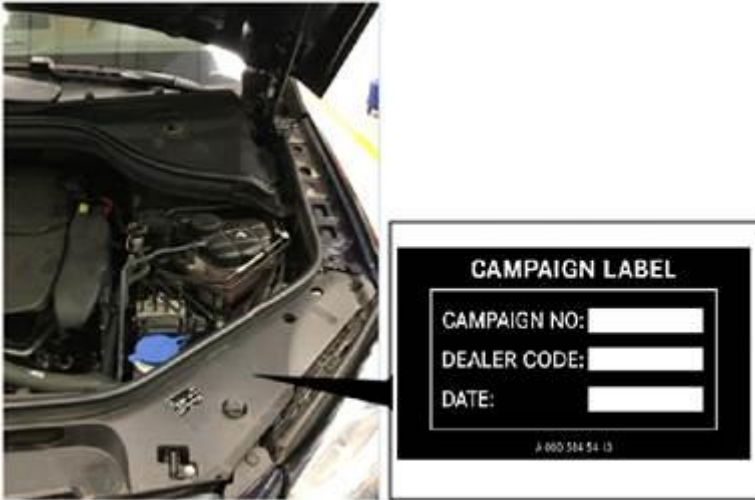
**Figure 1**

Apply Proof of Correction Label (A 000 584 54 13) to area identified in **Figure 1**. Fill in the blank areas of the label. The “**Campaign No.**” for the California Proof of Correction is unique and must be entered as such (**24V704**), your “**Dealer Code**”, and the “**Date**” of the repair, using a black permanent marker.

**i** Note: Clean bonding surface prior to affixing label.
