Safety Recall

N242477131 Door Striker May Fracture

Release Date: October 2024

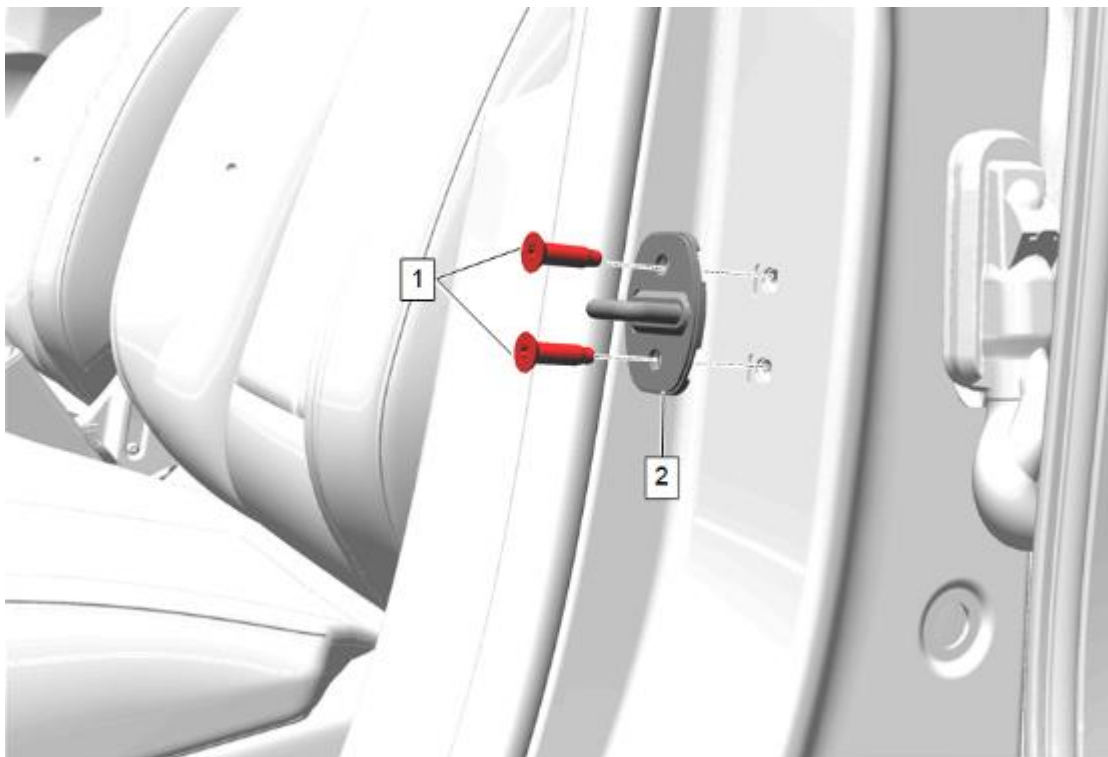
5946511

2. Remove the two bolts (1) holding the Side Door Latch Striker (2) in place. DISCARD the bolts.
3. Remove and replace the Side Door Latch Striker.

4. Install two NEW Door Latch Striker bolts (1). Torque NEW bolts to 22Nm (16 lb ft)
5. Remove all masking tape.
6. Repeat steps 1-5 for ALL remaining Door Latch Strikers.
