November 1, 2024

Version 5

Safety Recall: 2023–25 HR-V Steering Gearbox Repair

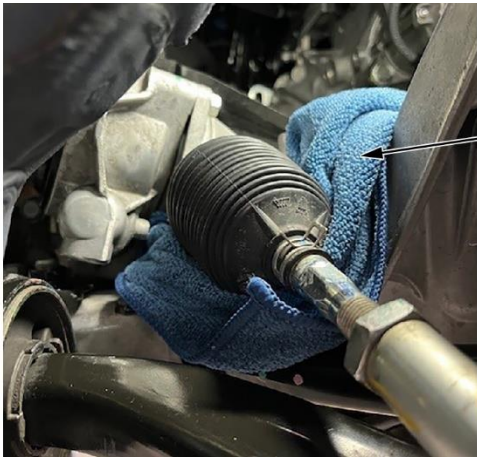
CLEAN RAG

6. Insert a clean rag between the steering gearbox and the subframe. This is to keep tools and/or parts from falling into this area.

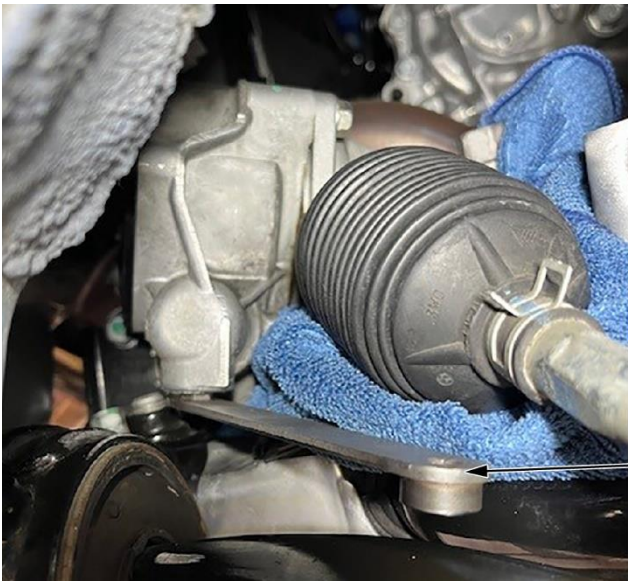
EPS PLUG
WRENCH

7. Use the EPS plug wrench to break loose the EPS end cover plug.
NOTE: The spring and spring seat may fall out during the end cap removal process.

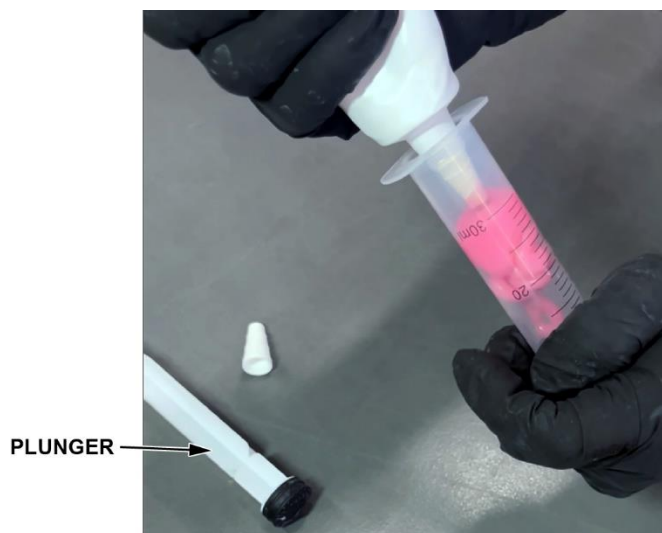
11. Open the tube of grease and squeeze the entire contents into the empty syringe, then insert the plunger.

- There should be a minimum of 15ml of grease in the syringe.
- **The syringe is a one-time use tool.**

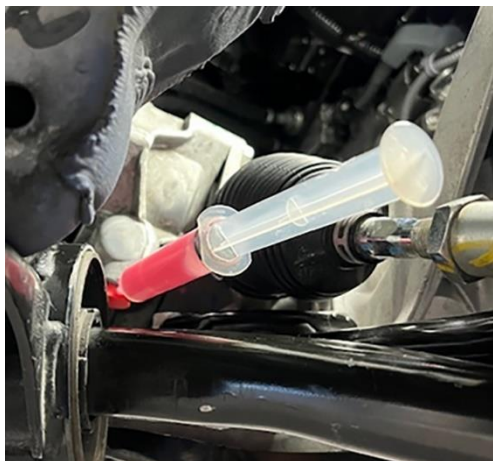
13. Insert the grease filled syringe into the grease plug and slowly inject the grease.

TIP: It may be necessary, apply pressure to the grease injection plug to keep it seated while injecting the grease.

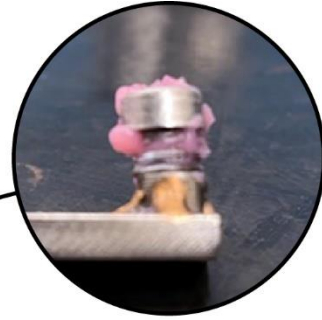
16. Using the spring/plug holder, install the **NEW** EPS spring and seat.

NOTE: Apply additional grease, saved in step 12, around the outside of the spring and spring seat to help hold them when inserted into the steering gearbox.

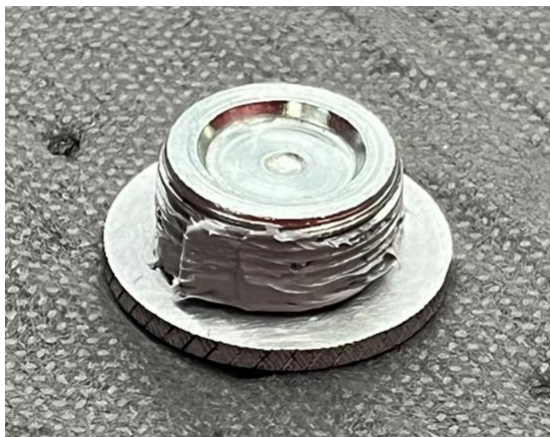
18. Apply a thin coat of Hondabond to the **NEW** EPS end cover plug threads and use the EPS plug thumb wheel to install.
