Safety Recall: 2023–25 Integra Steering Gear Repair

Supersedes 24-054 dated October 25, 2024, to revise the information highlighted in **yellow**.

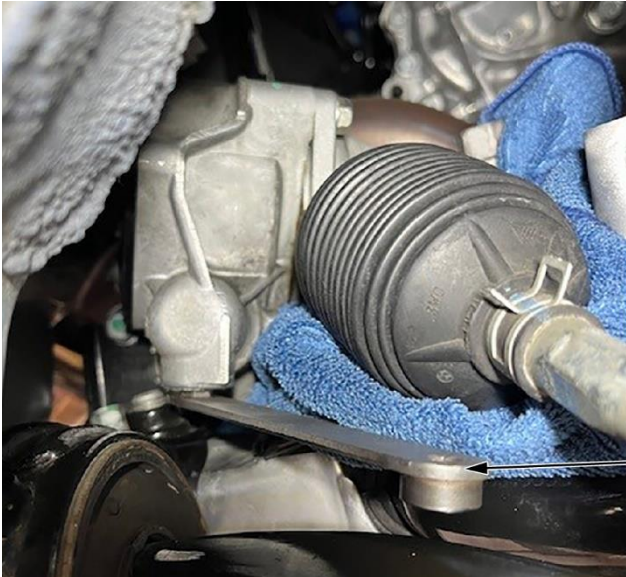
EPS PLUG
WRENCH

8. Use the EPS plug wrench to break loose the EPS end cover plug.
NOTE: The spring and spring seat may fall out during the end cap removal process.

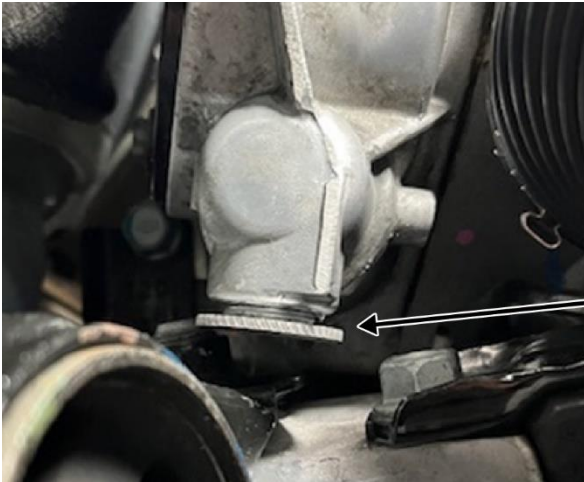
EPS PLUG
THUMB WHEEL

9. Then use the EPS plug thumb wheel to remove the EPS end cover plug.

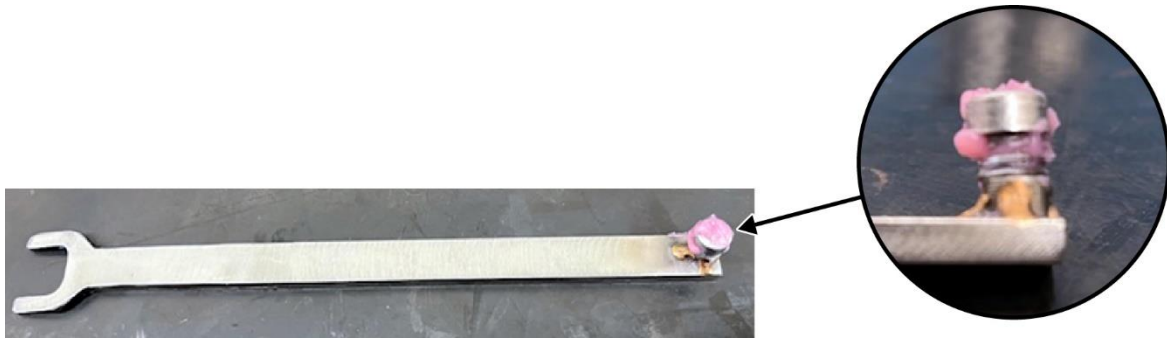
17. Using the spring/plug holder, install the **NEW** EPS spring and seat.

NOTE: Apply additional grease, saved in step 13, around the outside of the spring and spring seat to help hold them when inserted into the steering gearbox.

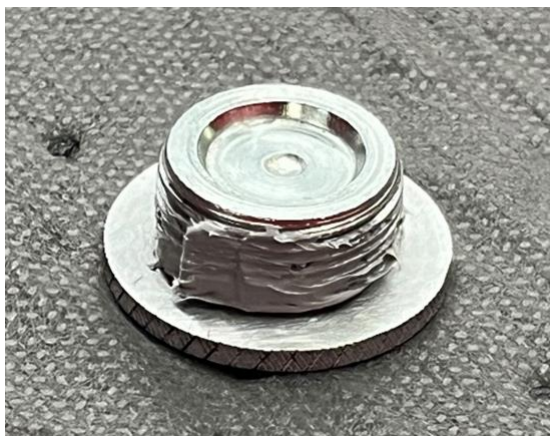
18. Apply a thin coat of Hondabond to the **NEW** EPS end cover plug threads and use the EPS plug thumb wheel to install.
