March 7, 2025

Version 6

Safety Recall: 2023–25 Integra Steering Gear Repair

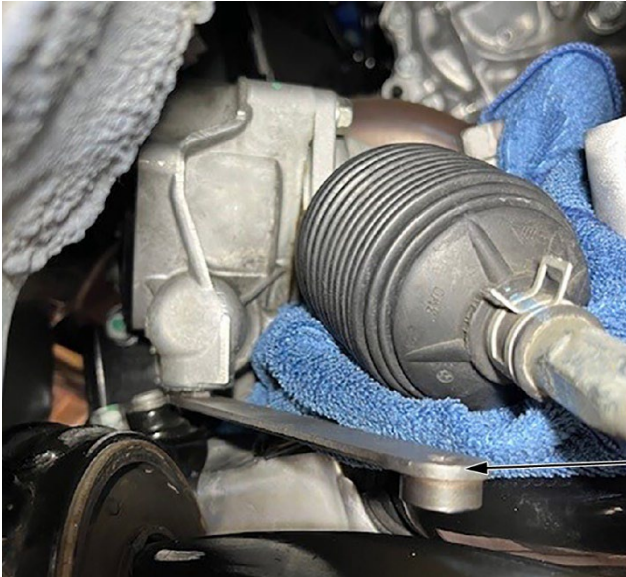
EPS PLUG
WRENCH

8. Use the EPS plug wrench to break loose the EPS end cover plug.
NOTE: The spring and spring seat may fall out during the end cap removal process.

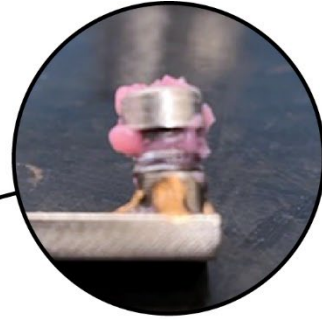
17. Using the spring/plug holder, install the **NEW** EPS spring and seat.

NOTE: Apply additional grease, saved in step 13, around the outside of the spring and spring seat to help hold them when inserted into the steering gearbox.

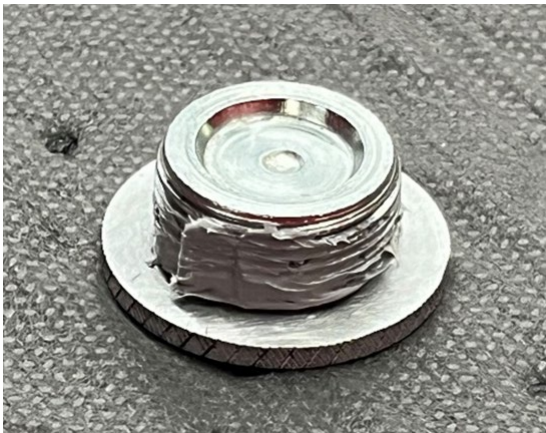
18. Apply a thin coat of Hondabond to the **NEW** EPS end cover plug threads and use the EPS plug thumb wheel to install.
