Remedy available for  
2024-2025 (GG) Dodge Hornet PHEV

Remedy available for  
2024-2025 (GC) Alfa Romeo Tonale PHEV

**SAFETY RECALL**  
NORTH AMERICA  
**Brake Pedal**

**Reference: B7B / NHTSA 24V-752**

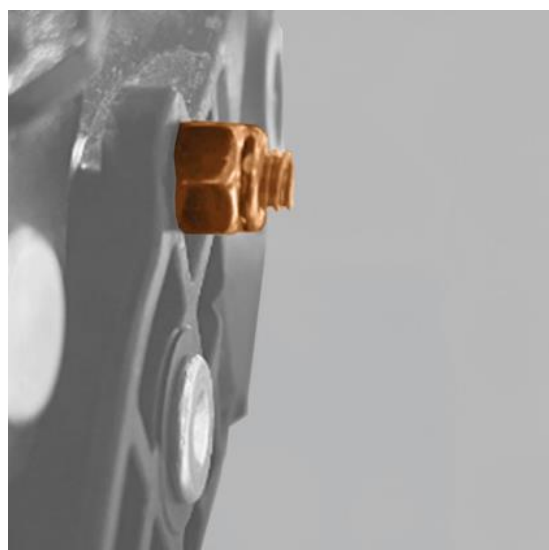
**Figure 5 – An Over Torqued Fastener**

**CAUTION:** Never apply more torque than prescribed. Even a minimal increase of torque will break the brake pedal.

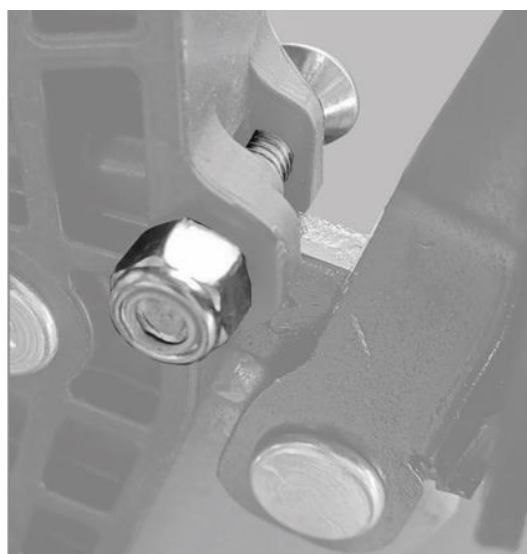
**Figure 6 – An Under Torqued Fastener**
