## **SAFETY RECALL CAMPAIGN 3A04**

### **2022 - 2024 Hayabusa Front Brake Master Cylinder Parts Replacement**

Suzuki Motor Corporation is initiating a safety recall campaign to replace parts in the front brake master cylinder.

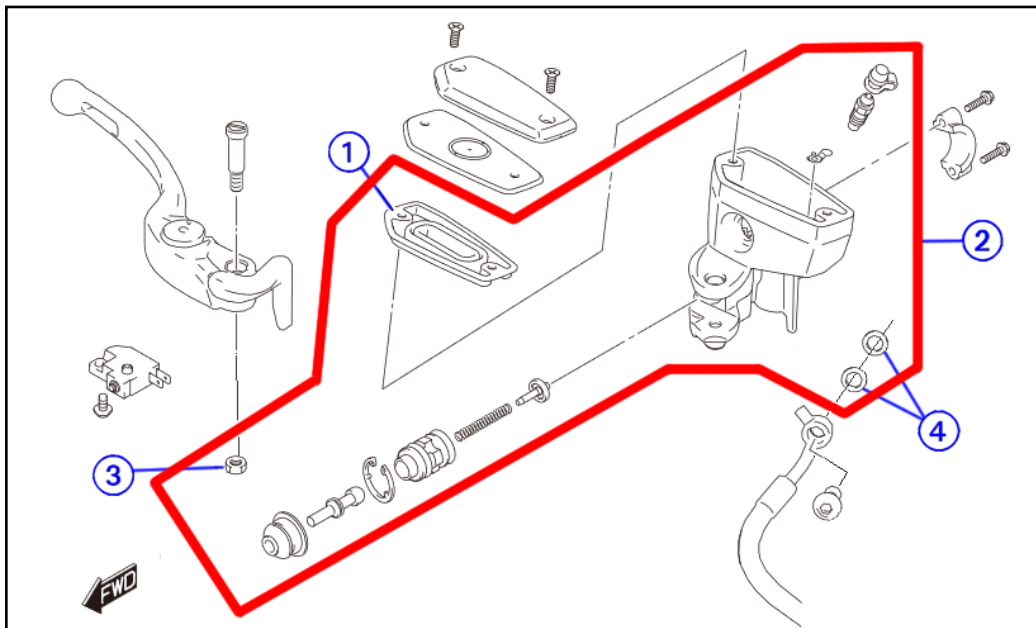
**Recall service parts:**

Part Name	Part Number	Quantity	Includes
<b>PARTS SET, FR MASTER CYLINDER</b>	<b>59600-10870-RX0</b>	<b>1</b>	DIAPHRAGM, R (59667-23H10-RX0) x 1 ①
			CYLINDER SET, FRONT MASTER (59601-10LA0-RX0) x 1 ②
			NUT (08319-2106A) x 1 ③
			WASHER (09161-10009) x 2 ④

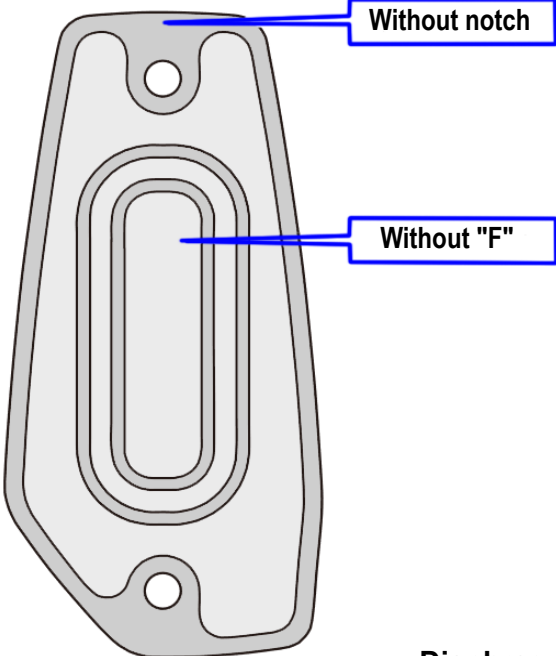
Existing (original) Parts	New (countermeasure) Parts
<ul style="list-style-type: none"><li>• 59667-23H00</li></ul>

<p data-bbox="602 894 760 926">Diaphragm</p>	<ul style="list-style-type: none"><li>• 59667-23H10-RX0</li></ul>

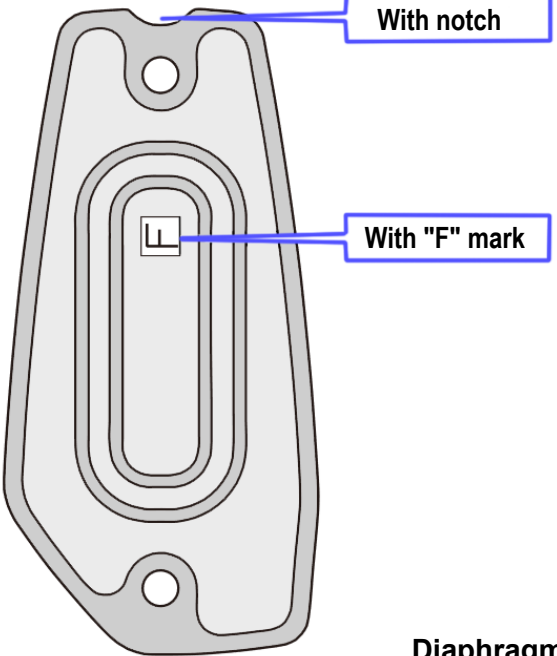
<p data-bbox="1284 884 1442 915">Diaphragm</p>
<ul style="list-style-type: none"><li>• 59600-10L**</li></ul>

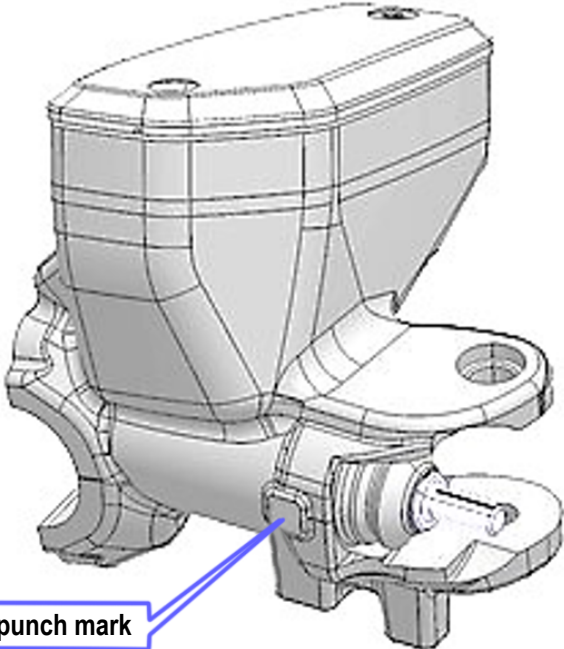
<p data-bbox="396 1696 776 1728">Front master cylinder body</p>	<ul style="list-style-type: none"><li>• 59601-10LA0-RX0</li></ul>

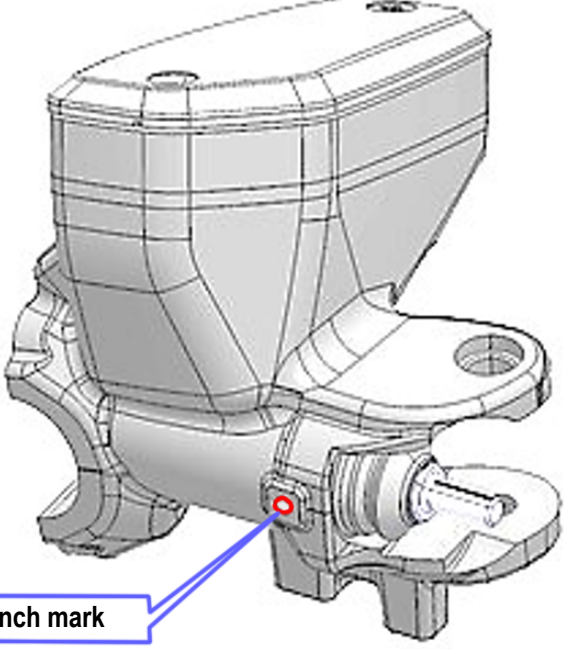
<p data-bbox="1094 1696 1474 1728">Front master cylinder body</p>

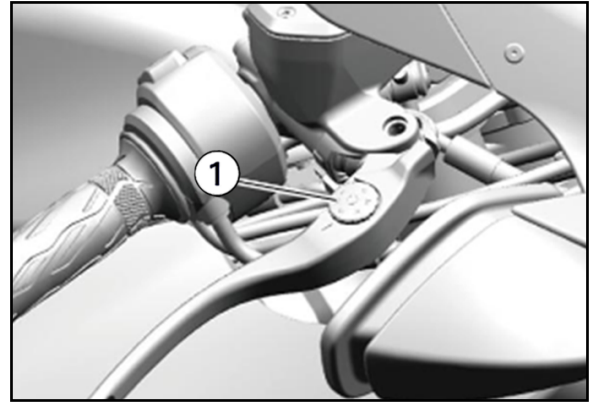
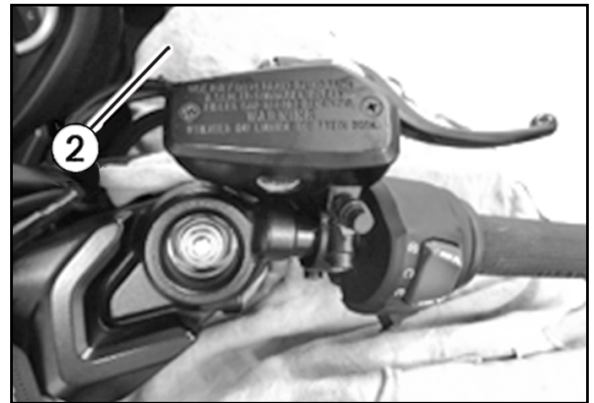
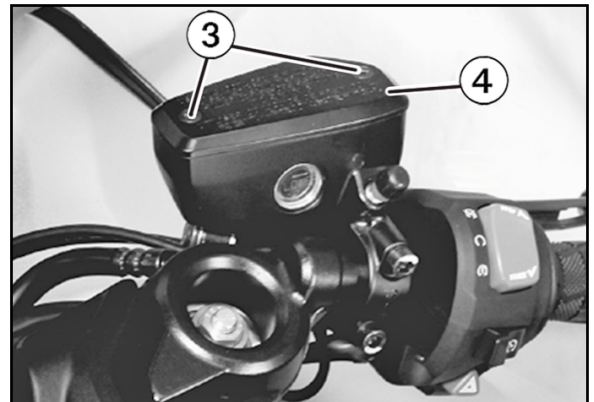
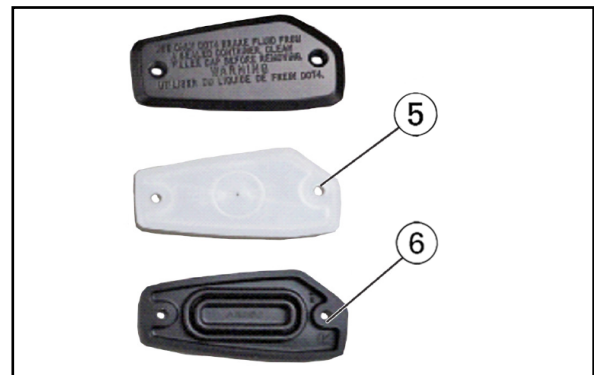
1. Turn the ignition switch OFF.
2. Record the position of the brake lever adjuster ①.
3. Position the motorcycle on a level surface and adjust the handlebars so the front brake master cylinder is level.
4. Place a clean absorbent cloth ② underneath the master cylinder as shown in the image at right. This helps prevent brake fluid from getting on other parts if it is spilled or splashed during the repair.
5. Remove the reservoir cap screws ③, the reservoir cap ④, and the plate ⑤, and diaphragm ⑥ from the front brake master cylinder.

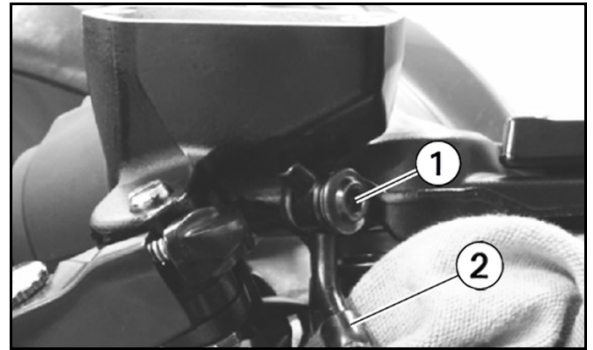
- Unscrew and remove the brake hose union bolt ① and disconnect the brake hose ② from the front brake master cylinder.

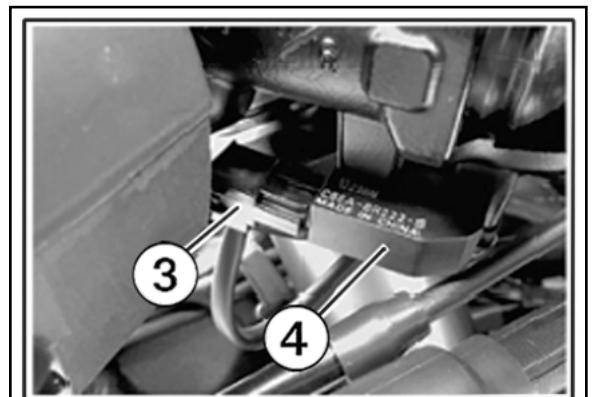
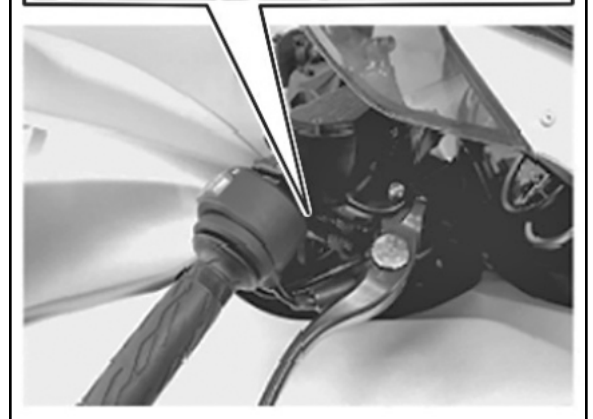
- Disconnect the front brake light switch lead wire coupler ③ from the front brake light switch ④.

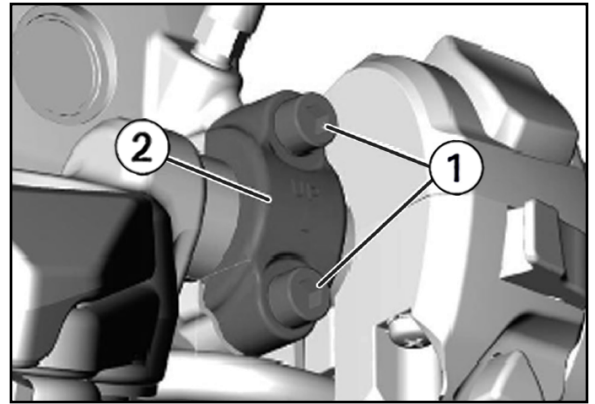
9. Remove the master cylinder holder bolts ①, and then remove the master cylinder holder (clamp) ②.

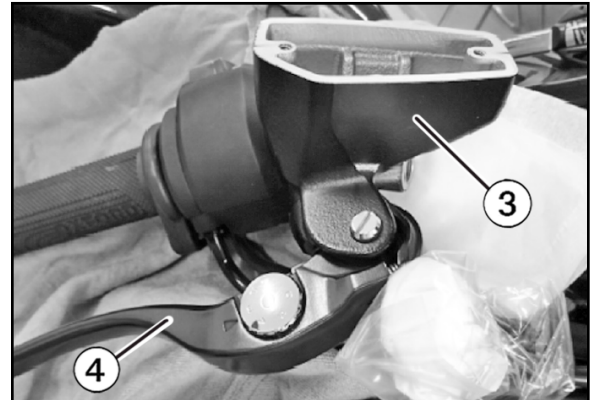
10. Remove the front brake master cylinder ③ and the front brake lever ④ as an assembly..

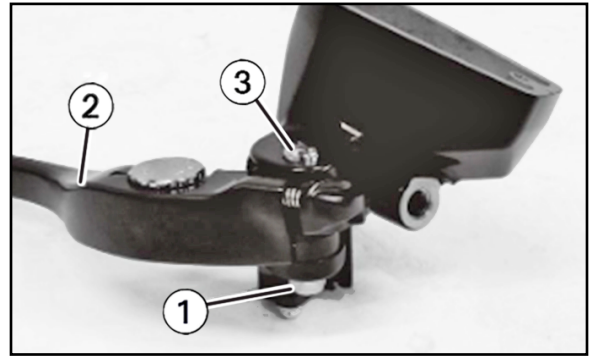
1. Remove the brake lever pivot lock nut ①, bolt, ②, and brake lever ③.

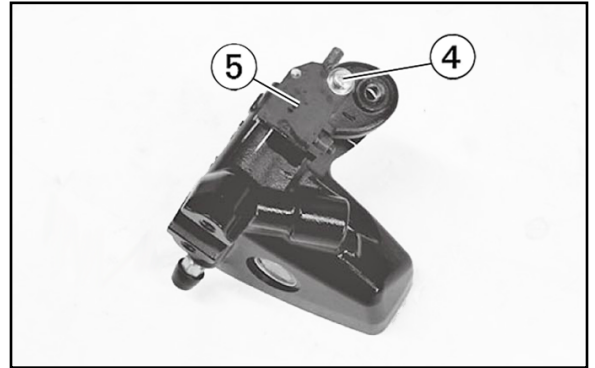
2. Remove the front brake light switch screw ④ and the front brake light switch ⑤ from the master cylinder body.

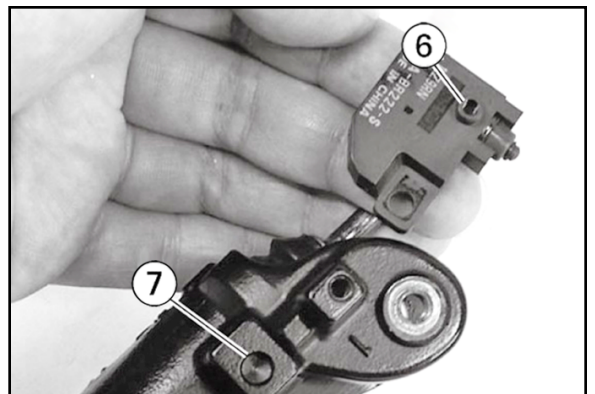
3. Align the protrusion ⑥ of front brake light switch with the hole ⑦ of the new front brake master cylinder, and then install the front brake light switch.

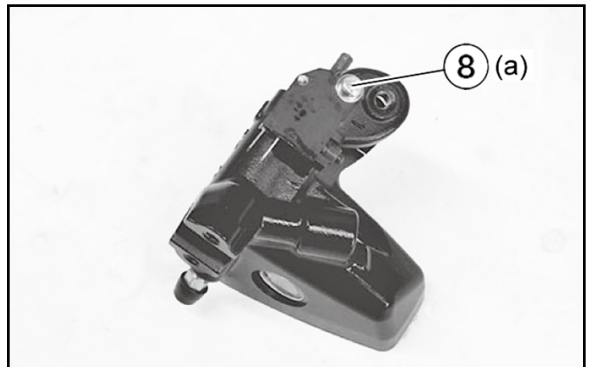
4. Tighten the front brake light switch screw ⑧ to the specified torque.

**Tightening torque - Brake light switch screw (a):**  
**0.90 lb-ft (1.2 N.m, 0.12 kgf-m)**

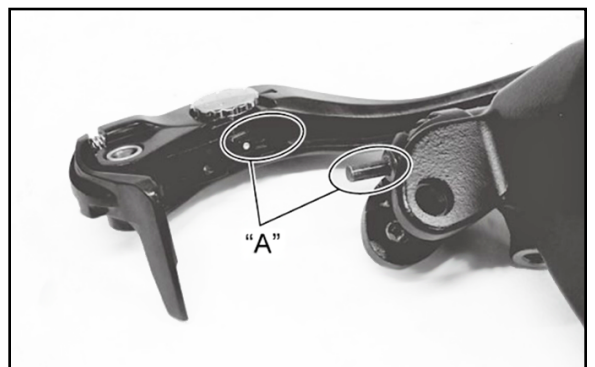
5. Apply grease to the contact points "A" between push rod and brake lever.

**Chemical:**  
**Suzuki Silicone Grease (99000-25100)**  
*(Or equivalent silicone grease generally available in your market)*

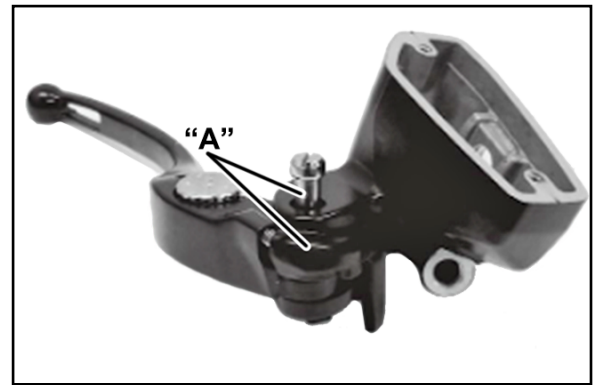
- Apply grease to the brake lever pivot bolt and front brake lever sliding surfaces "A" and install the front brake lever and brake lever pivot bolt.

**Chemical:**  
**Suzuki Silicone Grease (99000-25100)**  
*(Or equivalent silicone grease generally available in your market)*

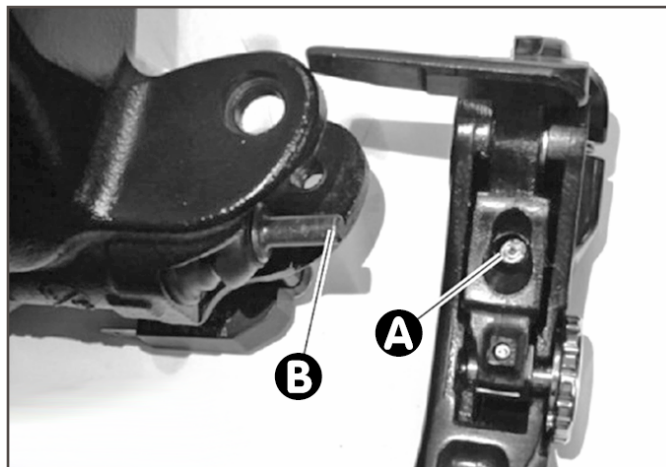
Make sure that the push rod **B** is inserted into the brake lever hole **A** in the correct position.

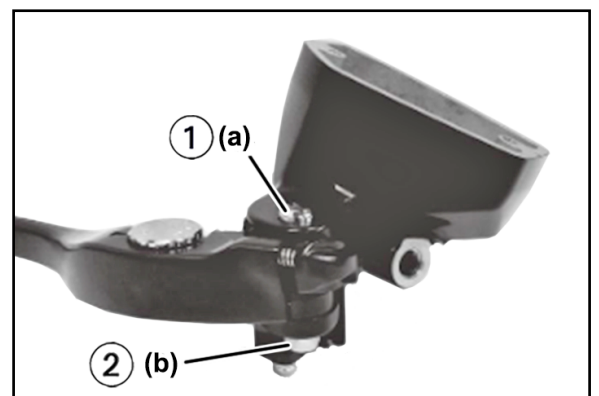
- Tighten the brake lever pivot bolt **①** and the new brake lever pivot bolt lock-nut **②** to the specified torque.

**Tightening torque - Brake lever pivot bolt (a):**  
**0.75 lb-ft (1.0 N.m, 0.10 kgf-m)**

**Brake lever pivot bolt lock-nut (b):**  
**4.35 lb-ft (5.9 N.m, 0.60 kgf-m)**

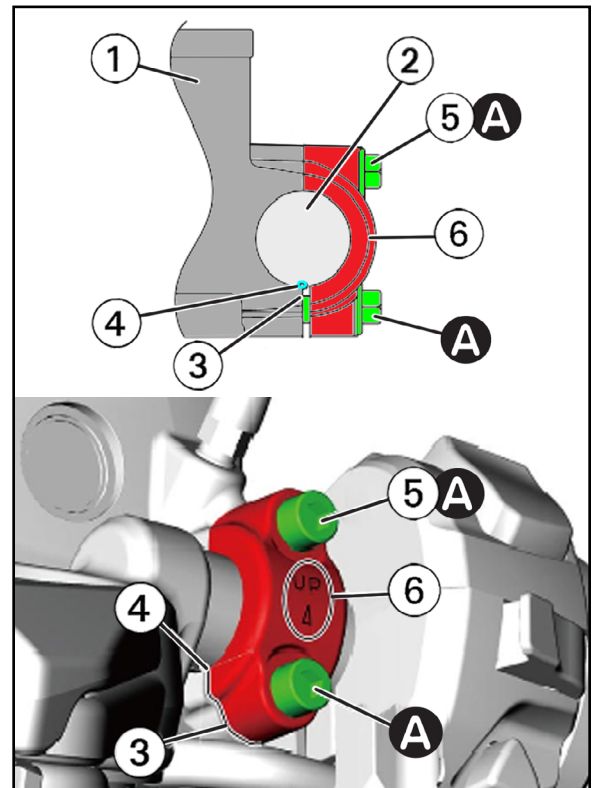
1. Install the new front brake master cylinder ① and front brake lever as an assembly onto the handlebar ②, paying attention to the following points:
  - Align the edge ③ of the master cylinder body with the punch mark ④ on the handlebar ②.
  - Tighten the upper front brake master cylinder holder bolt ⑤ to the specified torque first, and then tighten the lower bolt to the specified torque.

**Front brake master cylinder holder bolt (A):**  
7.5 lb.-ft (10 N.m, 1.0 kgf-m)

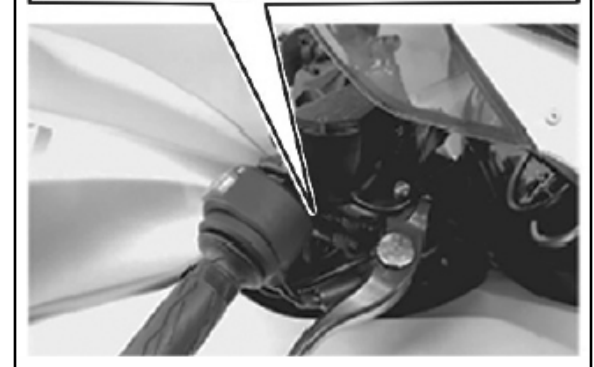
2. Connect the front brake light switch lead wire coupler ⑦ to the front brake light switch ⑧.

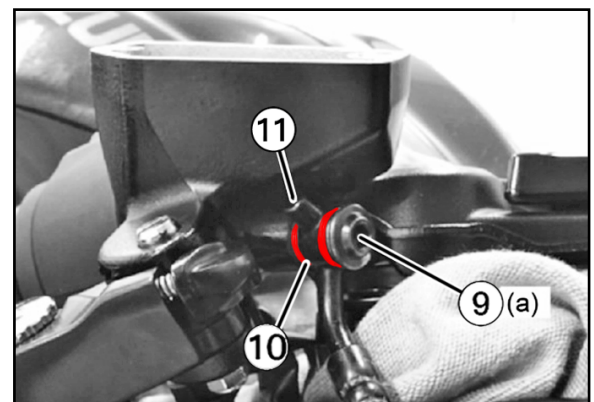
3. Install the brake hose union bolt ⑨ and new **sealing washers** ⑩ onto the brake hose ⑪.
4. Hand tighten the brake hose union bolt ⑨ to the master cylinder body and then tighten it to the specific torque.

**Tightening torque - Brake hose union bolt (a):**  
17 lb-ft (23 N.m, 2.3 kgf-m)

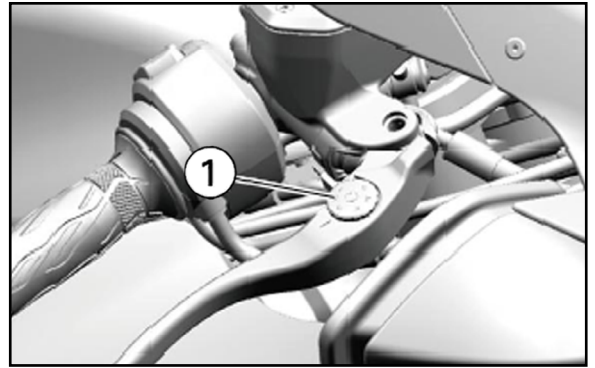
1. Verify that the brake lever adjuster ① is set in the #3 position.

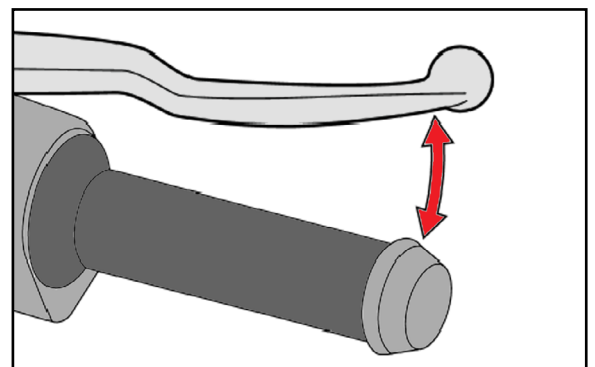
5. Squeeze the brake lever several times and, while holding the lever as close to the hand grip as possible, loosen the front brake master cylinder air bleeder valve ④ to drain the brake fluid and air into the receptacle.
6. Tighten the master cylinder air bleeder valve ④ and slowly release the brake lever.
7. Repeat steps 5 and 6 until the brake fluid is flowing out of the tube with no air bubbles present.

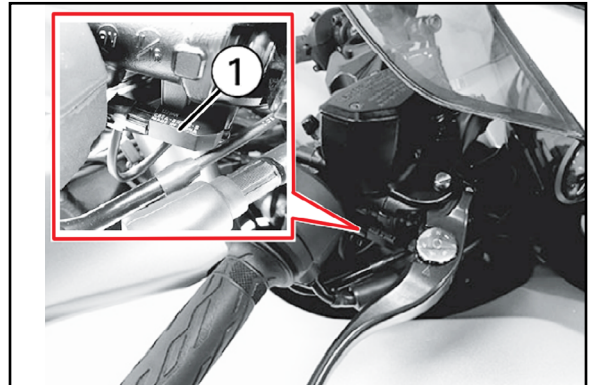
4. Verify that the brake light illuminates when you operate the front brake lever (when the ignition is switched ON). If the brake lamp does not function correctly, make sure the front brake light switch ① and its electrical coupler and properly connected. If they are, check the taillight's connection under the passenger seat.

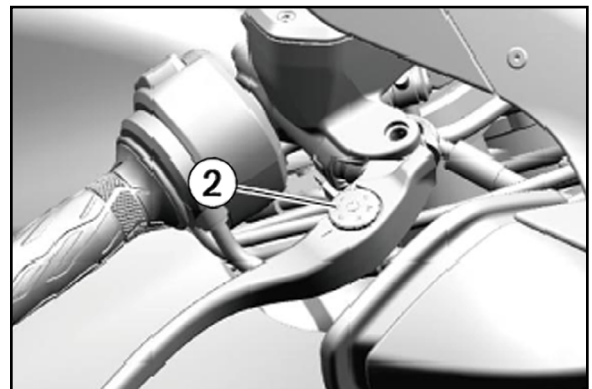
5. Reset the brake lever adjuster ② to the same position that was recorded during the recall service ([page 10, step 1](#)).
6. Test ride the motorcycle on a dry, paved road and operate the front brake to make sure is braking performance is proper. During the test ride, watch for any abnormal operation and listen for any unusual sounds and resolve them before returning the motorcycle to the customer.
7. Clean the motorcycle with special attention to areas where the recall service was performed. When delivering the motorcycle to the customer, explain the recall service and thank them for their patience.
