**Volvo Car USA LLC****Quality Bulletin**

Bulletin Title		Group	NO
Recall R10289: BCM2 Push Rod, MY 2020 S60, V60, S90I, XC60 and XC90		52	R10289
Issuer (Dept.)	Car Market	Issue Date	Status Date
Product, Safety and Compliance	United States and Canada	11/25/24	11/25/24
Revisions		Page	
		Page 1 of 4

A. RECALL R10289 DESCRIPTION

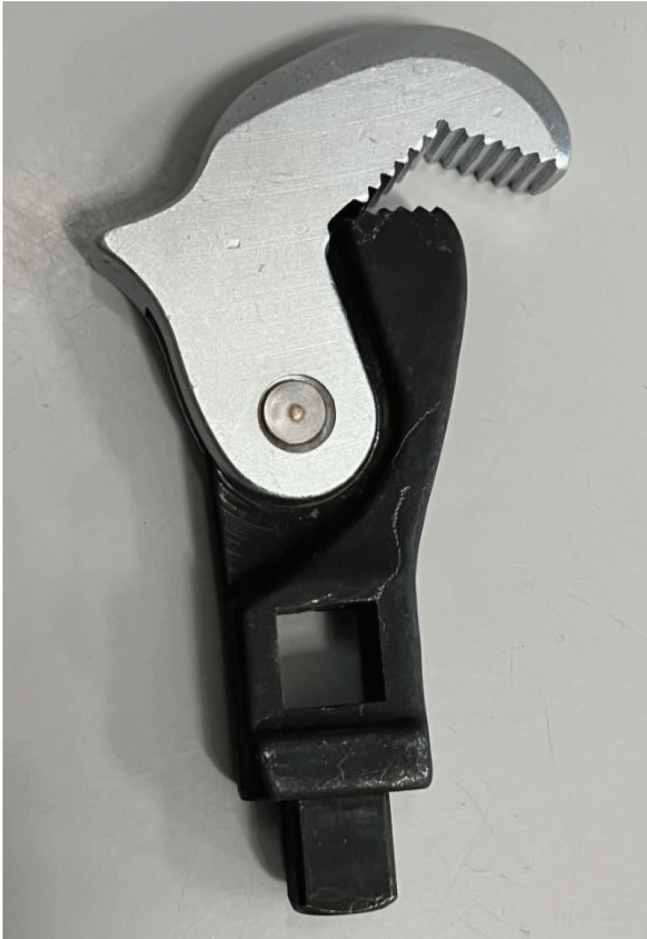
Note: There is a special tool required for this repair. However, due to the small population affected by this recall, the tool should only be ordered if needed. The tool needed is a crowfoot adjustable wrench (see below). This tool can be claimed one time as a sublet on the QB (see section I). This tool can be purchased here:

Please note: Retailers can claim the cost of **ONE** tool. The cost for the tool can be claimed by using sublet operation **97083-2** on the QB.
