## RECALL 24V803 REMEDY INSTRUCTIONS

<b>FOREST RIVER</b>	Make(s): PALOMINO Model(s): PAT2085BHS Model Year(s): 2025	Repair Code: RC-026-13-00-004624 Allotted Time: .50 HRS. Inspection Code: N/A Allotted Time: N/A
	Concern: The LP Gas manifold block may be installed in the jounce path of the axles' equalizer.	Photo(s) Required: NO Prior Authorization Required: YES Part(s) Kit Number: N/A Part(s) Return: N/A

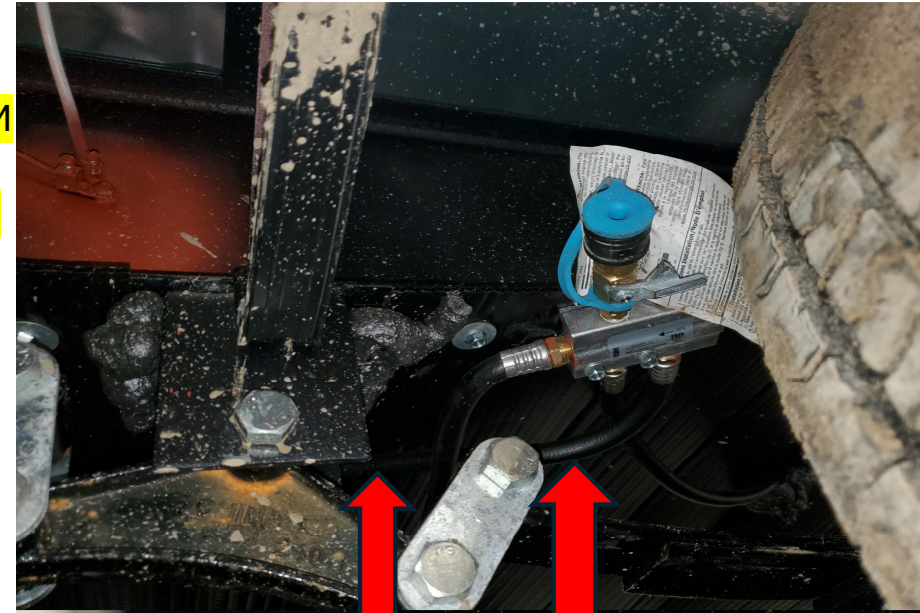
PICTURES TO THE RIGHT ARE THE REPAIR EXAMPLES GAS LINE, MANIBLOCK AND RVQ-DISCONNECT MUST BE 5" FORWARD FROM CENTER AXLE HANGER TO PROVIDE ENOUGH CLEARANCE FROM EQUALIZER FAILURE TO DO SO MAY RESULT IN 1 OR MORE OF THE GAS LINE PARTS TO BE CRUSHED

STEP 2: REMOVE FASTENERS FROM LPG MANIFOLD AND MOVE THE MANIFOLD TO 5" FROM THE CENTER AXLE HANGER;

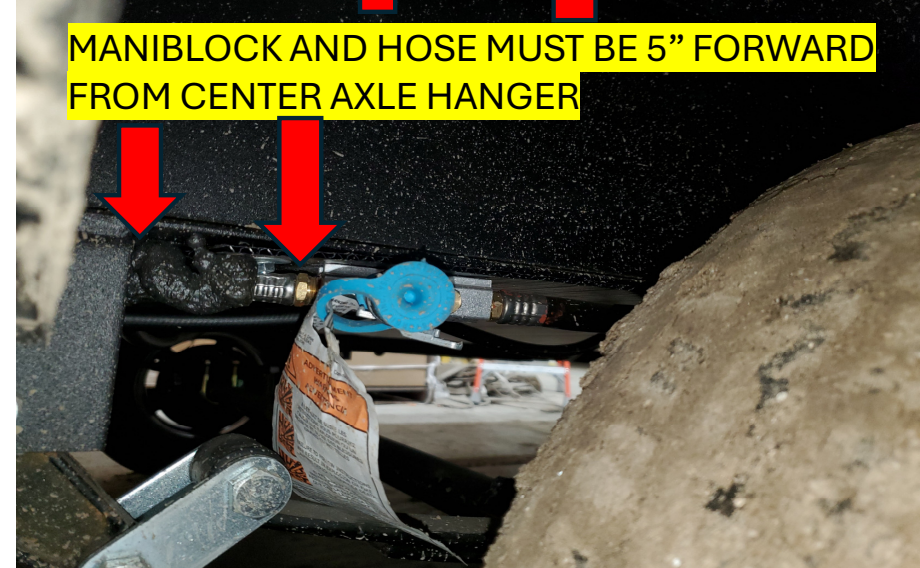
MANIBLOCK AND HOSE MUST BE 5" FORWARD FROM CENTER AXLE HANGER

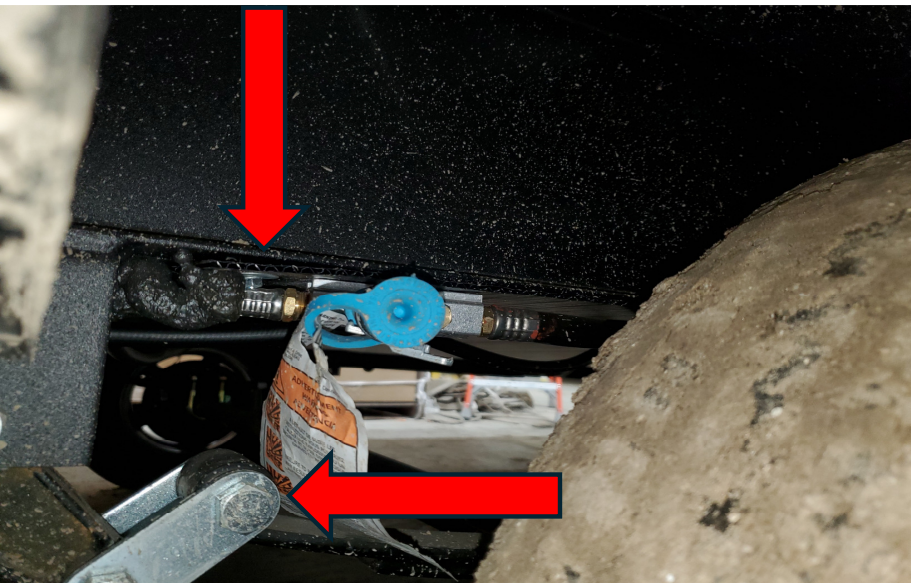
PICTURE BELOW SHOWS THE EQUALIZER BEING BELOW THE GAS LINE WHEN GOING OVER A CURB OR POTHOLE IT MAY CAUSE IT TO CRUSH THE GASLINE
