RECALL 24V832 / 2024-666 REMEDY INSTRUCTIONS

Make(s): VIBE Model(s): MANY, SEE BELOW Model Year(s): 2025	Repair Code: RC-029-12-00-004644 Allotted Time: .50 HRS. Inspection Code: N/A Allotted Time: N/A
	Concern: The 3 in 1 Stove may need resecured into the cabinet.	Photo(s) Required: NO Prior Authorization Required: YES Part(s) Kit Number: N/A Part(s) Return: N/A

CERTAIN 2025 – VIBE: VBT2400RB, VBT2500DB, VBT2500SP, VBT2600RK, VBT2800RL, VBT3400BH, VBT3400SB & VBT3400XL

High Pointe TF044E4MD-SHODKO Recall Step-by-Step Correction

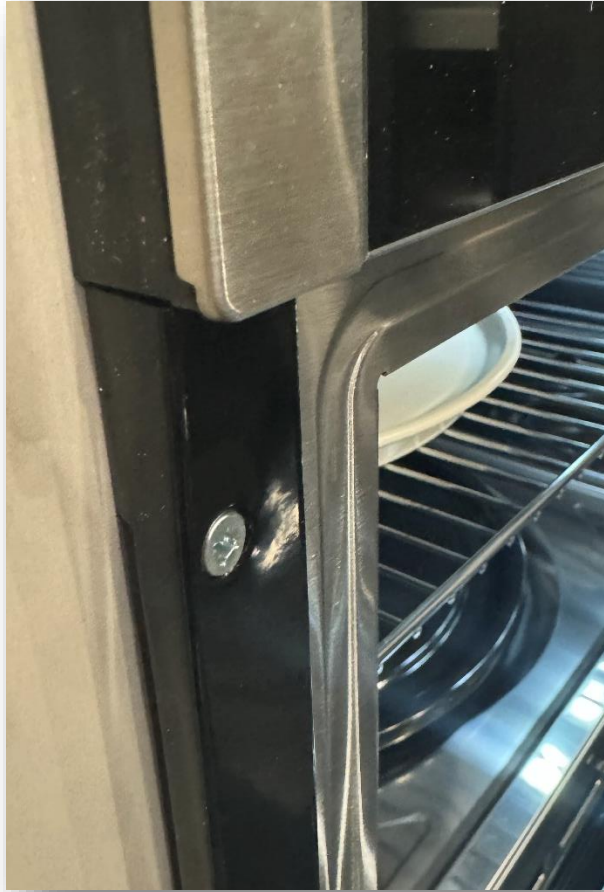
Step 3: Upon the installation of the plywood backer behind the cabinet's face, the microwave may be reinstalled using a 2-inch #10 flat self-piercing wood screw. Please refer to the accompanying reference for further details.
