QB Instruction VCC-494157-2

Title	Rear seat, second row	Page	1 (4)
Action	Inspection	Operation number:	99922-2

Model year	Model
2025	EX90

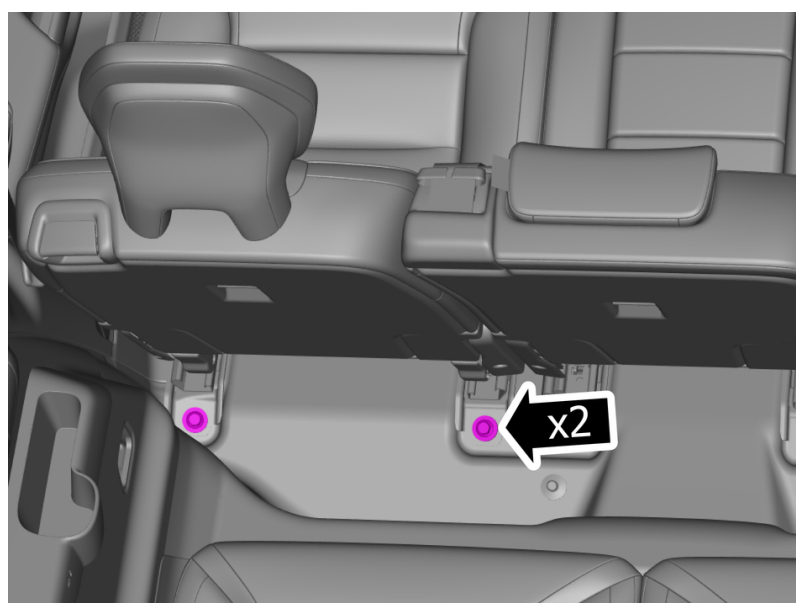
On both sides.

Torque:

Rear seat, to body , 40 Nm

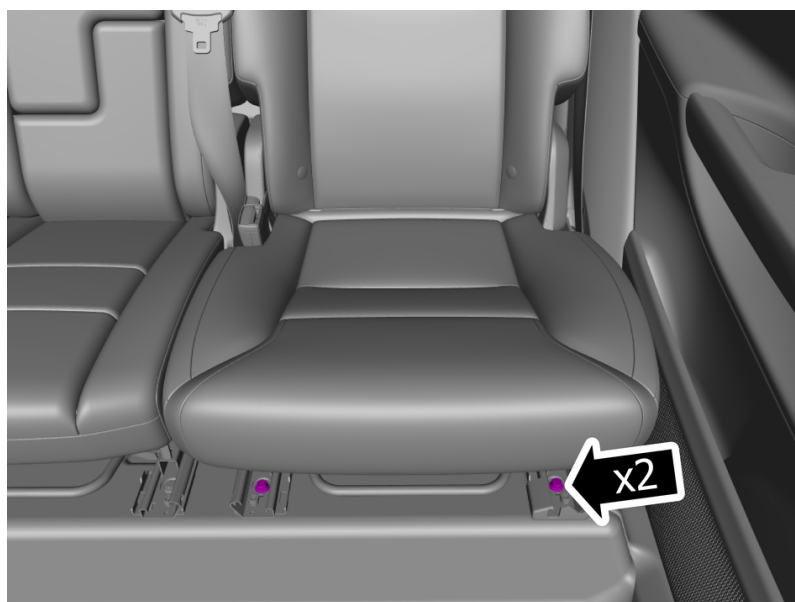
On both sides.

Torque:

Rear seat, to body , 40 Nm

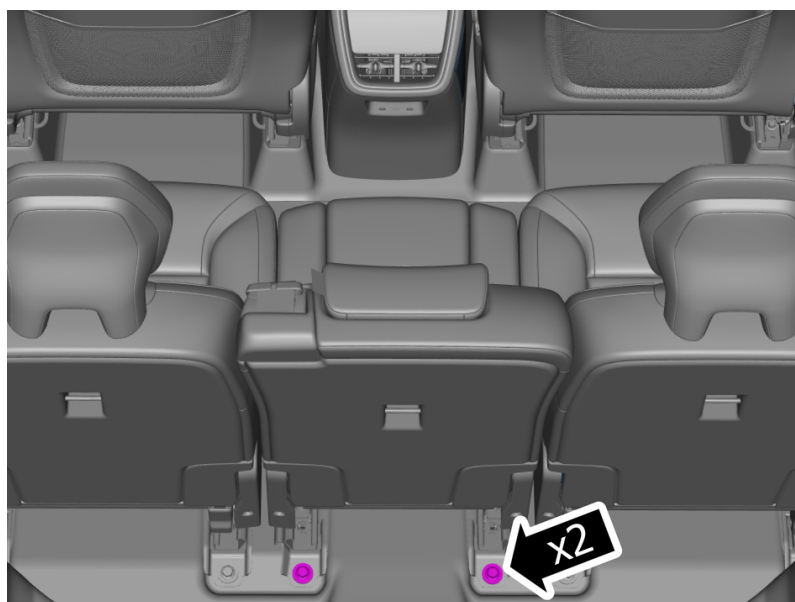
Torque:

Rear seat, to body , 40 Nm

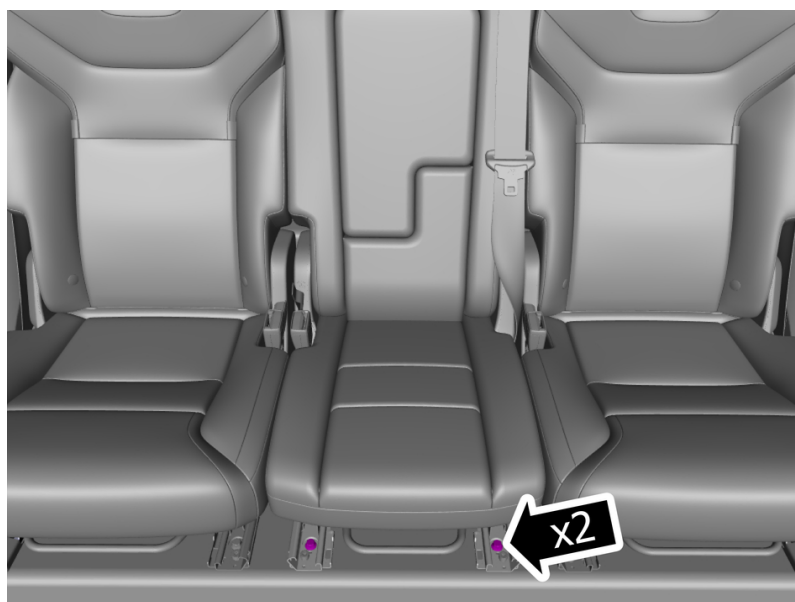
**Torque:**

Rear seat, to body , 40 Nm
