RECALL 24V929 / 2024-758 REMEDY INSTRUCTIONS

FOREST RIVER	Make(s): R. POD Model(s): RPT197 & RPT205 Model Year(s): 2025	Repair Code: RC-706-09-00-004654 Allotted Time: .60 HRS. Inspection Code: RC-706-05-00-004653 Allotted Time: .10 HRS.
	Concern: The LP tray may not have adequate fasteners attaching it to the chassis.	Photo(s) Required: NO Prior Authorization Required: YES Part(s) Kit Number: SOURCE LOCALLY Part(s) Return: N/A

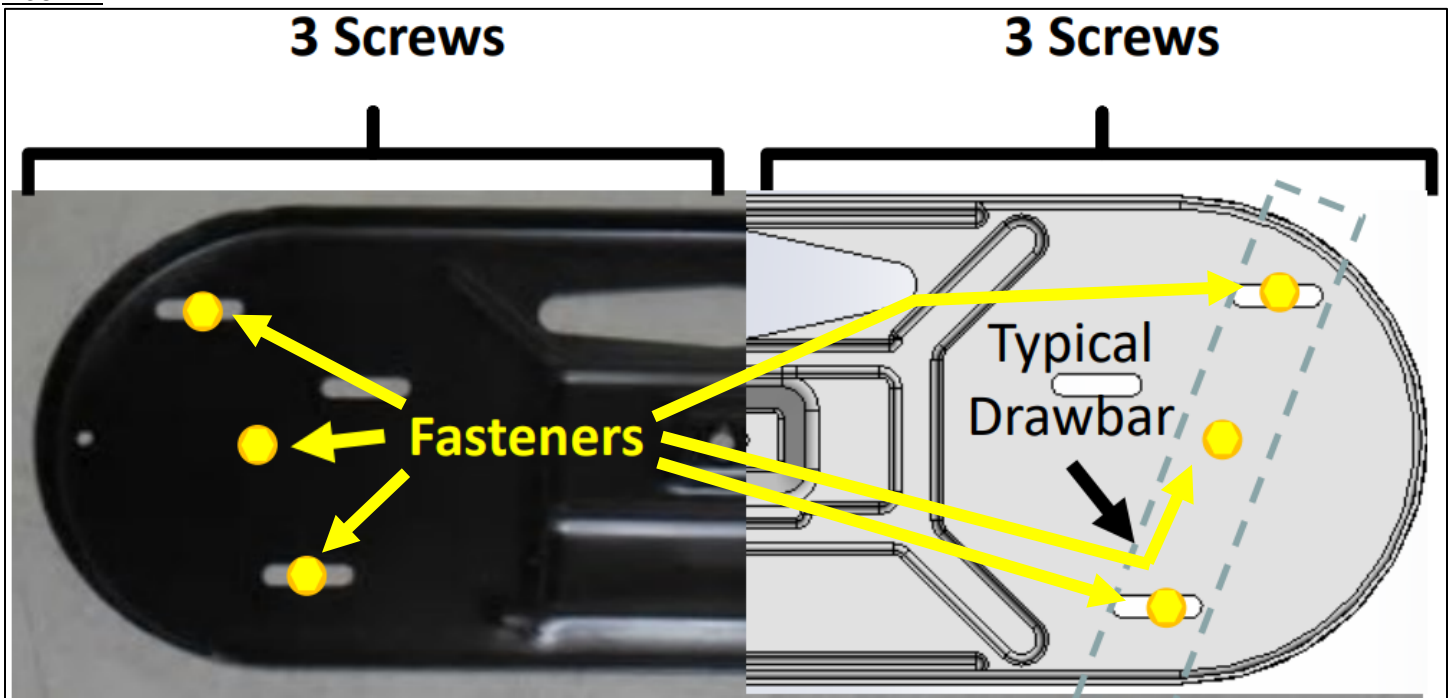
STEP 2: INSPECT FOR 6 FASTENERS ATTACHING THE LP TRAY TO THE A-FRAME OF THE CHASSIS;

- IF 6 FASTENERS ARE COUNTED PRESENT (AS SHOWN IN FIGURE 1), CLAIM THE INSPECTION CODE ONLY;
- IF THERE ARE **NOT** A TOTAL OF 6 FASTENERS (AS SHOWN IN FIGURE 1), MOVE ON TO THE REMEDY;

STEP 1: REFERENCE FIGURE 1 FOR PROPER LOCATIONS OF THE FASTENERS;

STEP 2: INSTALL THE FASTENERS, **THE TOTAL COUNT OF FASTENERS NEEDS TO BE 6:**
