TRAIL KING industries

NHTSA Recall Number: 24V670
Trail King Recall Number: TK202401

IMPORTANT SAFETY RECALL – 3rd NOTIFICATION

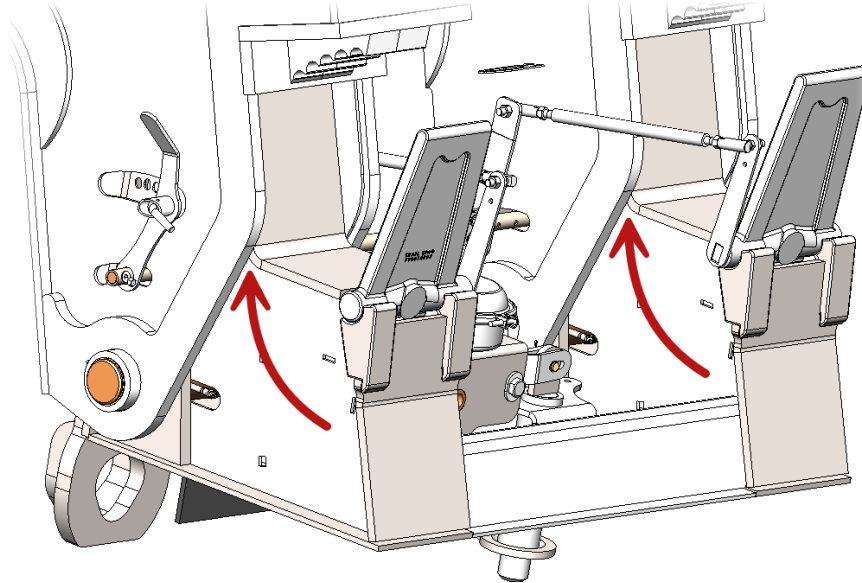
Figure 1 – GN Inspection Location

- All cracks will need to be evaluated by Trail King customer service to determine repairs.
- Inspect the webs near the bottom of the cylinder mounting plate to the riser panel web on the lower cylinder mount assembly. This will be visible on the outside and inside of the gooseneck during the gooseneck inspection.

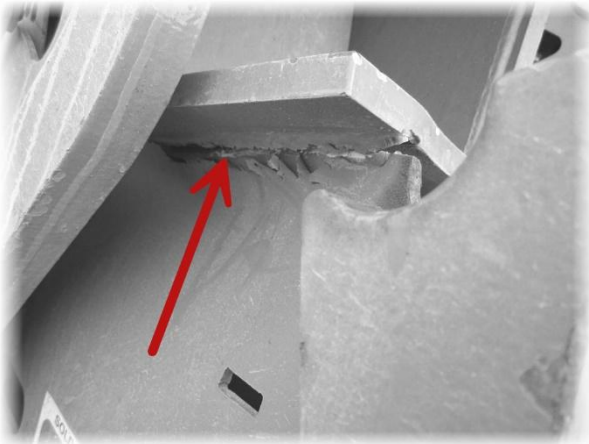
The gooseneck lift cylinder lower mount can develop cracks and could fail during the raise or lowering of the gooseneck throughout the loading operations. If the lower mount fails, the trailer may drop to the ground increasing the risk of injury to the operator. Once in the transport position, it cannot fail due to a mechanical stop that supports the load for transport.

The picture above shows an example of a crack on the outside of the lower cylinder mount assembly.

Trail King Industries is conducting a safety recall campaign to address this issue. An authorized Trail King Industries Service Center will provide new reinforcements for the Paver Special hydraulic detachable gooseneck lower lift cylinder mount. This repair should take approximately 15 hours and will be performed at no charge to you.

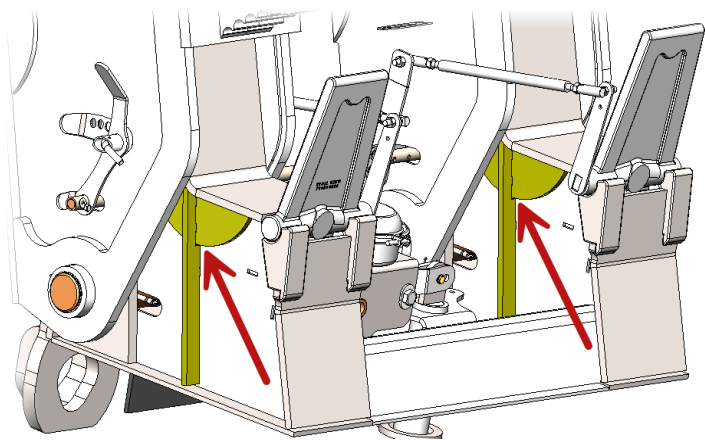
- Inspection should include looking for any cracks and/or for the added reinforcements. Note: These reinforcements should be on the outside and the inside of each lower cylinder mount assembly.

The picture above shows the newly added reinforcements. If the lower cylinder mount has these, no further measures need to be taken.
