Safety Recall Notice

601309 REV A.

NHTSA Recall 24V888

Applicable for 2024 Chrysler Pacifica & Voyager
I4, E4 & CV

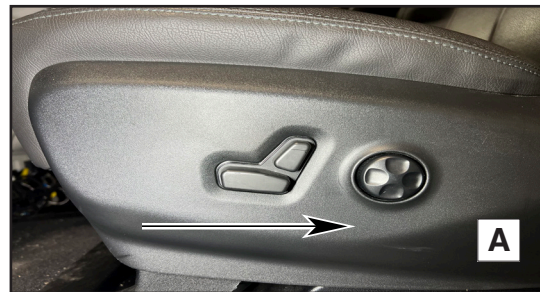
1. Adjust the driver front seat to its rear most position. See Photo A.

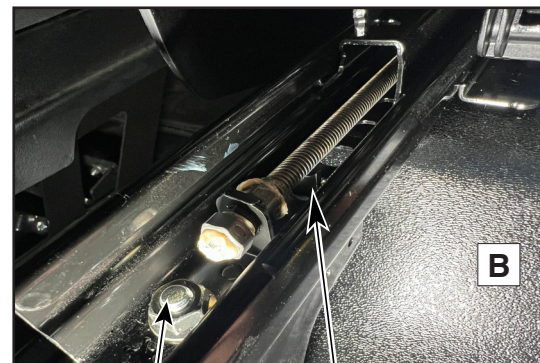
2. Verify if the stop bracket, bolt and nut are installed on both the inboard and outboard seat tracks. See Photo(s) B.

Bolt & Nut

Stop Bracket

NOTE: If the stop bracket, nut and bolt are installed, no further steps are needed. If they are NOT, proceed to Step 3.

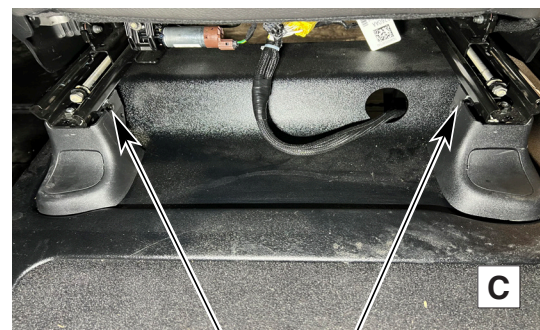
3. Remove the torx screw(s) securing the seat track covers followed by the covers. See Photo C.

NOTE: I4 and E4's will have one screw for each panel. CV's will have additional screws securing the rear of the panel.

T20 Torx Screws

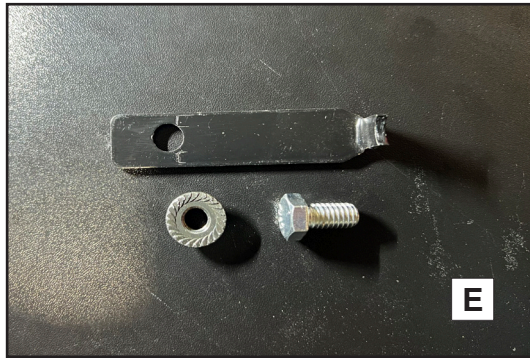
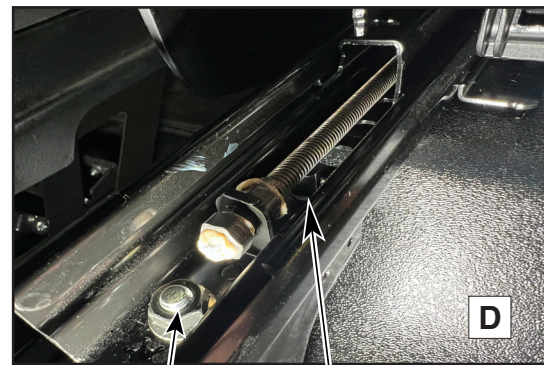
4. Install the stop bracket, bolt and nut.
See Photo D.

NOTE: Hardware shown below. See
Photo E.

Bolt & Nut Stop Bracket

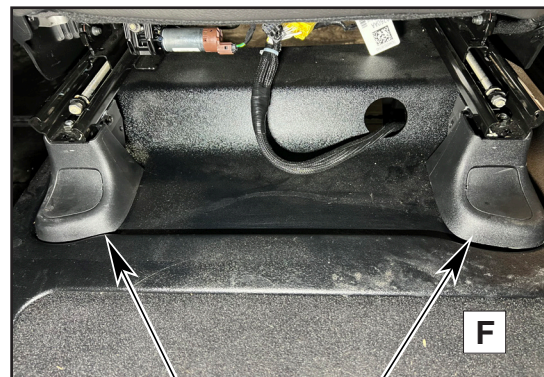
5. Reinstall both of the seat track covers.
See Photo F.

Covers
