Recall Information Bulletin

No: C10131 Issued: 1/17/2025

Safety Recall C10131 – Vehicle Control Unit Circuit

FEC7K (E16L/E16M), FEC9K (E18L/E18M)

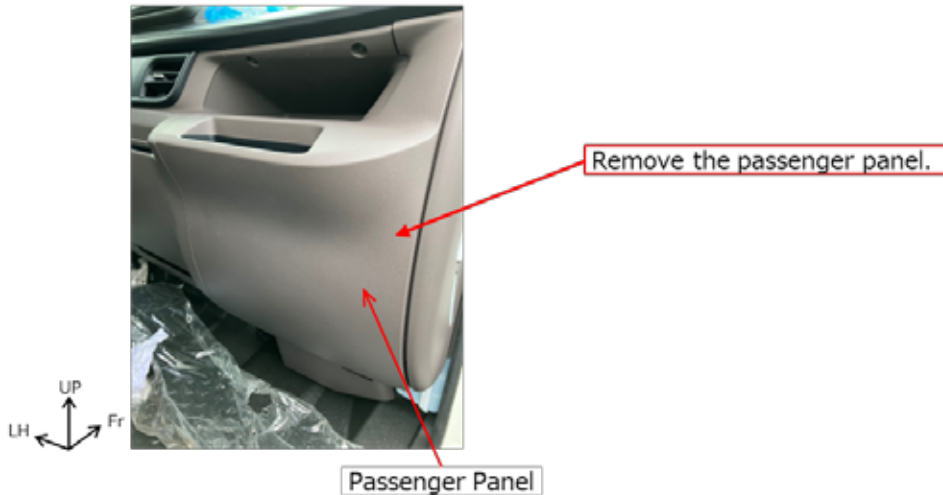
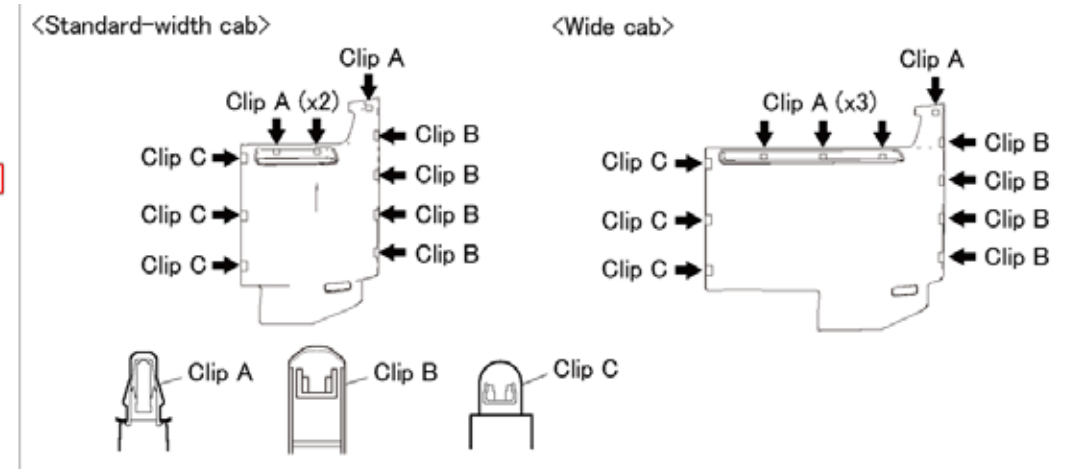
Step-2 :
Remove the passenger side panel.

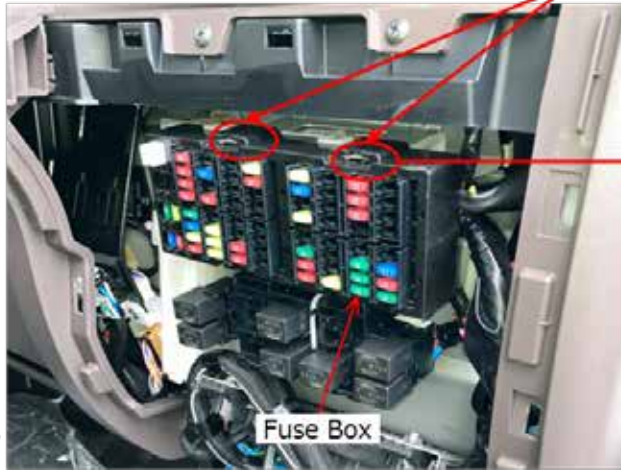
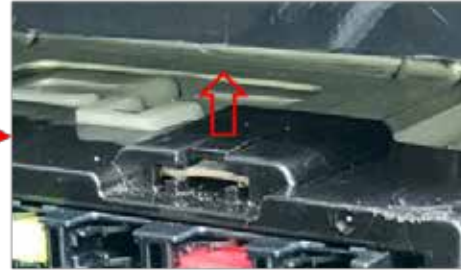
Remove the fuse box from the bracket.

Lift the tab (2 places) on the fuse box to unlock it, and then remove the fuse box from the bracket.

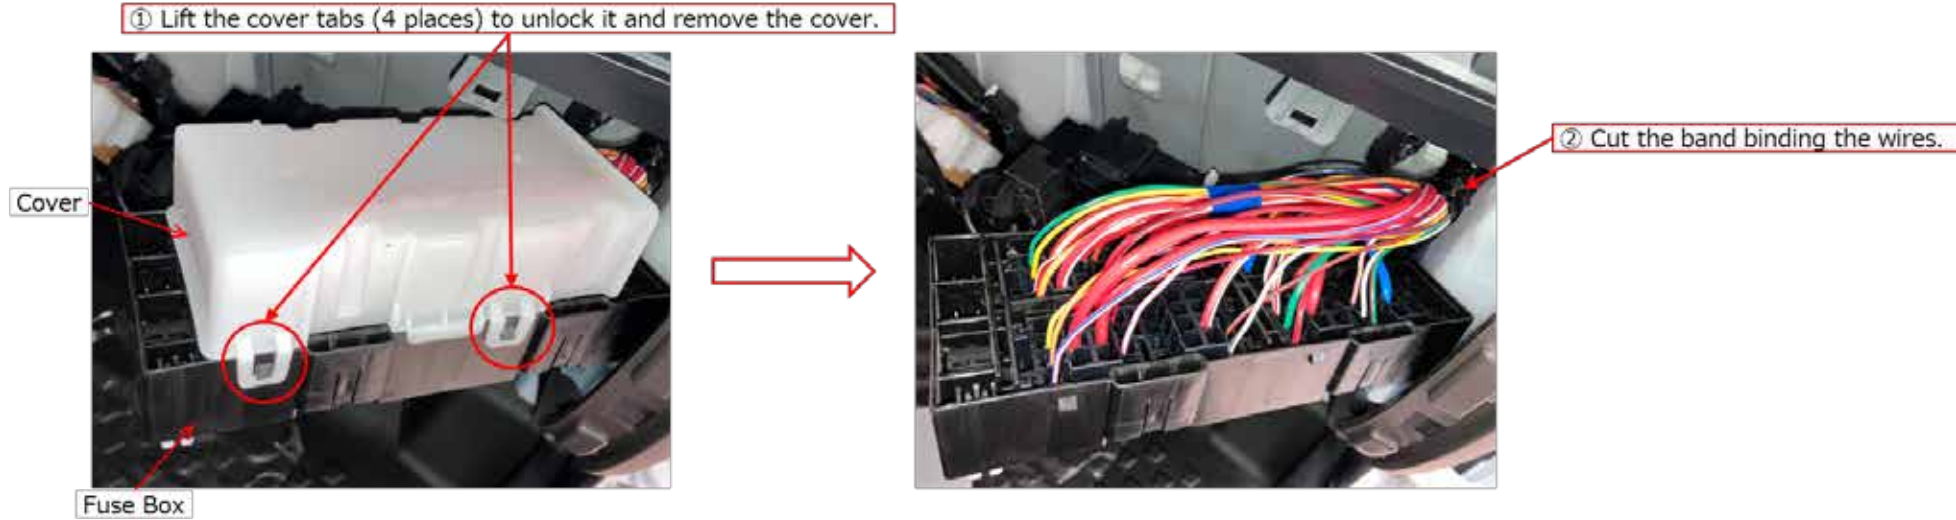
Remove the cover on the back of the fuse box and cut the band binding the wires.

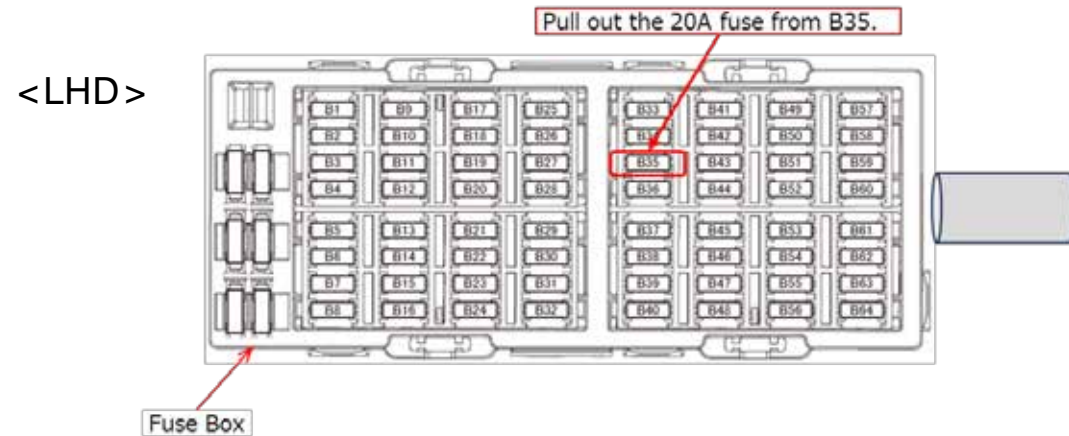
Remove the 20A fuse from B35 in the fuse box.

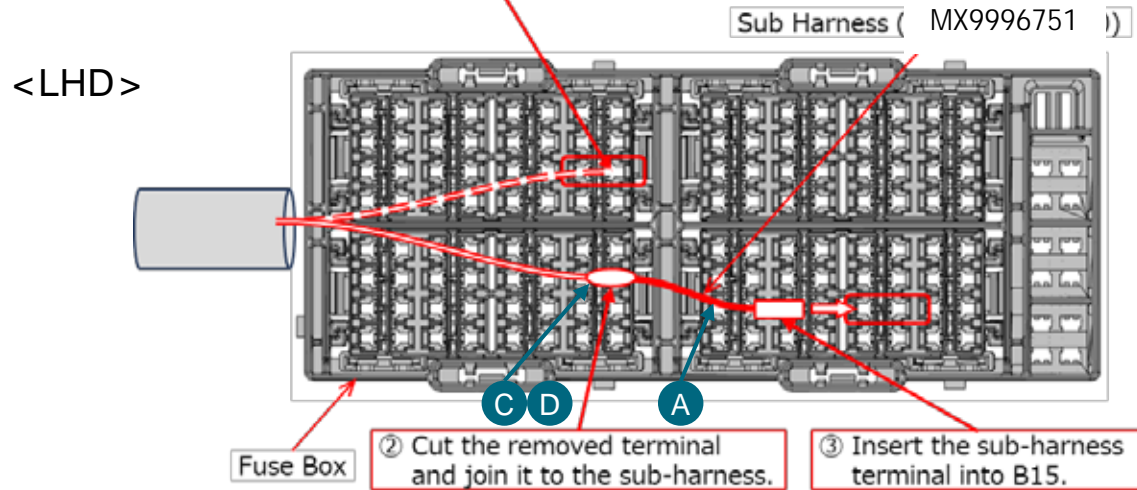
Remove the terminal (W/R) from B35 in the fuse box and connect to B15.

(Only LHD : use the sub-harness to extend harness to B15)

① Pull out the terminal (W/R) from B35.

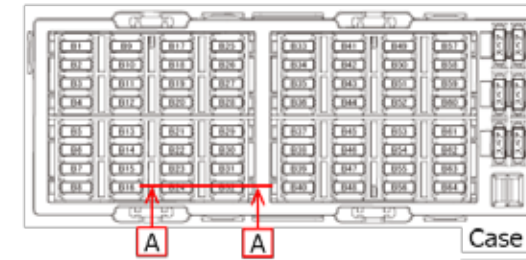
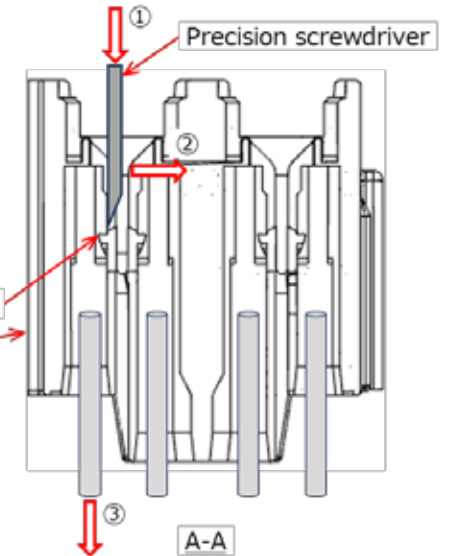
<Fuse box terminal removal instructions>

- ① Insert a precision screwdriver into the gap between the terminal and the case lance.
- ② Move the precision screwdriver in the direction of the arrow to lift the case lance and unlock it from the terminal.
- ③ Gently pull the wire to remove the terminal from the housing.

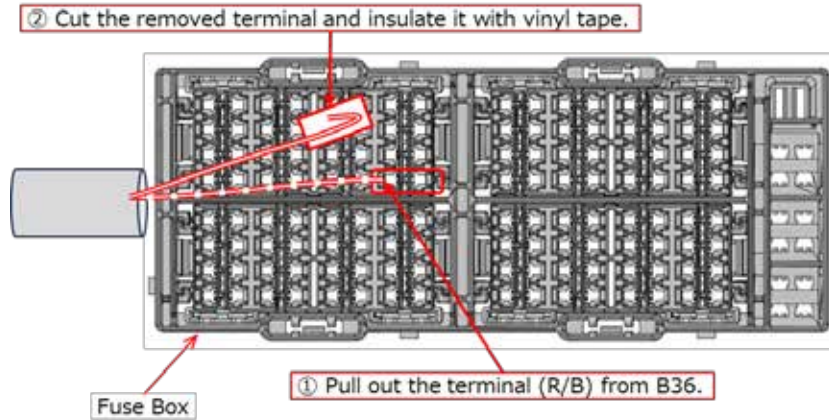
Remove the terminal (R/B) from B36 in the fuse box, cut the terminal, and insulate it with vinyl tape.

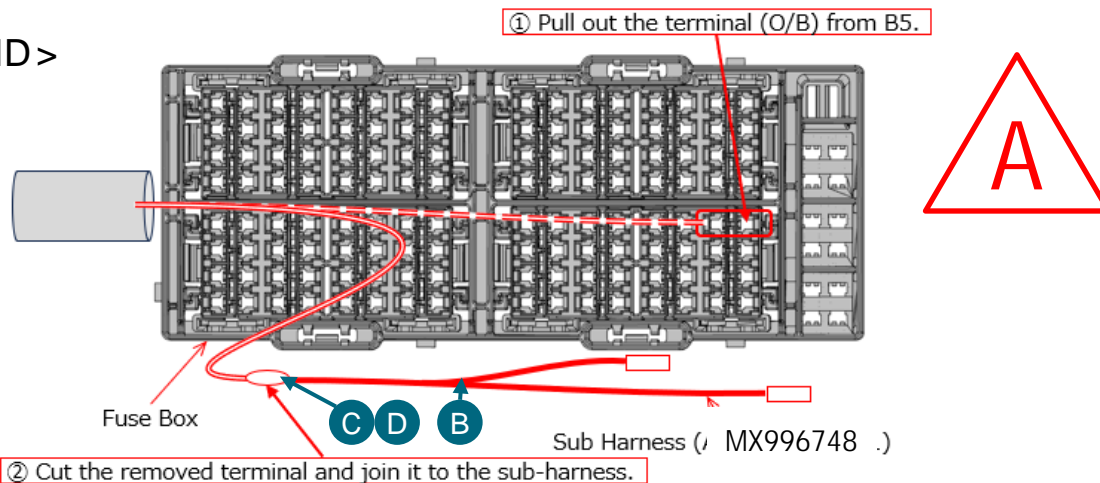
Remove the terminal (O/B) from B5, cut the terminal, and connect it to the sub-harness.

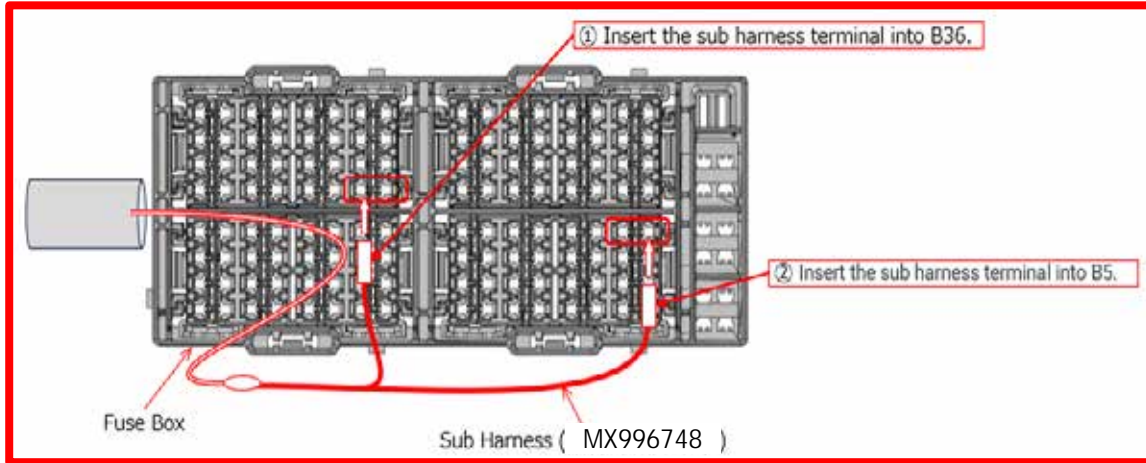
Insert the sub harness terminals into B36 and B5 of the fuse box.

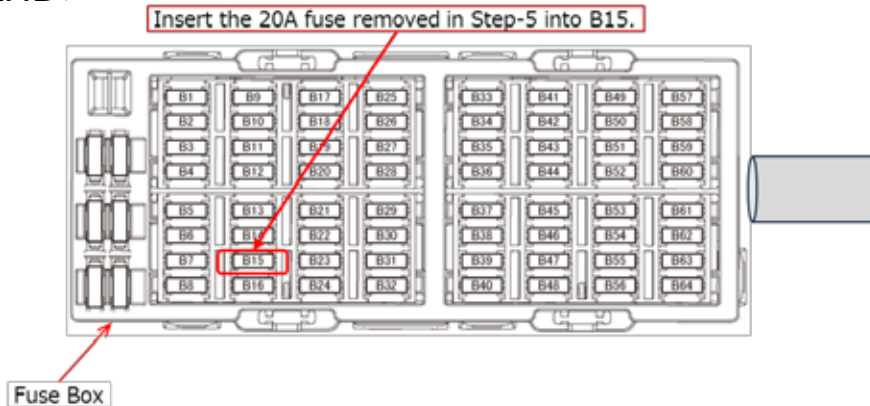
Insert a 20A fuse into B15 in the fuse box.

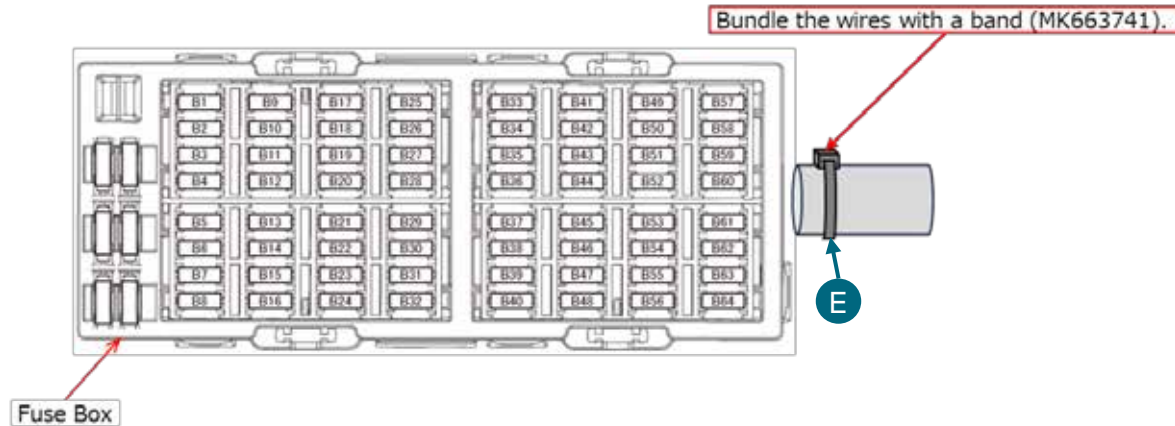
Bundle the wires with a band (MK663741) and cut off the excess length of the band

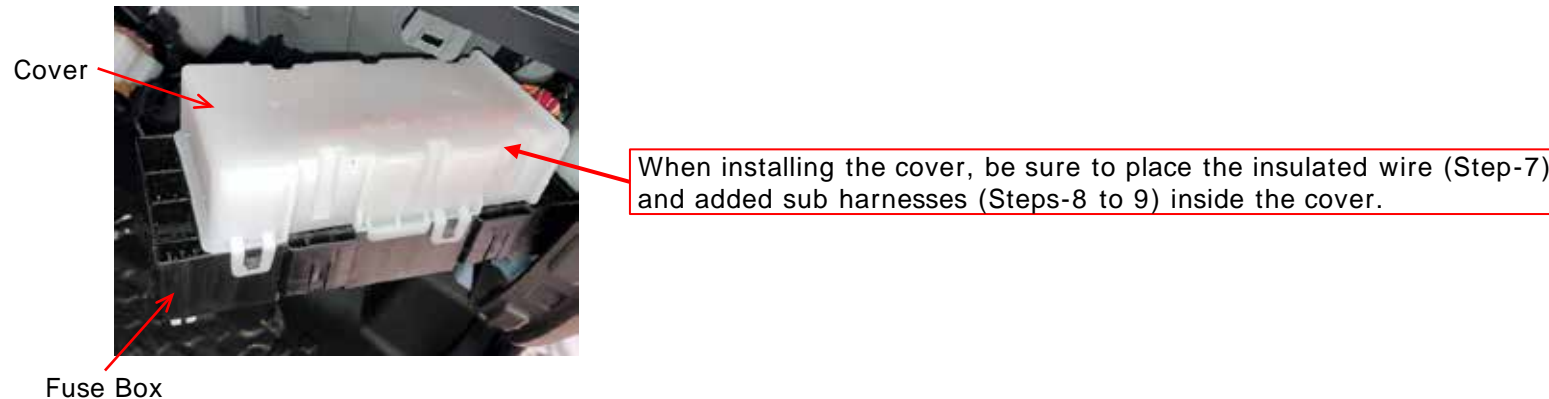
Restore the vehicle by reversing steps 3 to 4. When installing the cover on the back of the fuse box, be sure to place the insulated wire and added sub harness inside the cover.

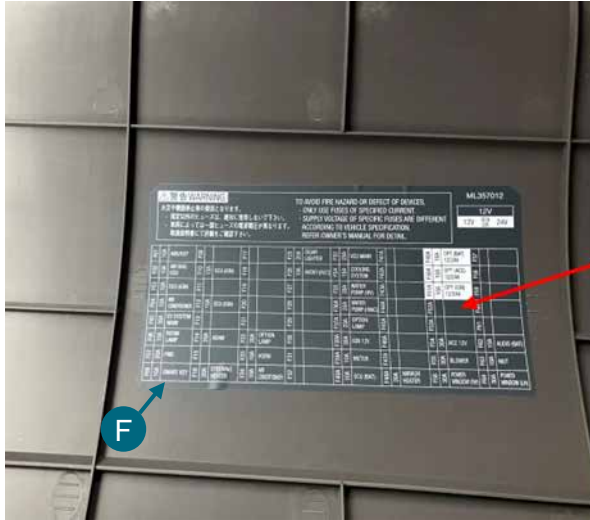
Remove the fuse information label (MX995730) from the back of the passenger side panel that was removed in step-2 and paste the countermeasure parts.

Peel off the fuse label and paste the countermeasure parts.

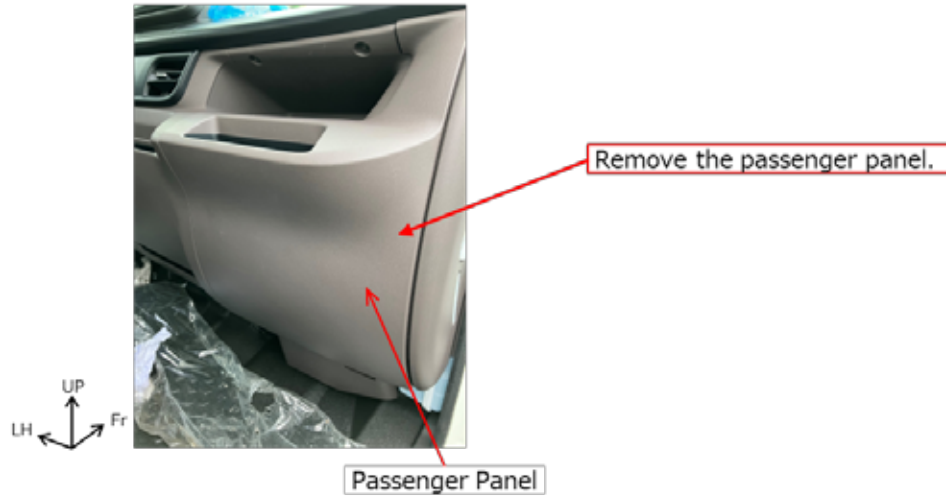
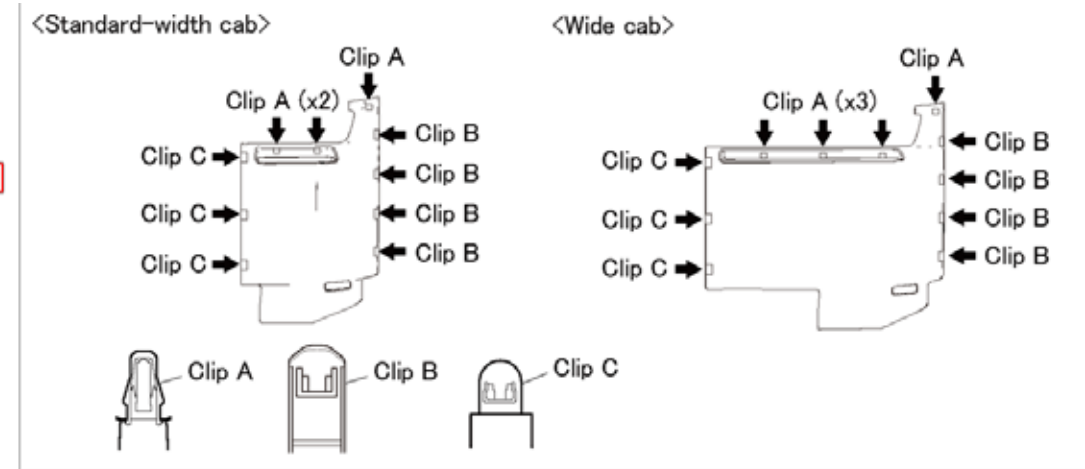
Step-1 :
Remove the passenger side panel.

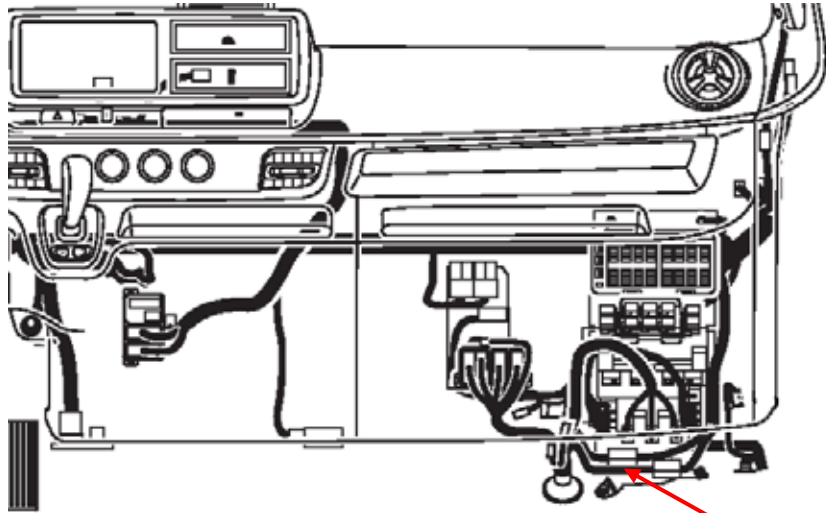
Check C6 connector condition

Based on the flow chart for the field fix action, check the condition of the C6 connector.

- If connector housing color change / melting / damage is found, go to Step-3
- If no abnormalities are found, restore the vehicle by reversing step 1 and the procedure is complete.

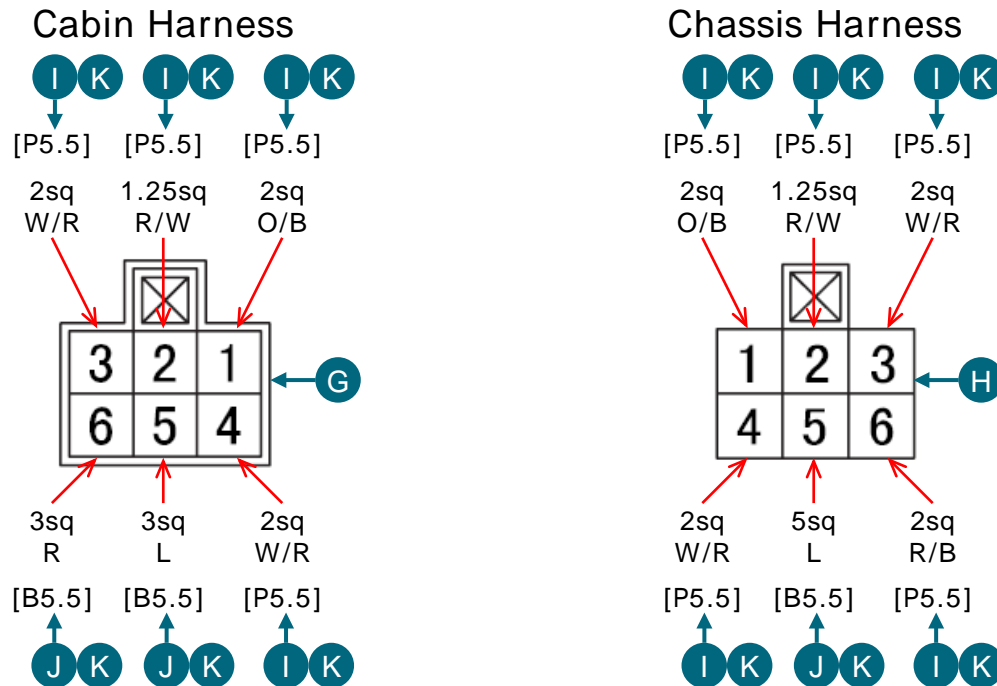
If only the connector housing is discolored but no deformation or other damage is found in the housing:

2 à Replace only the connector housing (do not use the terminal kit from the repair kit). **G H**

If the connector housing is melted or deformed:

3 à Replace both the terminal kit and the housing.

Please refer to the following for the joint terminals to be used.

(Please note that it is necessary to use P-Type or B-Type depending on the wire diameter.)

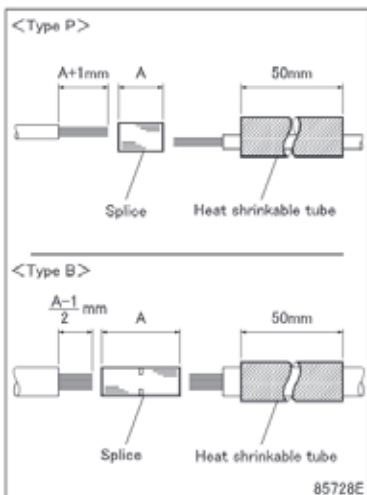
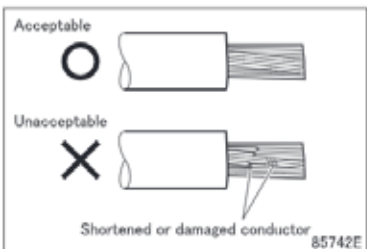
Connection with joint terminal

Slide a piece of heat shrinkable tube over the wire on one side, then strip the plastic insulation off the wire ends on both sides. (See "5. Stripping insulation off wires" in P1-20.)

The heat shrinkable tube is available in the following two types:

Heat shrinkable tube	
MC037692 (Inner diameter: 7.4mm)	
MK410770 (Inner diameter: 7.5mm)	K

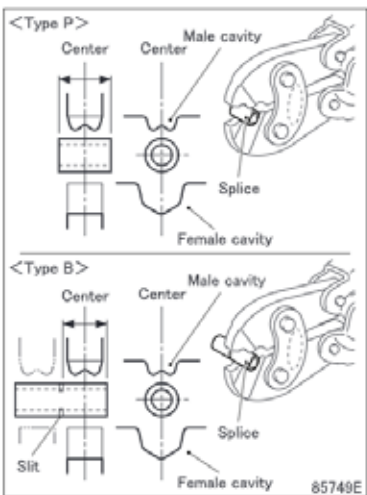
- Open the jaws of the wire clamping tool to a sufficient width.
- Place the splice sleeve on the crimping section of the wire clamping tool as described below, then gradually close the handles until the sleeve is held securely.

<Type P>
Center the splice on the crimping section of the tool.

<Type B>
Align the midpoint of one sleeve segment (section from sleeve end to center slit) with the longitudinal centerline of the tool.

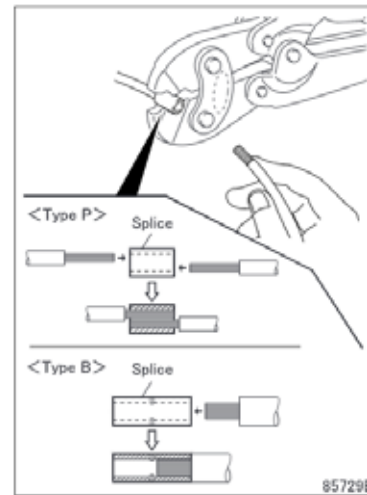
<Type P>

With the splice sleeve held in this position, insert the wires to be joined into the sleeve, one from each end, until the insulation-stripped sections of the wires overlap each other up to their root.

<Type B>

With the splice sleeve held in this position, insert each of the wires to be joined into the sleeve until the insulation comes in contact with the sleeve end face.

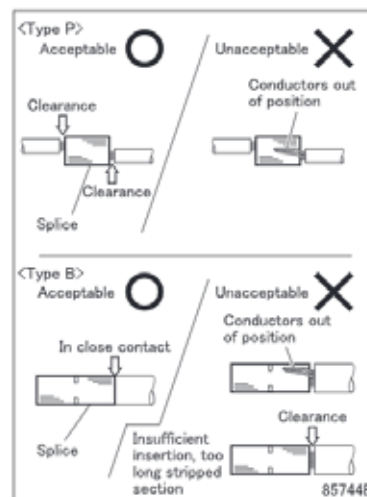
Condition judgment of wires inserted in splice.

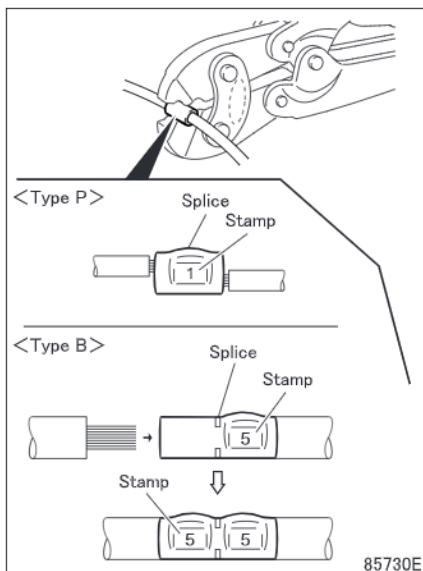
- Fully close the handles of the wire clamping tool. The handles will then come open again and the crimping operation will be complete.
- The area crimped with the wire clamping tool is stamped on the splice.

Area crimped	Stamp
1.25	1
2	2
5.5	5

- Make sure that the wire clamping force satisfies the values in the table below.

Wire size	0.5	0.85	1.25	2	3	5
Wire clamping force (N {kgf} or more)	88 {9}	125 {13}	165 {17}	245 {25}	345 {35}	390 {40}

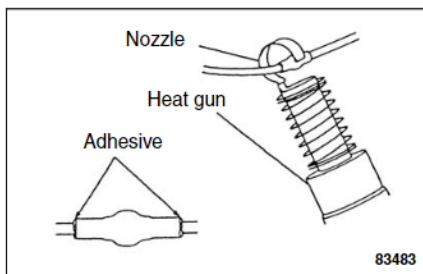
- Set the heat shrinkable tube at the center of the crimp cavity. Heat it with a heat gun (See Special tools on P2-2.) to shrink the heat shrinkable tube.

After crimping, check the following items:

- Check if the wire insulation is inside the heat shrinkable tube.
- Check if adhesive is coming out from the ends of the heat shrinkable tube.
- Check if the heat shrinkable tube is shrunk completely to the wire.
- Check if there is any damage or crack on the heat shrinkable tube.
- Check if the wire is deformed by heating.

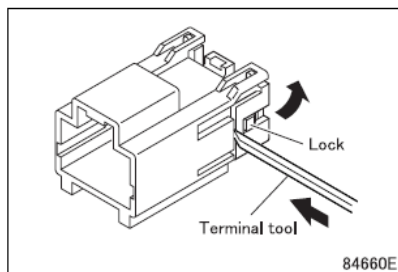
<Retainer for 4 or more pin>

- Insert the tip of the terminal tool (MH062845) into the gap between the retainer and the housing near at one of the two locks.
- Pry up the retainer to release the lock.
- Release the other lock on the opposite side in the same manner. Then, pull out the retainer while turning it.

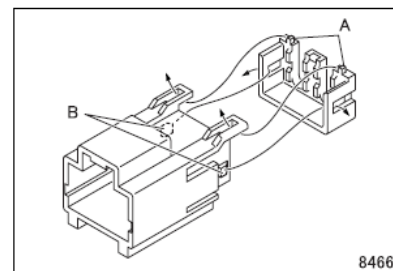
<Retainer for 4 or more pin>

- Fit the projections A into the corresponding openings in the housing, then fit the projections B on the housing into the slits in the retainer.
- Check to confirm that the retainer is held evenly on both sides and that it is firmly locked into the left and right arrester section on the housing.

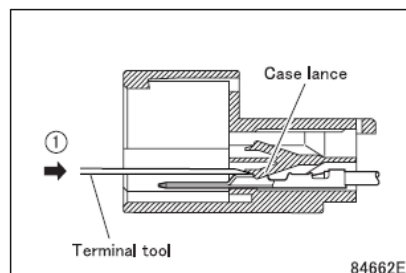
● Removal of male terminal

- ① After removing the retainer, insert the tip of the terminal tool (MH062846) into the gap between the terminal and the case lance.

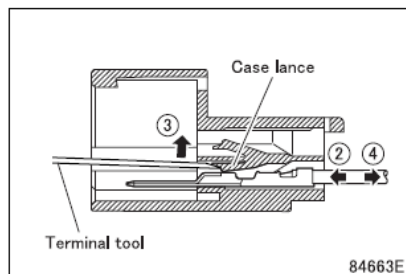
- ② Push in the terminal until it stops moving.

- ③ Move the terminal tool in the direction shown in the figure to push up and release the case lance from the terminal.

When pushing up the case lance, never allow the terminal tool to come in contact with the terminal. Contact may deform the terminal. The terminal then may be bent when the connector is mated with a female connector, which can cause the terminal to come out of position, resulting in poor continuity.

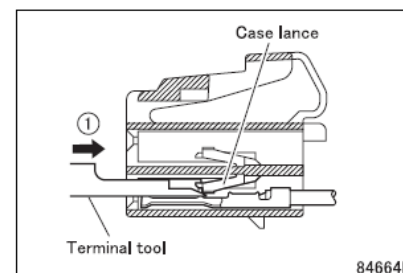
● Removal of female terminal

- ① After removing the retainer, insert the tip of the terminal tool (MH062844) into the gap between the terminal and the case lance.

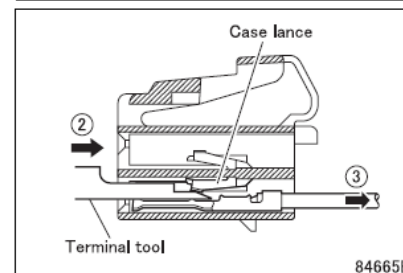
- ② Insert the terminal tool farther, and the case lance will be pushed up and the terminal will be unlocked.

- ③ Pull the wire gently to remove the terminal from housing.

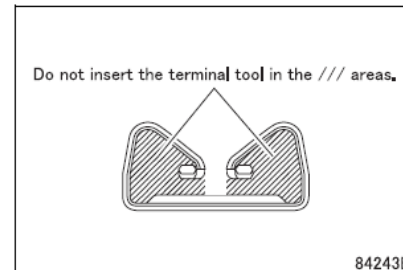
Never insert the terminal tool in the terminal socket. This can lead to deformed or damaged terminal contact and thereby to poor contact.

If the terminal tool is inserted in the socket accidentally, always replace the terminal with a new one even if it appears to be free from any damage.

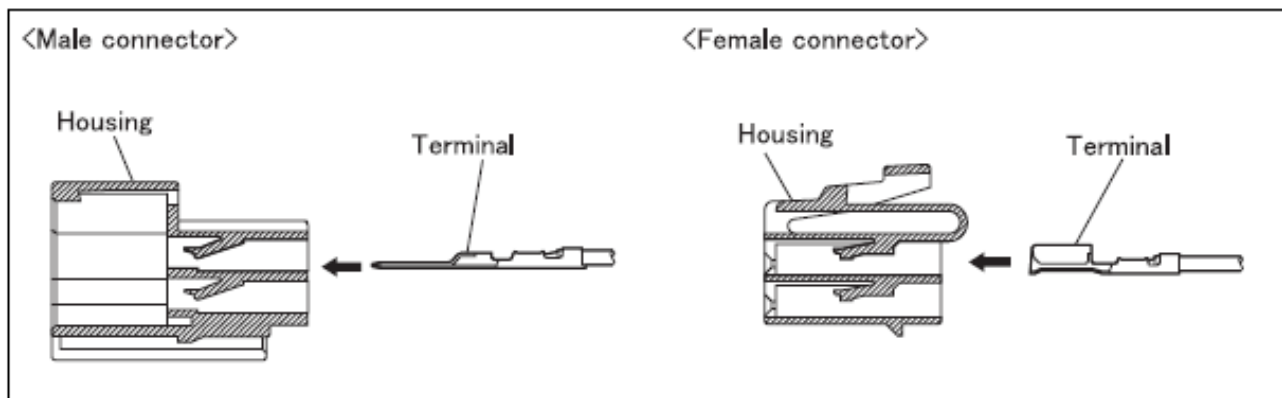
●Fitting of terminal

- Insert the terminal straight into the housing from the backward.
- Push in the terminal until a "clicking" sound for locking is heard.
- After completing the insertion, pull the wire gently to verify that the terminal is securely locked.

If the terminal fails to be fitted into position or if it comes out of position when pulling the wire after fitting, upside down fitted terminal, deformed case lance or deformed terminal is suspected. Determine the cause and replace the faulty parts if any. Then, repeat the steps.
