Recall Notice

Recall #TS-0042 : Trailer Winch Strap Routing

Tracker Topper™ Trailer 374140 KIT, TRAILER ROLLER INSTALL

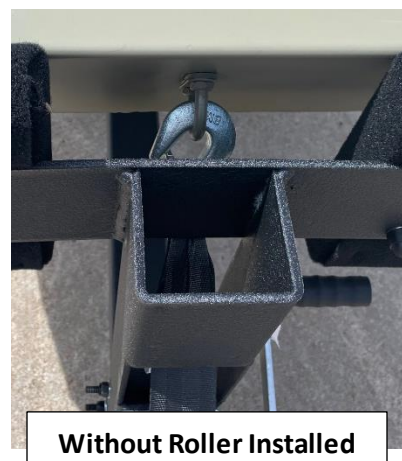
Current State: Assess the current condition of the winch stand to confirm that it has not undergone any modifications, such as the addition of a 3-inch strap roller. During this assessment, it is crucial to inspect the condition of the existing winch strap. Verify that there are no signs of fraying or damage to the strap. If any damage is detected, kindly request a replacement.

Without Roller Installed

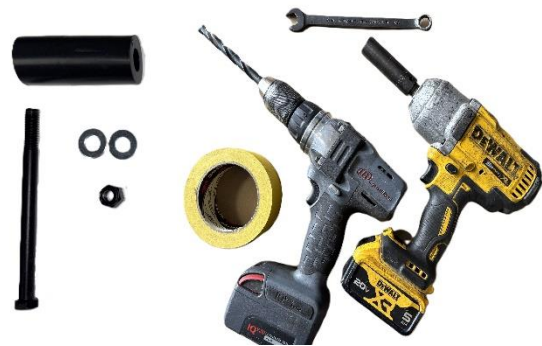
Description	QTY
ROLLER, W/S, BLK, PL	1
SCREW, HXCAP, 3/8-16X4.5 GR5, CTD	1
NUT, NYLOCK, CTD, 3/8-16, BLK	1
WASHER, FLAT, 3/8, SAE, BZ	2

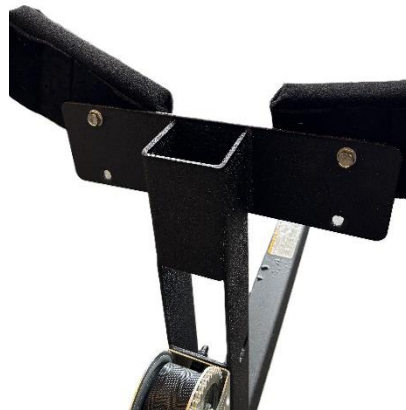
Step 1: Remove the lower two lag screws from the winch stand bunk boards and rotate boards 90 degrees as shown.

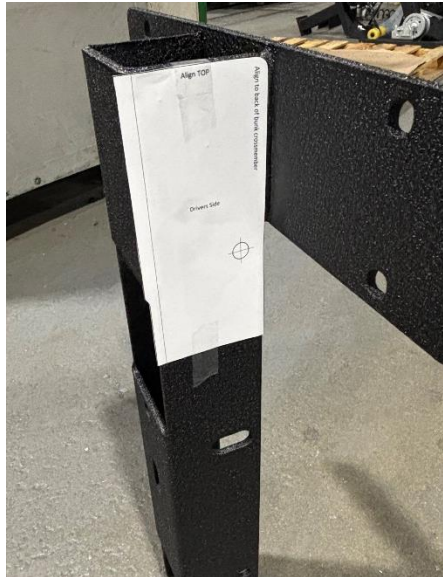
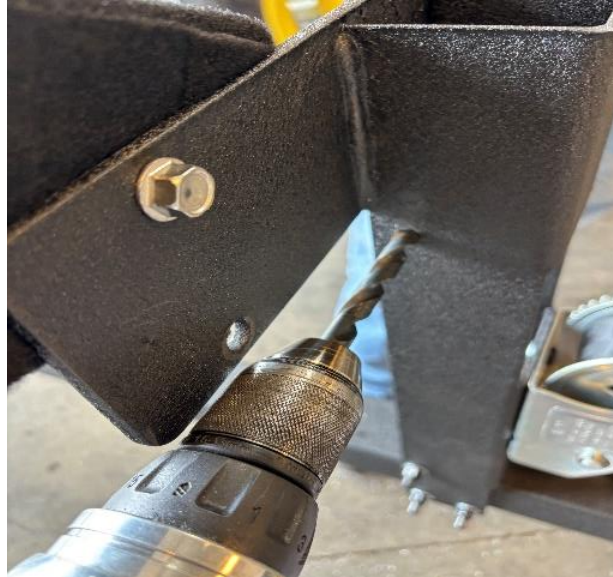
Step 2: Overlay the template provided on page (4) to mark the hole locations with a grease pencil.

Step 3: Drill the two 7/16" holes in the winch stand.

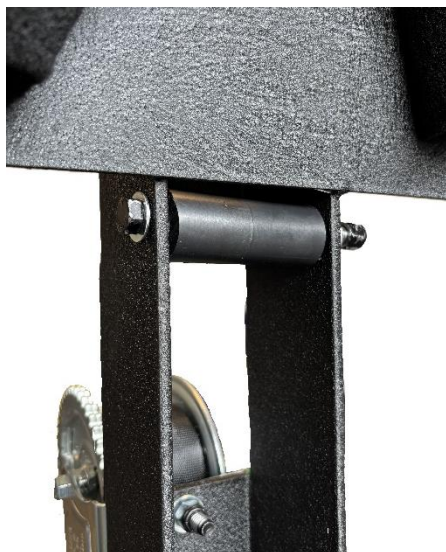
Step 4: Place a flat washer onto the 3/8" bolt and insert it through the first drilled hole on the winch stand. Simultaneously, slide the 3-inch roller between the two holes, ensuring the bolt passes through until it emerges from the other side.

Step 5: Attach a flat washer and nut onto the 3/8" bolt and securely fasten the nut.
