## Safety Recall Launch Notification

Campaign #	NHTSA ID	Description	<b>Replace Front Short-Range Radar Sensor</b>
2025110002	25V711	25P3091002

# Recall Campaign Bulletin

CAMPAIGN NO.	<b>2025110002</b>
CAMPAIGN DESC.	<b>25P3091002</b>
NHTSA ID	<b>25V711</b>
SUBJECT	<b>Replace Front Radar Sensor</b>
MODEL(S)	<b>G-Class (465 platform)</b>
MODEL YEAR(S)	<b>2025</b>
CAMPAIGN POPULATION	<b>12</b>

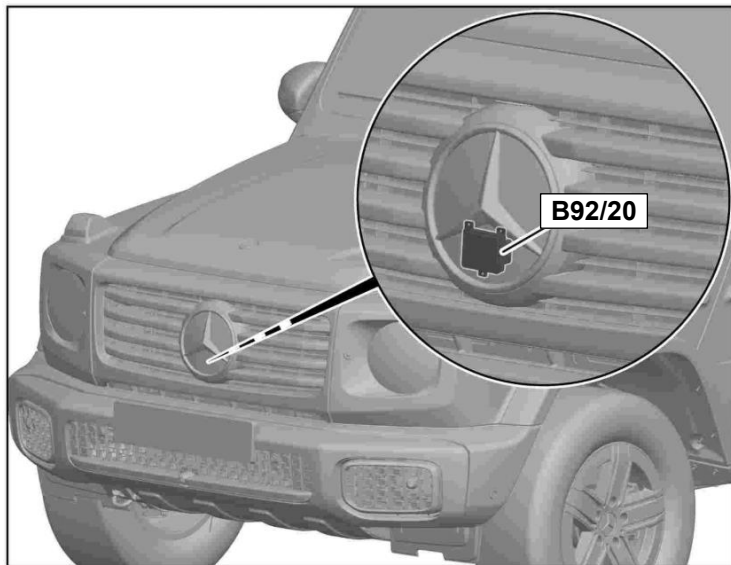
Figure 1

1. Replace front **Midrange radar (B92/20)**.

**i** For basic repair information, see AR54.21-P-0701XG.
