IMPORTANT SAFETY RECALL

NHTSA Recall Number: 25V581

Altec Identifier: CSN-3247

Tank Heater Relay Replacement

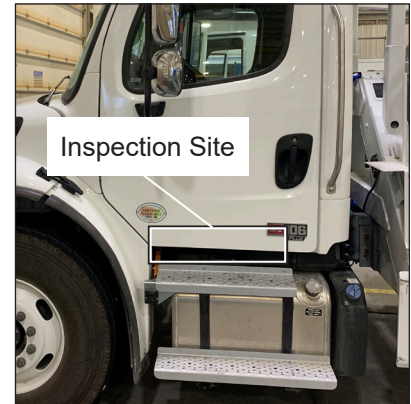
Figure 1 — Locating the Relay

3. On the street side of the unit under the vehicle cab, confirm if the unit has relay 059500048 or relay 990895200 installed (refer to Figures 1, 2, and 3).

- If no relay is installed, no repair is required. Proceed to step 4.
 - If either relay is installed, repair is required. Proceed to step 5.
4. No repair is required.
