Certification Labels - Incorrect Tire Aspect Ratio Information

Bulletin Type:	Recall	Publication Date:	February 2025
Bulletin #(s):	25V-054 US 2025-046 Canada	Make(s):	Highland Ridge
Job Code(s):	9904618	Model(s):	Open Range 3X FW
Flat Rate(s):	9904618 - 0.3 Hr. Labor - Replace Certification Label	Model Year(s):	2025

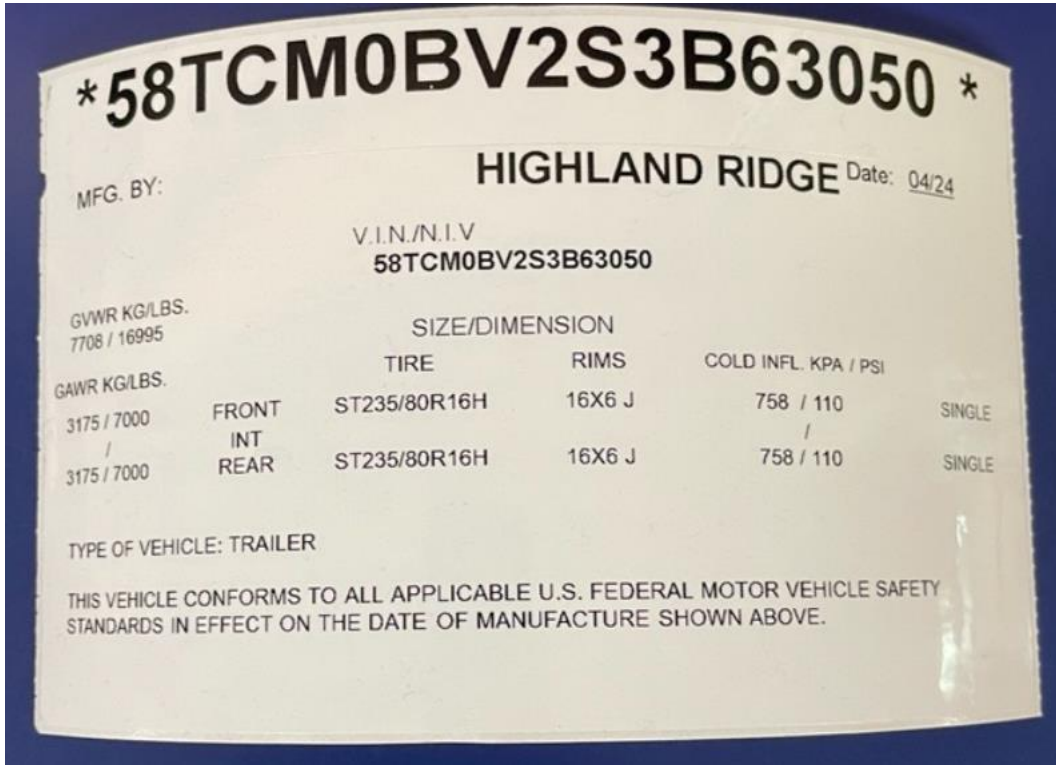
Incident:	Certification labels have the incorrect tire aspect ratio listed. Labels show the incorrect tire aspect ratio of 85 instead of the correct tire aspect ratio of 80.
Affected Units:	2025 Highland Ridge Open Range 3X FW
Part:	Part: Certification Label enclosed in owner/dealer notification letter
Misc. Tools & Supplies:	Isopropyl alcohol Shop rag
Parts Return Information:	N/A

The certification label below is only an example of the label you are to replace.

1. The location of the certification label will be on the front off door side of the fifth wheel travel trailer.
2. Remove the existing label. Using isopropyl alcohol and a shop rag, remove any adhesive residue from the surface where the original label was removed.
 - a. Allow the area to dry for at least 30 seconds.

1. Remove the protective back from the new label. Align the new label in the same location of the original label and apply it to the surface. Remove any air bubbles from the label.
 - a. **Note:** Do not attempt to remove or adjust the label once it has touched the surface. Doing so may damage the label or cause it not to adhere properly to the surface.
