Technical information

TI No.: 91.10T25327A

Model: Tourrider USA

TITLE: Tourrider USA – stop (fixate stop) not mounted on backrest of ISRI driver’s seat

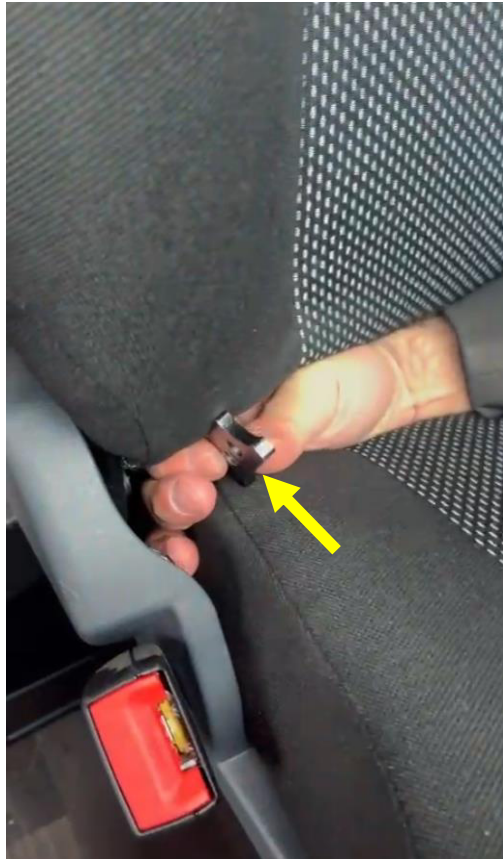
RETROFITTING

X
displayed without covers and seatframe
dargestellt ohne Abdeckungen und Sitzrahmen

- Fixate stop
loose in scope of delivery by seats without cover,
mounted by seats with cover
- Anschlag
beim Sitz ohne Bezug lose im Lieferumfang enthalten,
beim Sitz mit Bezug montiert
- Screw M₄×22Nm ±2Nm
loose in scope of delivery by seats without cover,
mounted by seats with cover
- Schraube M₄×22Nm ±2Nm
beim Sitz ohne Bezug lose im Lieferumfang enthalten,
beim Sitz mit Bezug montiert

Torque: 22 NM ± 2Nm

Pay attention to the correct orientation of the component!

Check whether the stop (fixate stop) is installed and retrofit if necessary.
